# Forensic ROOF® Inspection

**Report No :**  
129263

**Published On :**  
01/14/2024

**Inspection Date :**  
12/26/2023

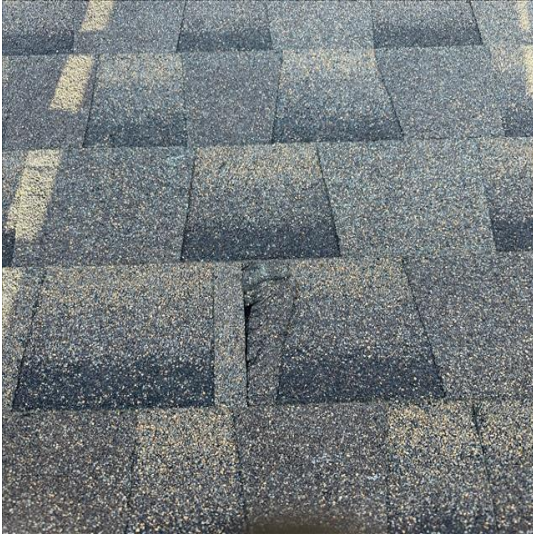
**Image Number: 1**

**Observation:** Damaged shingles were observed at time of inspection. These damaged shingles will deteriorate faster than the others and may present the chance of moisture intrusion at some point.

**Cause:** Improper installation. There were no indications that this damage was caused by a third party at time of inspection.

**Determination:** Roof Repair required for LeakFREE Roof Certification

**Remedy:** Replace shingles that are damaged.

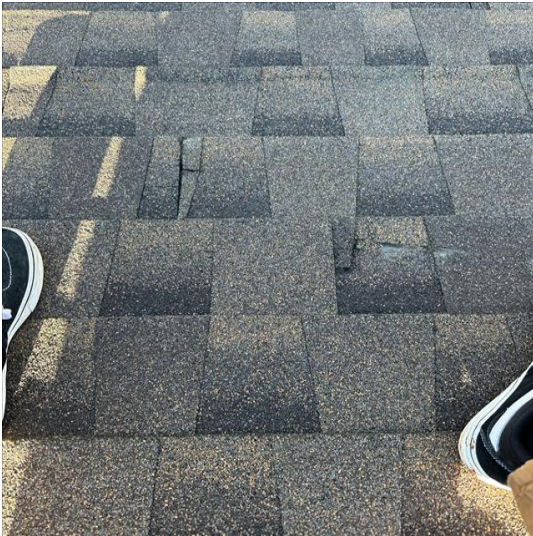
**Image Number: 2**

**Observation:** Damaged shingles were observed at time of inspection. These damaged shingles will deteriorate faster than the others and may present the chance of moisture intrusion at some point.

**Cause:** Improper installation. There were no indications that this damage was caused by a third party at time of inspection.

**Determination:** Roof Repair required for LeakFREE Roof Certification

**Remedy:** Replace shingles that are damaged.

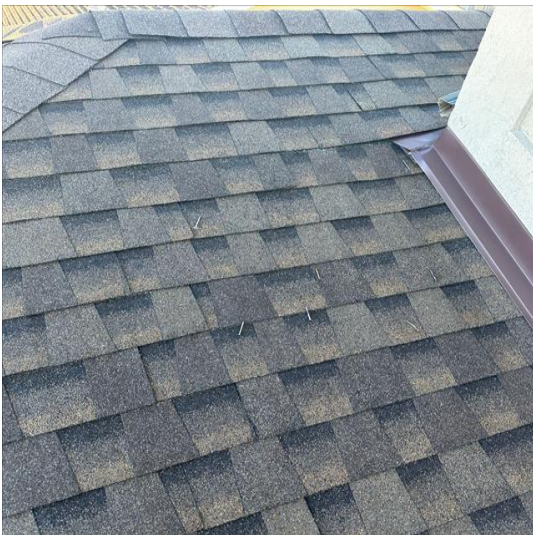
**Image Number: 3**

**Observation:** Nails, staples and debris was observed on roof and around property at time of inspection. It should be noted that the shingle on the ground in one of the photos is most likely a shingle missing from a hip cap that is mentioned elsewhere in this report. Leaving these items on the roof can cause damage to the roof if stepped on and should have been removed after roof replacement.

**Cause:** Poor workmanship.

**Determination:** Roof Repair required for LeakFREE Roof Certification

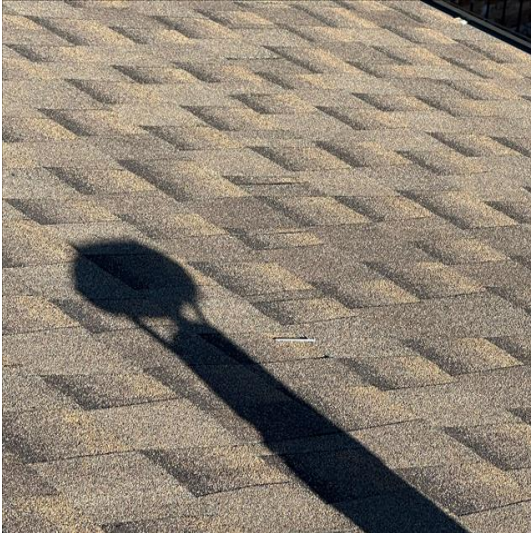
**Image Number: 4**

**Observation:** Nails, staples and debris was observed on roof and around property at time of inspection. It should be noted that the shingle on the ground in one of the photos is most likely a shingle missing from a hip cap that is mentioned elsewhere in this report. Leaving these items on the roof can cause damage to the roof if stepped on and should have been removed after roof replacement.

**Cause:** Poor workmanship.

**Determination:** Roof Repair required for LeakFREE Roof Certification

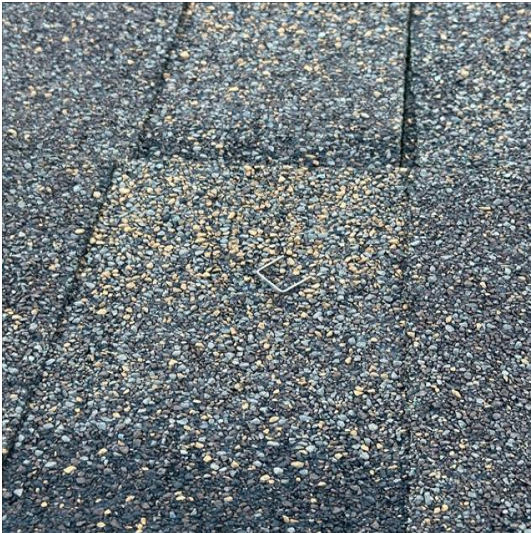
**Image Number: 5**

**Observation:** Nails, staples and debris was observed on roof and around property at time of inspection. It should be noted that the shingle on the ground in one of the photos is most likely a shingle missing from a hip cap that is mentioned elsewhere in this report. Leaving these items on the roof can cause damage to the roof if stepped on and should have been removed after roof replacement.

**Cause:** Poor workmanship.

**Determination:** Roof Repair required for LeakFREE Roof Certification

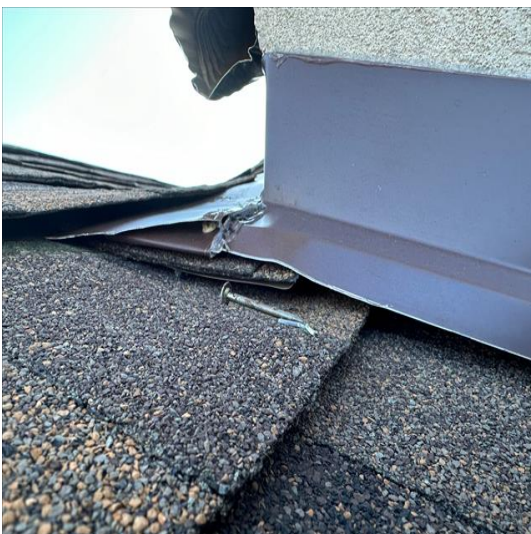
**Image Number: 6**

**Observation:** Nails, staples and debris was observed on roof and around property at time of inspection. It should be noted that the shingle on the ground in one of the photos is most likely a shingle missing from a hip cap that is mentioned elsewhere in this report. Leaving these items on the roof can cause damage to the roof if stepped on and should have been removed after roof replacement.

**Cause:** Poor workmanship.

**Determination:** Roof Repair required for LeakFREE Roof Certification

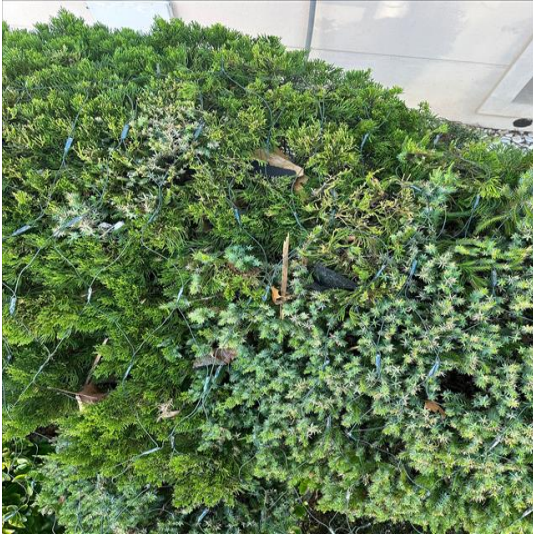
**Image Number:** 7

**Observation:** Debris was observed to be accumulated in multiple areas of the property.

**Cause:** Poor workmanship.

**Remedy:** Clean area of any debris or left over material.

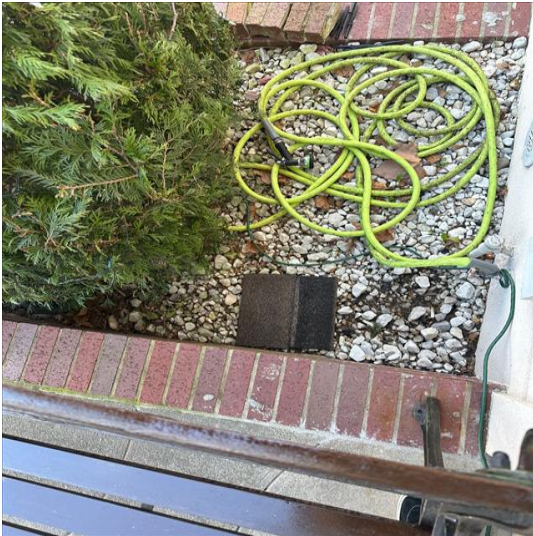
**Image Number:** 8

**Observation:** Nails, staples and debris was observed on roof and around property at time of inspection. It should be noted that the shingle on the ground in one of the photos is most likely a shingle missing from a hip cap that is mentioned elsewhere in this report. Leaving these items on the roof can cause damage to the roof if stepped on and should have been removed after roof replacement.

**Cause:** Poor workmanship.

**Determination:** Roof Repair required for LeakFREE Roof Certification

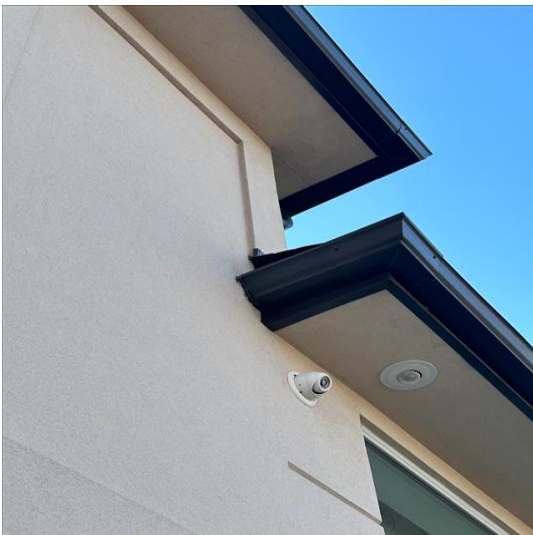
**Image Number:** 9

**Observation:** Kick-out flashing was observed to be missing at time of inspection. Water has the possibility of making direct contact with home which may eventually cause moisture intrusion, especially since this home has a EIFS system.

**Cause:** Improper installation.

**Determination:** Roof Repair required for LeakFREE Roof Certification

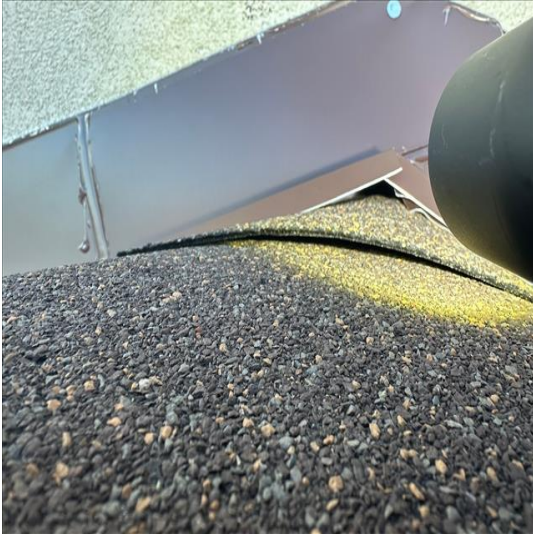
**Image Number:** 10

**Observation:** Sidewall flashing was observed to be installed properly unless otherwise mentioned in this report. Sealant was observed to be used along this flashing. Step flashing could be verified in all but one section of a sidewall and roof intersection.

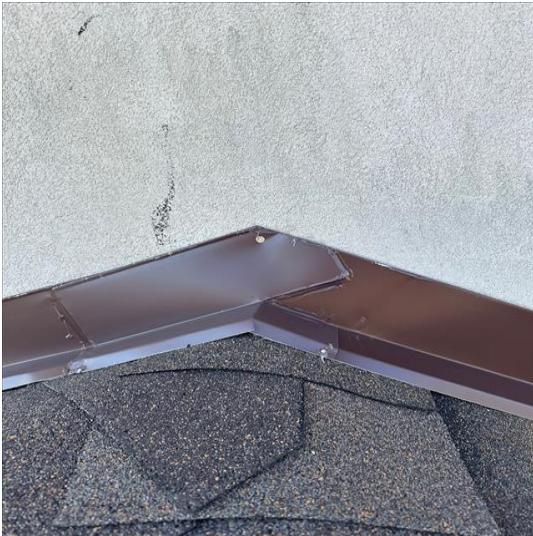
**Image Number:** 11

**Observation:** Sidewall flashing was observed to be installed properly unless otherwise mentioned in this report. Sealant was observed to be used along this flashing. Step flashing could be verified in all but one section of a sidewall and roof intersection.

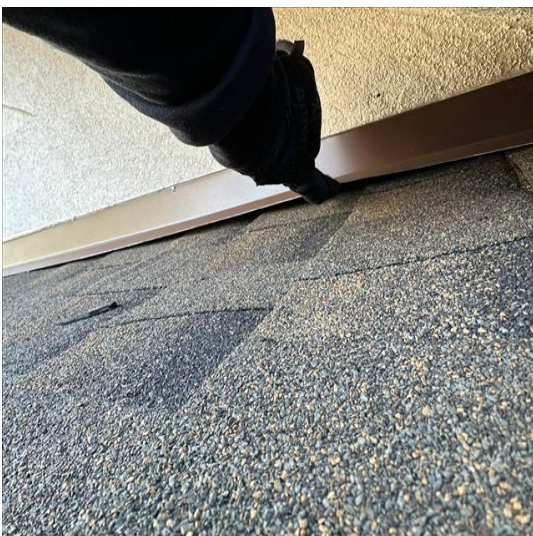
**Image Number:** 12

**Observation:** Step flashing could not be verified at lower front roof where the sidewall meets the roof. This is necessary to prevent any moisture intrusion, especially on a pitched roof at a vertical penetration or wall. Counter flashing was observed but is not sufficient in itself.

**Cause:** Improper installation.

**Determination:** Roof Repair required for LeakFREE Roof Certification

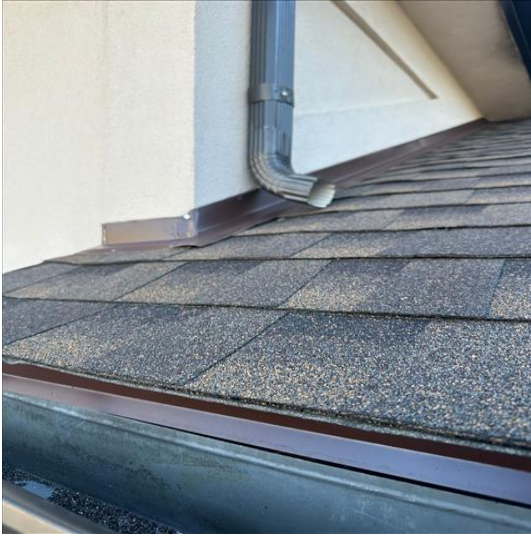
**Image Number: 13**

**Observation:** Gutters were observed to be in good condition with no 3rd party damage at time of inspection. However, downspouts need to be installed at gutter terminations on the roof surface to prevent excessive moisture exposure and potential moisture intrusion. One area of the roof had a gutter with no end cap, which can create moisture intrusion at the sidewall.

**Determination:** Roof Repair required for LeakFREE Roof Certification

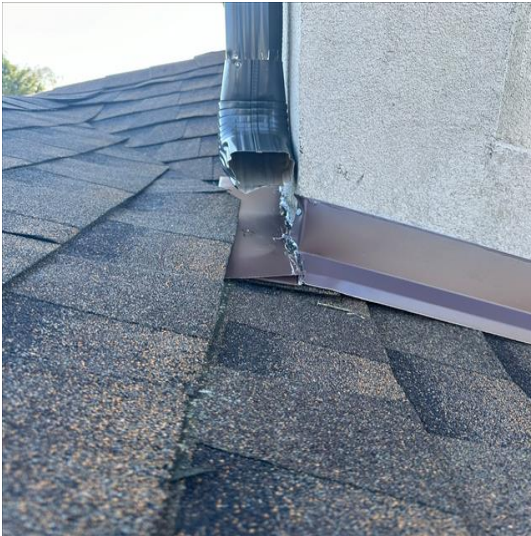
**Image Number: 14**

**Observation:** Gutters were observed to be in good condition with no 3rd party damage at time of inspection. However, downspouts need to be installed at gutter terminations on the roof surface to prevent excessive moisture exposure and potential moisture intrusion. One area of the roof had a gutter with no end cap, which can create moisture intrusion at the sidewall.

**Determination:** Roof Repair required for LeakFREE Roof Certification

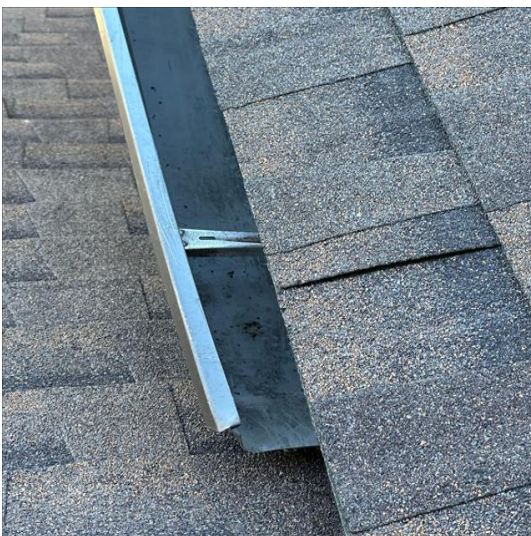
**Image Number: 15**

**Observation:** Gutters were observed to be in good condition with no 3rd party damage at time of inspection. However, downspouts need to be installed at gutter terminations on the roof surface to prevent excessive moisture exposure and potential moisture intrusion. One area of the roof had a gutter with no end cap, which can create moisture intrusion at the sidewall.

**Determination:** Roof Repair required for LeakFREE Roof Certification

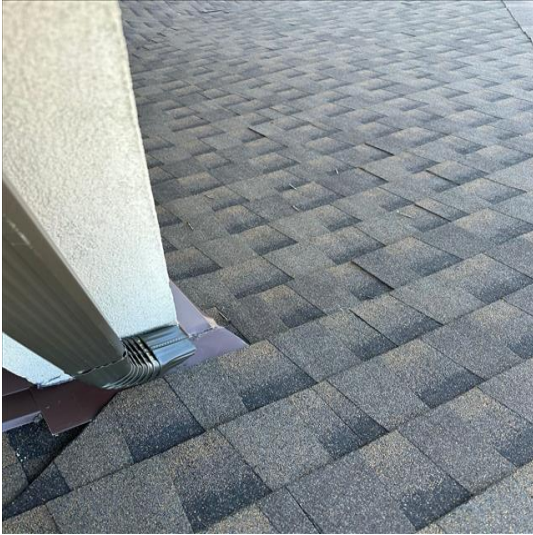
**Image Number: 16**

**Observation:** Gutters were observed to be in good condition with no 3rd party damage at time of inspection. However, downspouts need to be installed at gutter terminations on the roof surface to prevent excessive moisture exposure and potential moisture intrusion. One area of the roof had a gutter with no end cap, which can create moisture intrusion at the sidewall.

**Determination:** Roof Repair required for LeakFREE Roof Certification

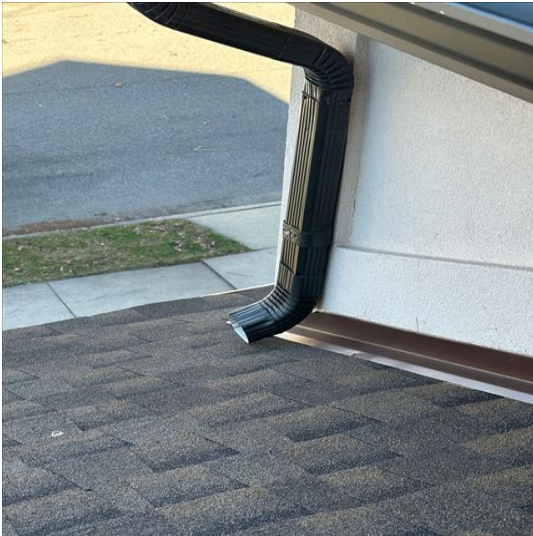
**Image Number: 17**

**Observation:** Gutters were observed to be in good condition with no 3rd party damage at time of inspection. However, downspouts need to be installed at gutter terminations on the roof surface to prevent excessive moisture exposure and potential moisture intrusion. One area of the roof had a gutter with no end cap, which can create moisture intrusion at the sidewall.

**Determination:** Roof Repair required for LeakFREE Roof Certification

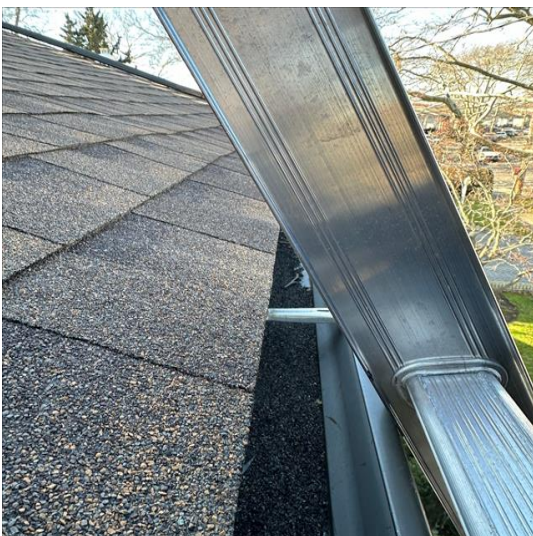
**Image Number: 18**

**Observation:** Gutters were observed to be in good condition with no 3rd party damage at time of inspection. However, downspouts need to be installed at gutter terminations on the roof surface to prevent excessive moisture exposure and potential moisture intrusion. One area of the roof had a gutter with no end cap, which can create moisture intrusion at the sidewall. Gutters also need to be cleaned. There was excessive granule build up in some of the gutters from the roof rip off and install.

**Cause:** Roof installation. Debris should always be cleaned up after roof repairs and installation.

**Determination:** Roof Repair required for LeakFREE Roof Certification

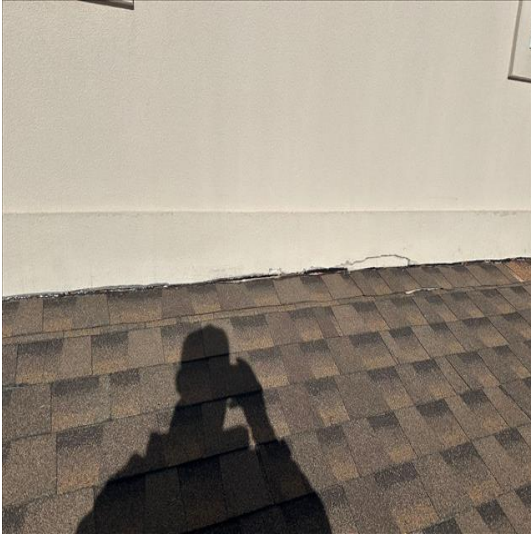
**Image Number:** 19

**Observation:** Headwall at rear of home was observed to have exposed fasteners and overexposure of flashing material, at time of inspection. Homeowner states this is an area that has or had leaking. Sealant was observed to be used over exposed fasteners. An interior analysis of the area in question could not be performed at time of inspection due to lack of access. Further analysis is required for this area.

**Cause:** Improper installation.

**Determination:** Roof Repair required for LeakFREE Roof Certification

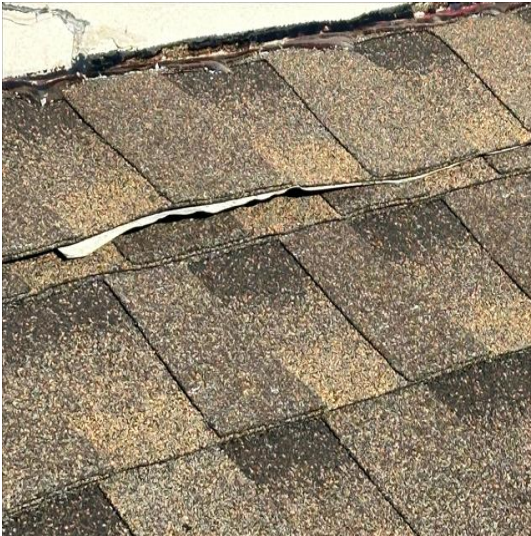
**Image Number:** 20

**Observation:** Headwall at rear of home was observed to have exposed fasteners and overexposure of flashing material, at time of inspection. Homeowner states this is an area that has or had leaking. Sealant was observed to be used over exposed fasteners. An interior analysis of the area in question could not be performed at time of inspection due to lack of access. Further analysis is required for this area.

**Cause:** Improper installation.

**Determination:** Roof Repair required for LeakFREE Roof Certification

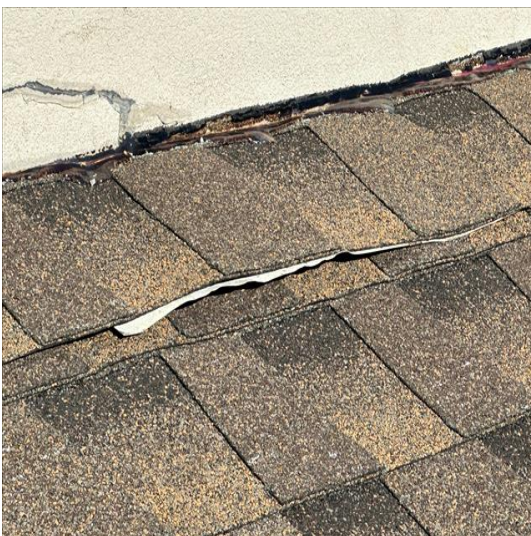
**Image Number:** 21

**Observation:** Headwall at rear of home was observed to have exposed fasteners and overexposure of flashing material, at time of inspection. Homeowner states this is an area that has or had leaking. Sealant was observed to be used over exposed fasteners. An interior analysis of the area in question could not be performed at time of inspection due to lack of access. Further analysis is required for this area.

**Cause:** Improper installation.

**Determination:** Roof Repair required for LeakFREE Roof Certification

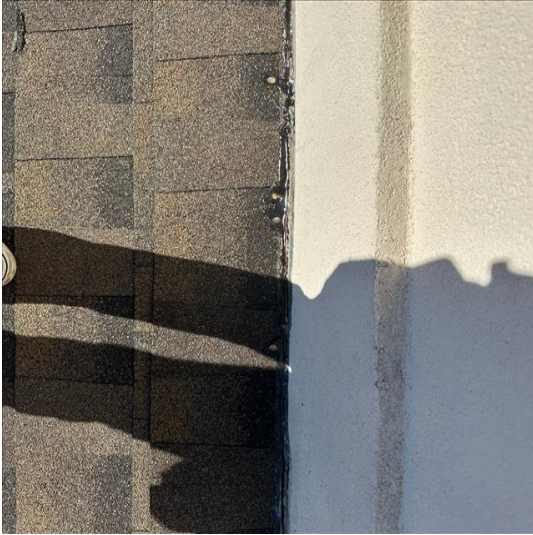
**Image Number: 22**

**Observation:** Headwall at rear of home was observed to have exposed fasteners and overexposure of flashing material, at time of inspection. Homeowner states this is an area that has or had leaking. Sealant was observed to be used over exposed fasteners. An interior analysis of the area in question could not be performed at time of inspection due to lack of access. Further analysis is required for this area.

**Cause:** Improper installation.

**Determination:** Roof Repair required for LeakFREE Roof Certification

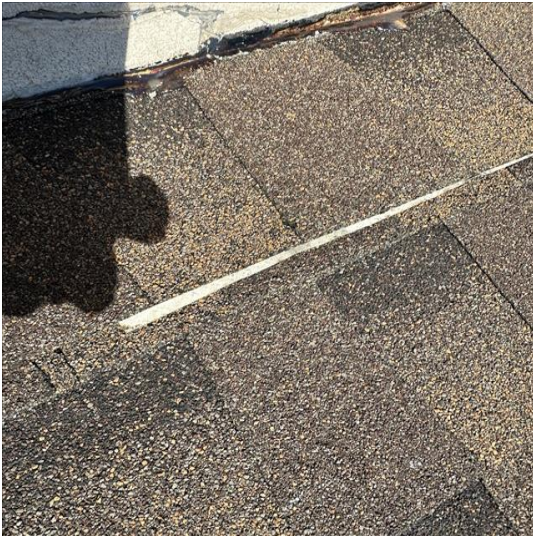
**Image Number: 23**

**Observation:** Headwall at rear of home was observed to have exposed fasteners and overexposure of flashing material, at time of inspection. Homeowner states this is an area that has or had leaking. Sealant was observed to be used over exposed fasteners. An interior analysis of the area in question could not be performed at time of inspection due to lack of access. Further analysis is required for this area.

**Cause:** Improper installation.

**Determination:** Roof Repair required for LeakFREE Roof Certification

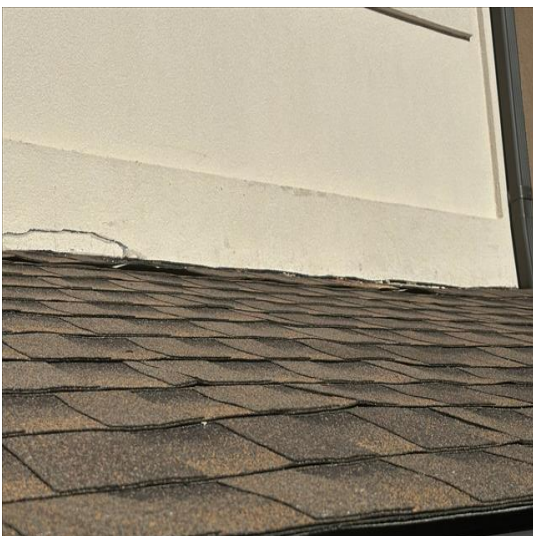
**Image Number: 24**

**Observation:** Headwall at rear of home was observed to have exposed fasteners and overexposure of flashing material, at time of inspection. Homeowner states this is an area that has or had leaking. Sealant was observed to be used over exposed fasteners. An interior analysis of the area in question could not be performed at time of inspection due to lack of access. Further analysis is required for this area.

**Cause:** Improper installation.

**Determination:** Roof Repair required for LeakFREE Roof Certification

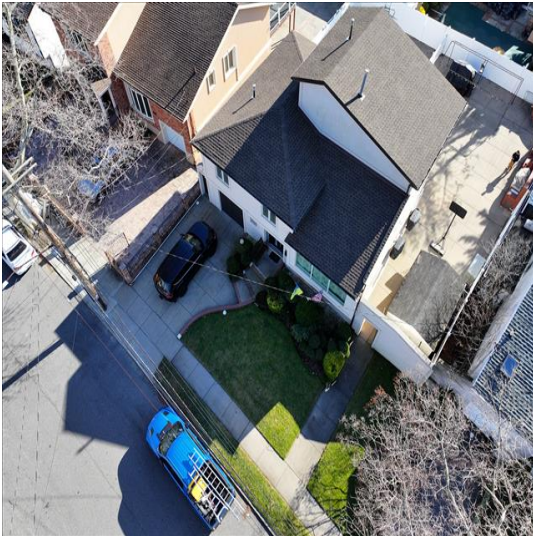
**Image Number:** 26

**Observation:** Overview photos of roof. Aerial image with red arrows indicates areas of concern and should be corrected.

**Determination:** Roof Repair required for LeakFREE Roof Certification

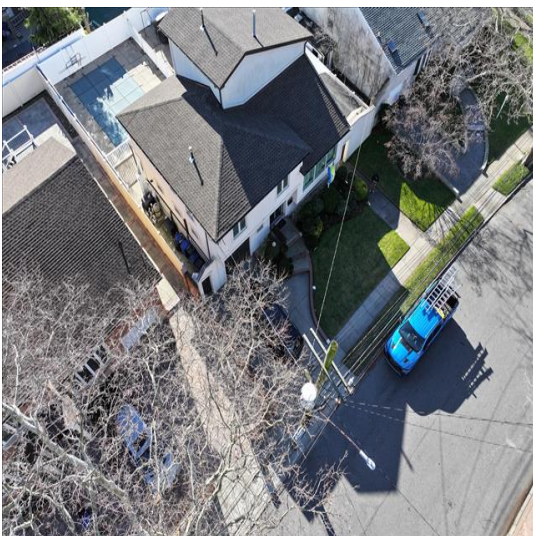
**Image Number:** 27

**Observation:** Overview photos of roof. Aerial image with red arrows indicates areas of concern and should be corrected.

**Determination:** Roof Repair required for LeakFREE Roof Certification

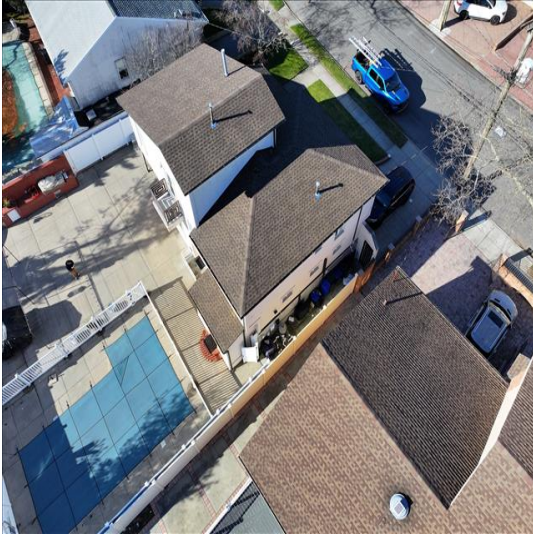
**Image Number:** 28

**Observation:** Overview photos of roof. Aerial image with red arrows indicates areas of concern and should be corrected.

**Determination:** Roof Repair required for LeakFREE Roof Certification

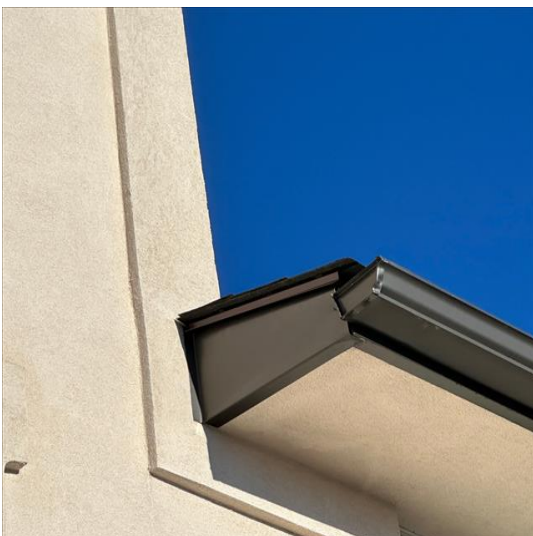
**Image Number:** 30

**Observation:** Starter course, storm shield, drip edge and gutters were observed to be properly installed and maintained, unless otherwise mentioned in this report, at time of inspection.

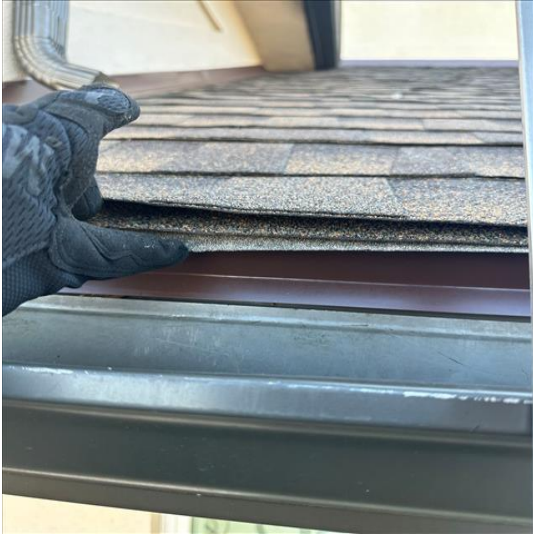
**Image Number:** 31

**Observation:** Starter course, storm shield, drip edge and gutters were observed to be properly installed and maintained, unless otherwise mentioned in this report, at time of inspection.

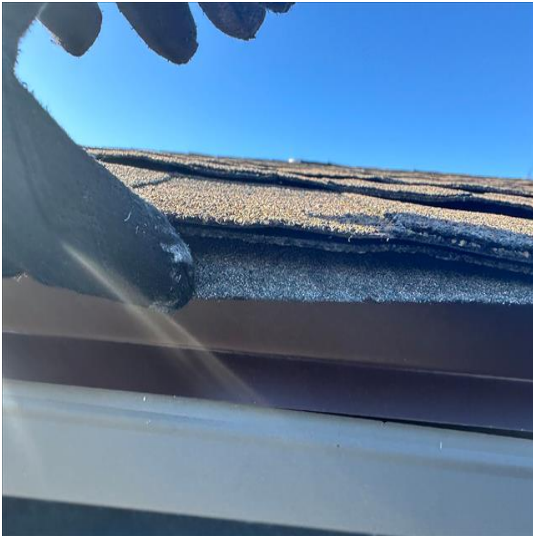
**Image Number:** 32

**Observation:** Starter course, storm shield, drip edge and gutters were observed to be properly installed and maintained, unless otherwise mentioned in this report, at time of inspection.

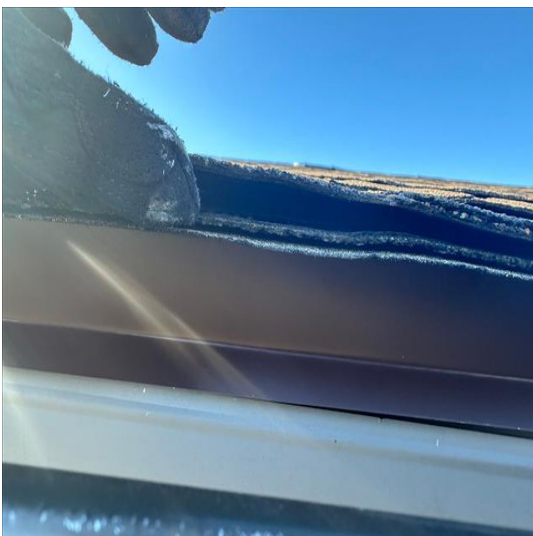
**Image Number:** 33

**Observation:** Starter course, storm shield, drip edge and gutters were observed to be properly installed and maintained, unless otherwise mentioned in this report, at time of inspection.

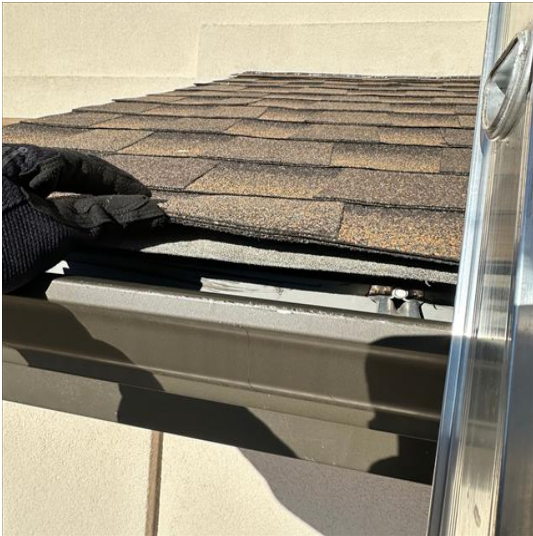
**Image Number:** 38

**Observation:** Starter course, storm shield, drip edge and gutters were observed to be properly installed and maintained, unless otherwise mentioned in this report, at time of inspection.

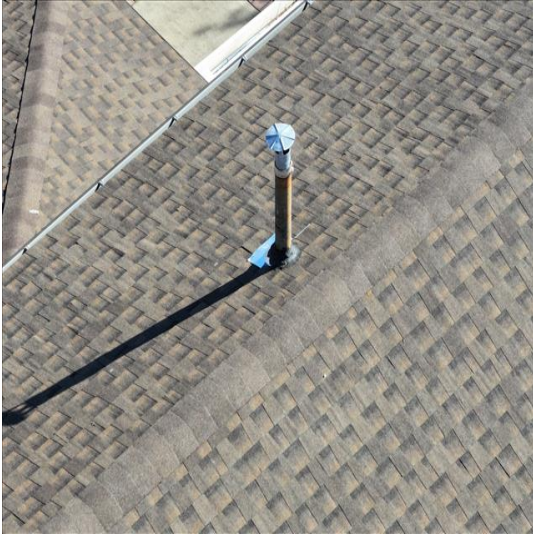
**Image Number:** 40

**Observation:** Unless otherwise mentioned in this report, roof penetration flashings, boots and sealant were observed to be properly installed and maintained at time of inspection.

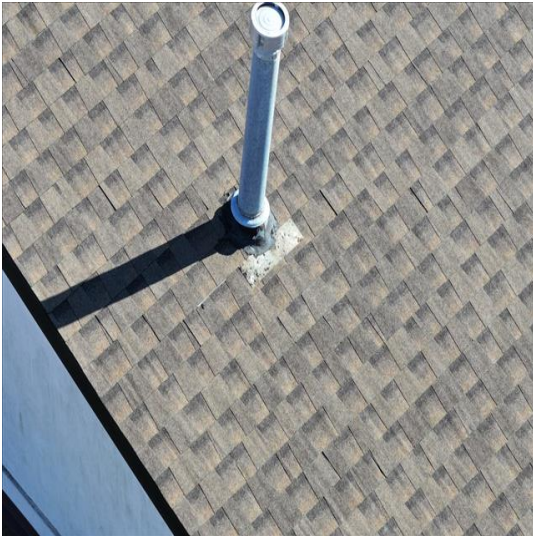
**Image Number:** 41

**Observation:** Roof penetration on top roof, right penetration has old flashing and should have been replaced with new flashing during roof replacement.

**Cause:** Improper installation.

**Determination:** Roof Repair required for LeakFREE Roof Certification

**Remedy:** Recommend replacing flashing.

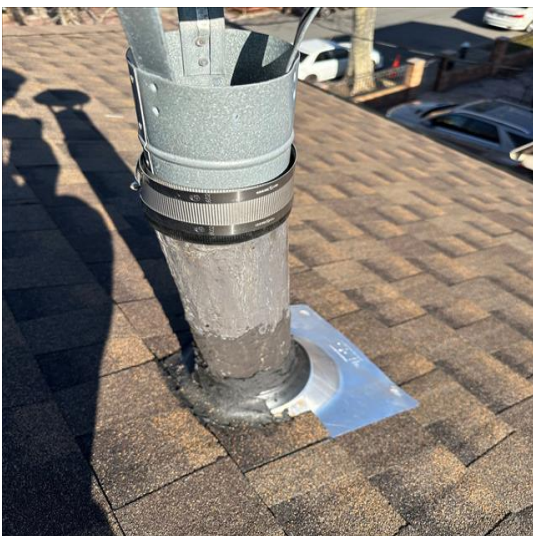
**Image Number:** 42

**Observation:** Unless otherwise mentioned in this report, roof penetration flashings, boots and sealant were observed to be properly installed and maintained at time of inspection.

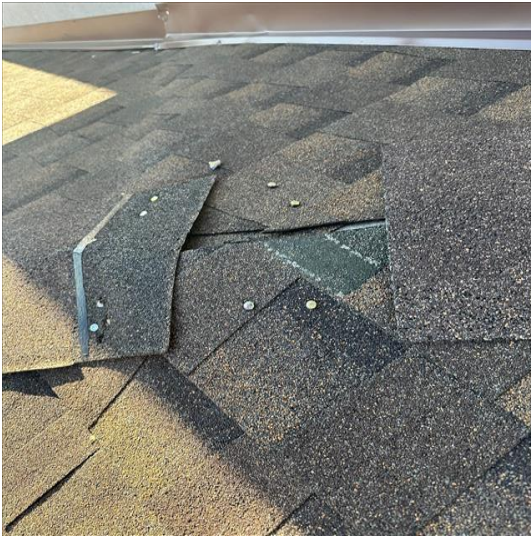
**Image Number:** 43

**Observation:** Multiple exposed fasteners, under driven nails, exposed storm shield and missing hip caps were observed at time of inspection. This area is almost certainly going to leak if not repaired. Under driven nails present the opportunity for remaining shingles to be damaged during high wind episodes, exposed storm shield presents the opportunity for moisture intrusion, exposed fasteners may introduce moisture intrusion.

**Cause:** The most probable cause of this observation was that high winds removed 2 to 3 hip caps due to improper installation. Due to installation during cold months, material transfer to create bonding of shingles has not taken place in addition to improper nail placement. This is a combination of both environmental and workmanship factors.

**Determination:** Roof Repair required for LeakFREE Roof Certification

**Remedy:** Replace hip caps.

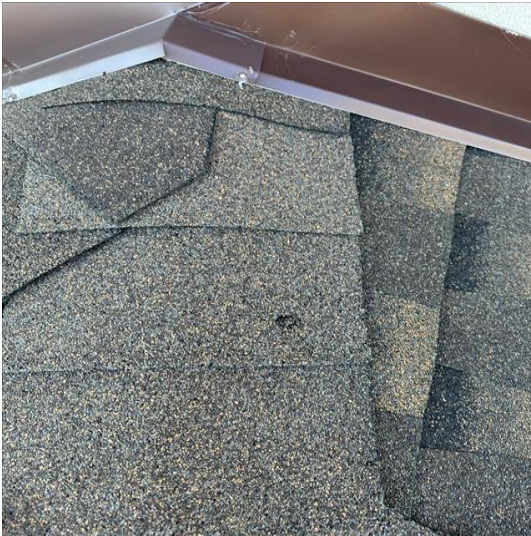
**Image Number:** 44

**Observation:** Inconsistent and/or improper nailing procedure was observed at time of inspection. Page 2 of the manufacturers installation manual indicates that when using 4 nails for installation, nails must be 1/2" from the edge of each shingle. Nails were observed to be missing, over driven and under driven at time of inspection in multiple areas that were readily accessible and possible to inspect without causing damage or invasive testing. It was also observed that nails were installed within the tar strip of some shingles, or multiple nails within a small area which is not within the manufacturers target zone that is indicated in the installation manual. Please note, some photos indicate proper nailing procedure where observed.

**Cause:** Improper installation.

**Determination:** Roof Repair required for LeakFREE Roof Certification

**Remedy:** Shingles should be replaced and properly installed with the correct nailing procedure. These shingles have a higher likelihood of leaking or blowing off in high wind events,

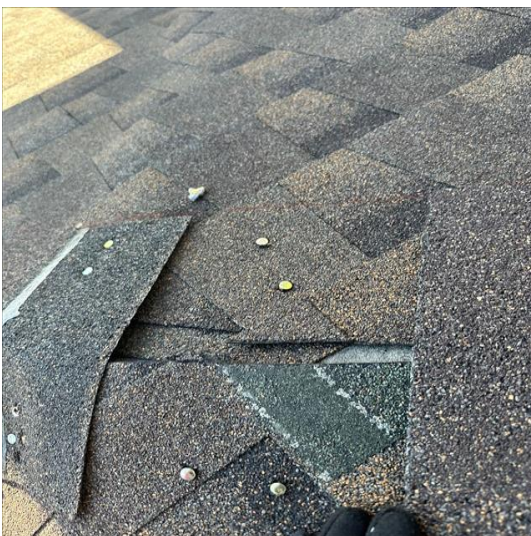
**Image Number:** 45

**Observation:** Multiple exposed fasteners, under driven nails, exposed storm shield and missing hip caps were observed at time of inspection. This area is almost certainly going to leak if not repaired. Under driven nails present the opportunity for remaining shingles to be damaged during high wind episodes, exposed storm shield presents the opportunity for moisture intrusion, exposed fasteners may introduce moisture intrusion.

**Cause:** The most probable cause of this observation was that high winds removed 2 to 3 hip caps due to improper installation. Due to installation during cold months, material transfer to create bonding of shingles has not taken place in addition to improper nail placement. This is a combination of both environmental and workmanship factors.

**Determination:** Roof Repair required for LeakFREE Roof Certification

**Remedy:** Replace hip caps.

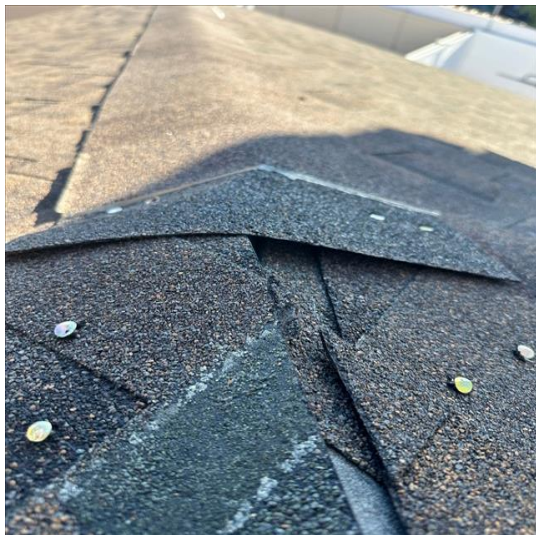
**Image Number:** 46

**Observation:** Multiple exposed fasteners, under driven nails, exposed storm shield and missing hip caps were observed at time of inspection. This area is almost certainly going to leak if not repaired. Under driven nails present the opportunity for remaining shingles to be damaged during high wind episodes, exposed storm shield presents the opportunity for moisture intrusion, exposed fasteners may introduce moisture intrusion.

**Cause:** The most probable cause of this observation was that high winds removed 2 to 3 hip caps due to improper installation. Due to installation during cold months, material transfer to create bonding of shingles has not taken place in addition to improper nail placement. This is a combination of both environmental and workmanship factors.

**Determination:** Roof Repair required for LeakFREE Roof Certification

**Remedy:** Replace hip caps.

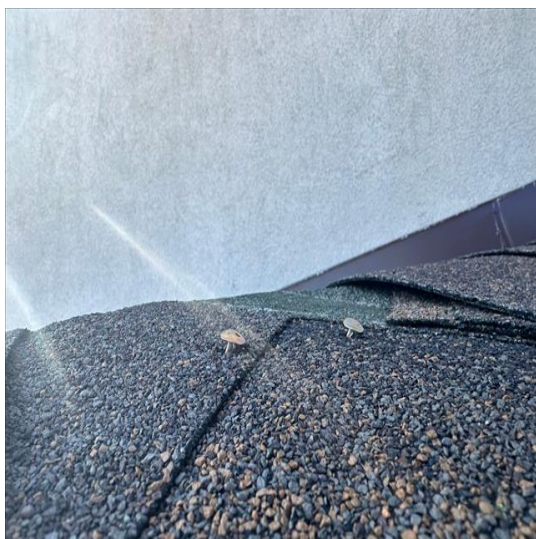
**Image Number:** 47

**Observation:** Multiple exposed fasteners, under driven nails, exposed storm shield and missing hip caps were observed at time of inspection. This area is almost certainly going to leak if not repaired. Under driven nails present the opportunity for remaining shingles to be damaged during high wind episodes, exposed storm shield presents the opportunity for moisture intrusion, exposed fasteners may introduce moisture intrusion.

**Cause:** The most probable cause of this observation was that high winds removed 2 to 3 hip caps due to improper installation. Due to installation during cold months, material transfer to create bonding of shingles has not taken place in addition to improper nail placement. This is a combination of both environmental and workmanship factors.

**Determination:** Roof Repair required for LeakFREE Roof Certification

**Remedy:** Replace hip caps.

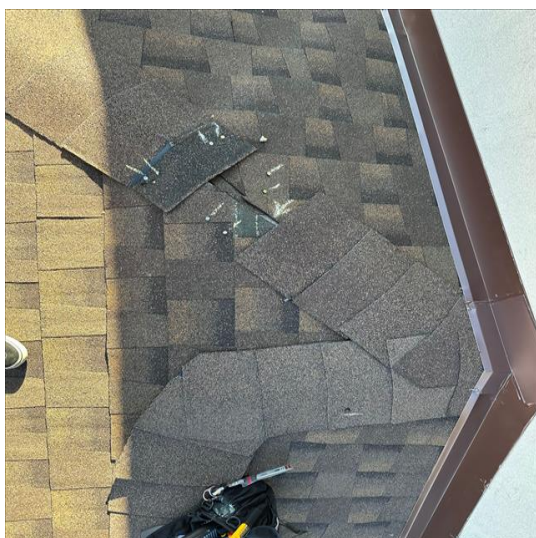
**Image Number:** 48

**Observation:** Multiple exposed fasteners, under driven nails, exposed storm shield and missing hip caps were observed at time of inspection. This area is almost certainly going to leak if not repaired. Under driven nails present the opportunity for remaining shingles to be damaged during high wind episodes, exposed storm shield presents the opportunity for moisture intrusion, exposed fasteners may introduce moisture intrusion.

**Determination:** Roof Repair required for LeakFREE Roof Certification

**Remedy:** Replace hip caps.
