# Forensic ROOF® Inspection

**Report No :**  
129959

**Property Inspected :**  
373 Prospect Pl  
Brooklyn, NY, 11238

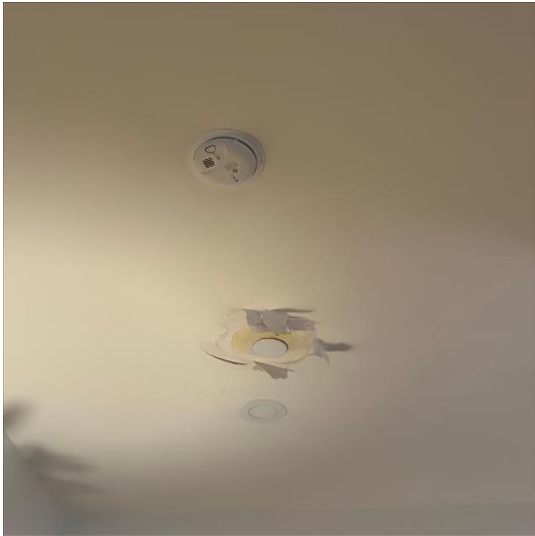
**Image Number: 1**  
**Observation:** Multiple moisture stains and damage were observed on the lower floor of the unit at time of inspection. These areas of concern were located near windows and sidewall transitions.  
**Cause:** Improper roof installation and maybe improper EIFS installation.  
**Remedy:** Contact a qualified EIFS professional to further evaluate the exterior system.

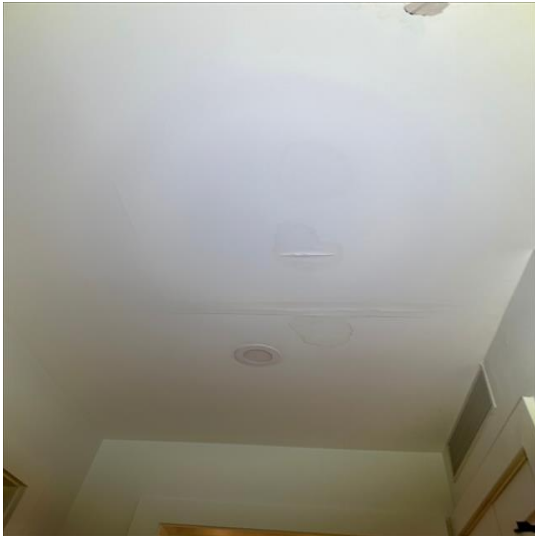
**Image Number: 2**  
**Observation:** Multiple moisture stains and damage were observed on the lower floor of the unit at time of inspection. These areas of concern were located near windows and sidewall transitions.  
**Cause:** Improper roof installation and maybe improper EIFS installation.  
**Remedy:** Contact a qualified EIFS professional to further evaluate the exterior system.

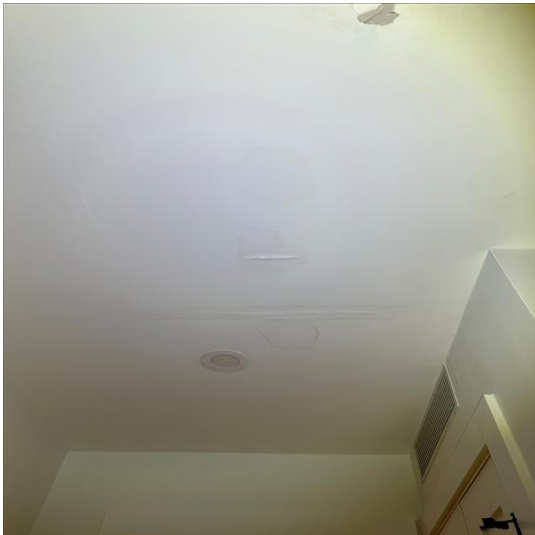
**Image Number: 3**  
**Observation:** Multiple moisture stains and damage were observed on the lower floor of the unit at time of inspection. These areas of concern were located near windows and sidewall transitions.  
**Cause:** Improper roof installation and maybe improper EIFS installation.  
**Remedy:** Contact a qualified EIFS professional to further evaluate the exterior system.

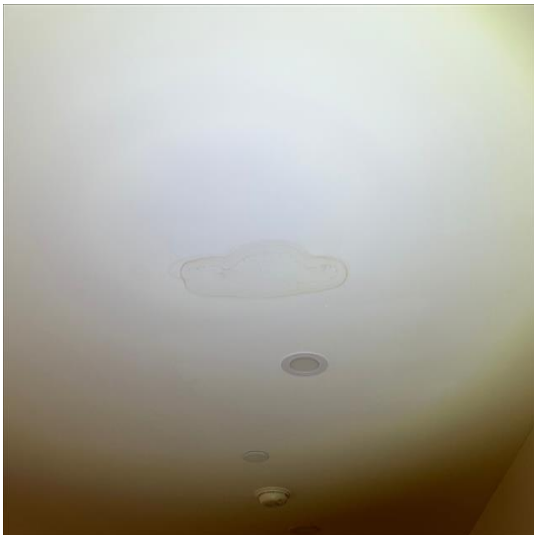
**Image Number: 5**

**Observation:** Multiple moisture stains and damage were observed on the lower floor of the unit at time of inspection. These areas of concern were located near windows and sidewall transitions.

**Cause:** Improper roof installation and maybe improper EIFS installation.

**Remedy:** Contact a qualified EIFS professional to further evaluate the exterior system.

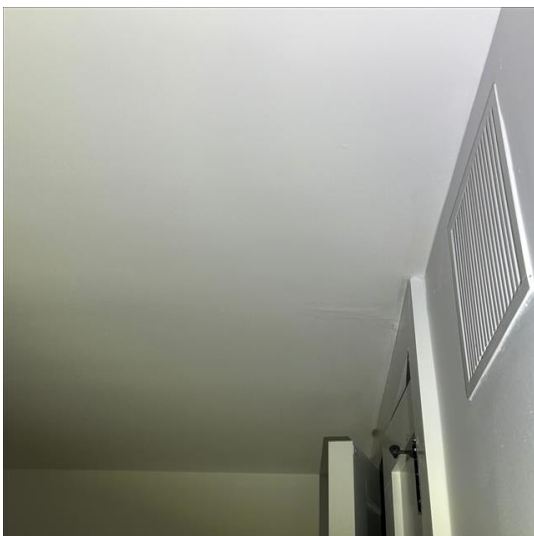
**Image Number: 6**

**Observation:** Multiple moisture stains and damage were observed on the lower floor of the unit at time of inspection. These areas of concern were located near windows and sidewall transitions.

**Cause:** Improper roof installation and maybe improper EIFS installation.

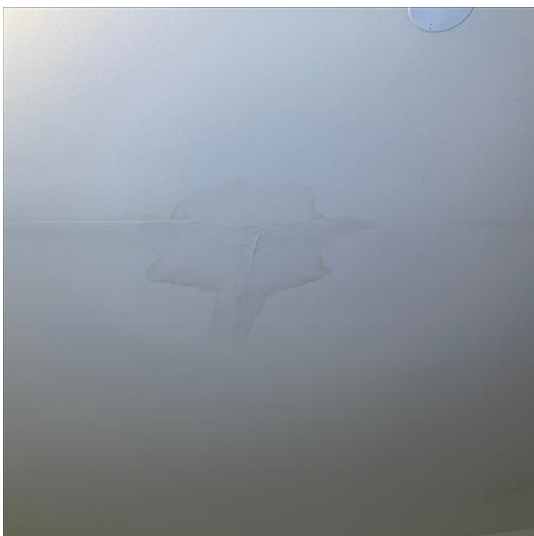
**Image Number: 9**

**Observation:** Multiple moisture stains and damage were observed on the lower floor of the unit at time of inspection. These areas of concern were located near windows and sidewall transitions.

**Cause:** Improper roof installation and maybe improper EIFS installation.

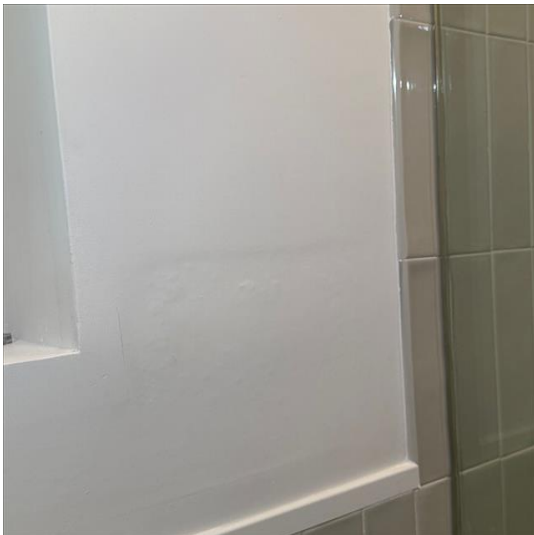
**Image Number:** 11

**Observation:** Multiple moisture stains and damage were observed on the lower floor of the unit at time of inspection. These areas of concern were located near windows and sidewall transitions.

**Cause:** Improper roof installation and maybe improper EIFS installation.

**Remedy:** Contact a qualified EIFS professional to further evaluate the exterior system.

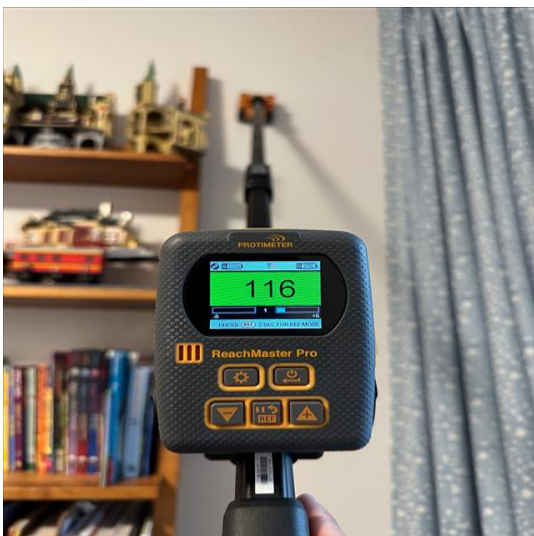
**Image Number:** 12

**Observation:** All areas with moisture staining were gauged with a moisture meter at time of inspection. Readings indicating lower numbers and green or amber colors are areas that are not active leaks or do not possess high moisture content. Readings with red numbers in the 200's indicate areas of concern with active leaking and higher than acceptable moisture readings.

**Cause:** This may be a result of moisture making contact with roof insulation and substrate, causing the moisture to create leaks. The property contained a flat roof with TPO material and soft spots along the roof. These areas are consistent with the soft spots observed above.

**Remedy:** A core sample is required for further analysis to determine extent of damage and level of moisture intrusion.

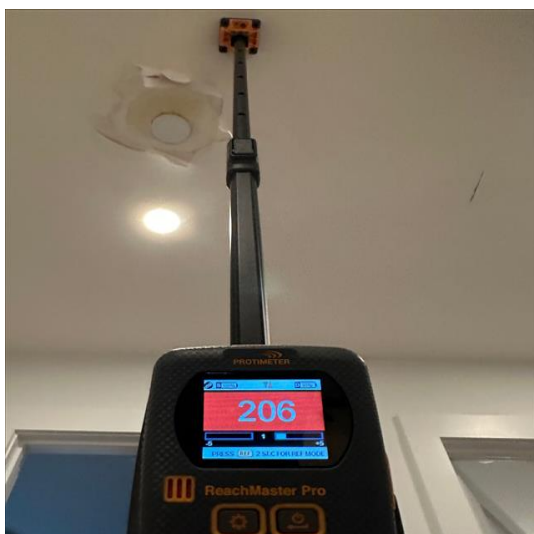
**Image Number: 15**

**Observation:** All areas with moisture staining were gauged with a moisture meter at time of inspection. Readings indicating lower numbers and green or amber colors are areas that are not active leaks or do not possess high moisture content. Readings with red numbers in the 200's indicate areas of concern with active leaking and higher than acceptable moisture readings.

**Cause:** This may be a result of moisture making contact with roof insulation and substrate, causing the moisture to create leaks. The property contained a flat roof with TPO material and soft spots along the roof. These areas are consistent with the soft spots observed above.

**Remedy:** A core sample is required for further analysis to determine extent of damage and level of moisture intrusion.

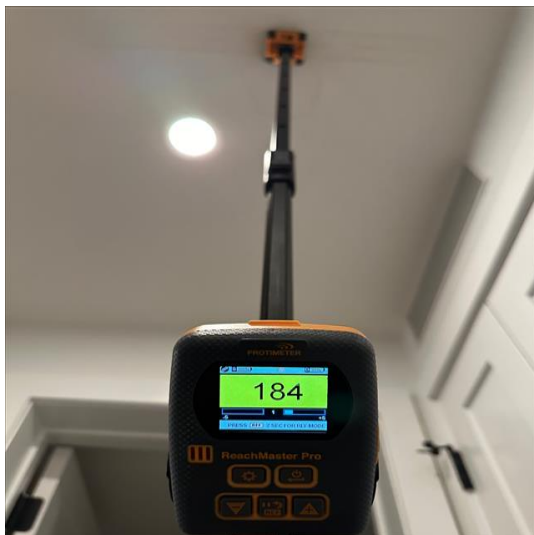
**Image Number: 17**

**Observation:** All areas with moisture staining were gauged with a moisture meter at time of inspection. Readings indicating lower numbers and green or amber colors are areas that are not active leaks or do not possess high moisture content. Readings with red numbers in the 200's indicate areas of concern with active leaking and higher than acceptable moisture readings.

**Cause:** This may be a result of moisture making contact with roof insulation and substrate, causing the moisture to create leaks. The property contained a flat roof with TPO material and soft spots along the roof. These areas are consistent with the soft spots observed above.

**Remedy:** A core sample is required for further analysis to determine extent of damage and level of moisture intrusion.

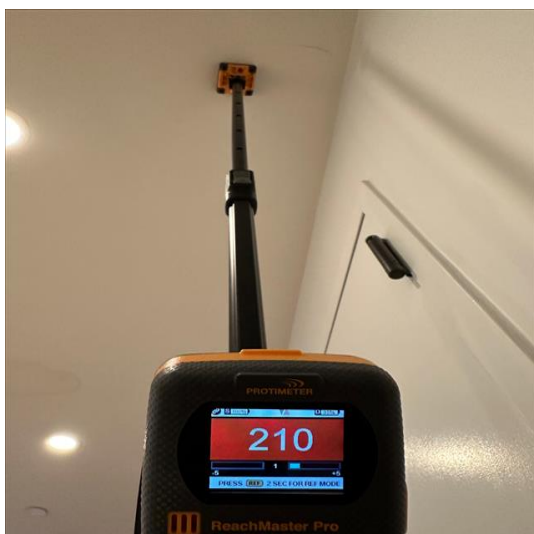
**Image Number: 18**

**Observation:** All areas with moisture staining were gauged with a moisture meter at time of inspection. Readings indicating lower numbers and green or amber colors are areas that are not active leaks or do not possess high moisture content. Readings with red numbers in the 200's indicate areas of concern with active leaking and higher than acceptable moisture readings.

**Cause:** This may be a result of moisture making contact with roof insulation and substrate, causing the moisture to create leaks. The property contained a flat roof with TPO material and soft spots along the roof. These areas are consistent with the soft spots observed above.

**Remedy:** A core sample is required for further analysis to determine extent of damage and level of moisture intrusion.

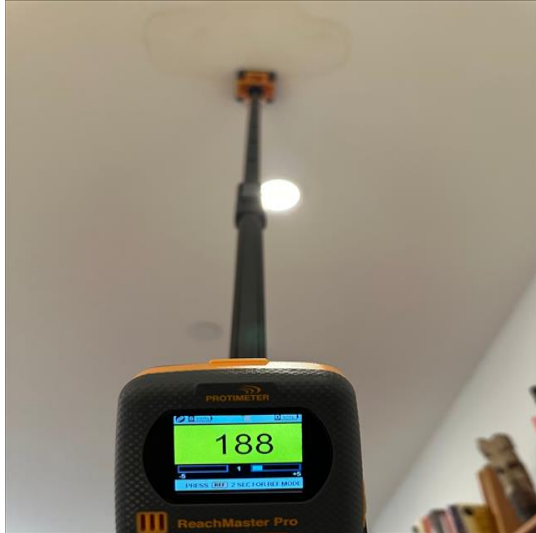
**Image Number: 19**

**Observation:** All areas with moisture staining were gauged with a moisture meter at time of inspection. Readings indicating lower numbers and green or amber colors are areas that are not active leaks or do not possess high moisture content. Readings with red numbers in the 200's indicate areas of concern with active leaking and higher than acceptable moisture readings.

**Cause:** This may be a result of moisture making contact with roof insulation and substrate, causing the moisture to create leaks. The property contained a flat roof with TPO material and soft spots along the roof. These areas are consistent with the soft spots observed above.

**Remedy:** A core sample is required for further analysis to determine extent of damage and level of moisture intrusion.

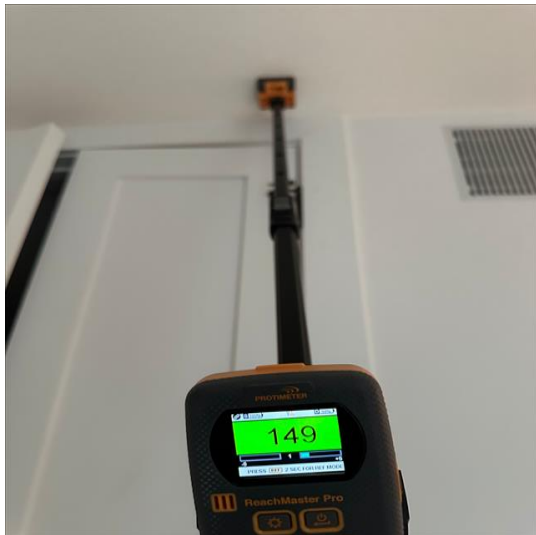
**Image Number: 20**

**Observation:** All areas with moisture staining were gauged with a moisture meter at time of inspection. Readings indicating lower numbers and green or amber colors are areas that are not active leaks or do not possess high moisture content. Readings with red numbers in the 200's indicate areas of concern with active leaking and higher than acceptable moisture readings.

**Cause:** This may be a result of moisture making contact with roof insulation and substrate, causing the moisture to create leaks. The property contained a flat roof with TPO material and soft spots along the roof. These areas are consistent with the soft spots observed above.

**Remedy:** A core sample is required for further analysis to determine extent of damage and level of moisture intrusion.

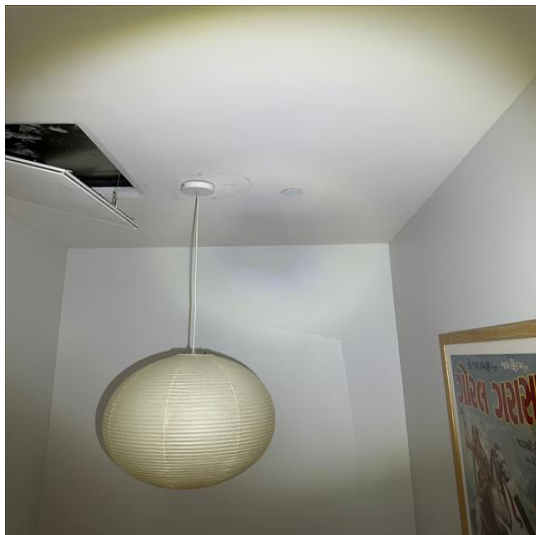
**Image Number: 21**

**Observation:** Thermal imaging was conducted and yielded results within the stairwell that were consistent with moisture damage, which is evident by the puddle like appearance and colder temperature difference at this location.

**Cause:** Area in question does not have exterior access.

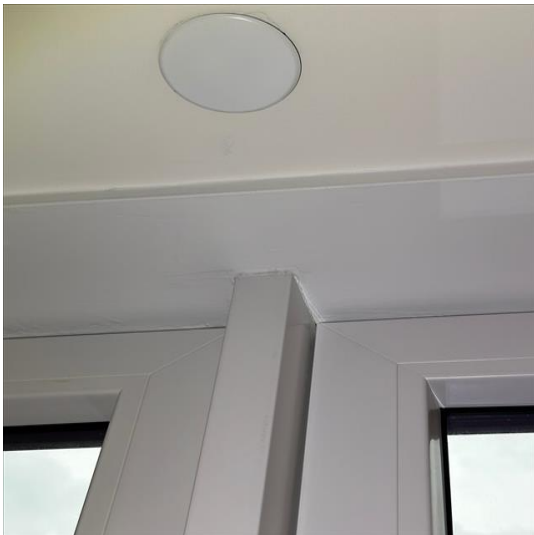
**Image Number: 32**

**Observation:** High moisture content levels were observed at time of inspection at the window near the living room. 205 represents the high moisture content reading and the other 2 moisture content readings under this observation represent the general moisture content in this area.

**Remedy:** Contact a qualified EIFS professional to further evaluate.

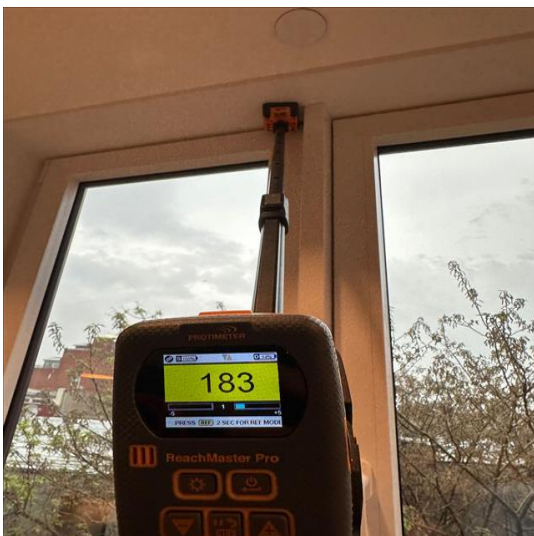
**Image Number: 33**

**Observation:** High moisture content levels were observed at time of inspection at the window near the living room. 205 represents the high moisture content reading and the other 2 moisture content readings under this observation represent the general moisture content in this area.

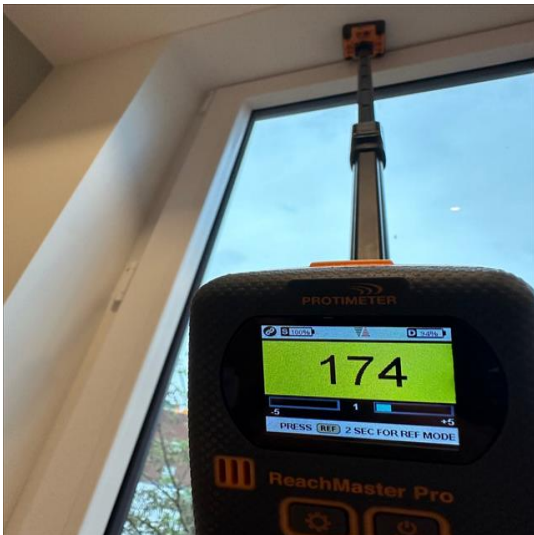
**Image Number: 35**

**Observation:** High moisture content levels were observed at time of inspection at the window near the living room. 205 represents the high moisture content reading and the other 2 moisture content readings under this observation represent the general moisture content in this area.

**Remedy:** Contact a qualified EIFS professional to further evaluate.

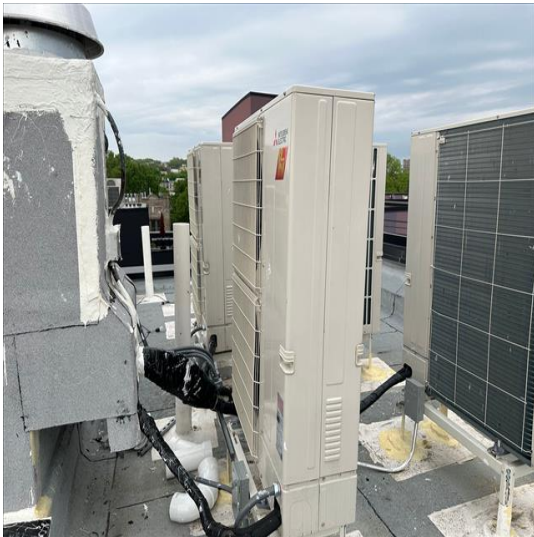
**Image Number:** 47

**Observation:** Roof top units were observed to be properly installed at time of inspection. The flashings, curbs and mounts appeared to be adequate and properly installed. It should be noted that two different types of liquid flashing were used, which is evident by the differing colors of the material (one being yellow the other being white).

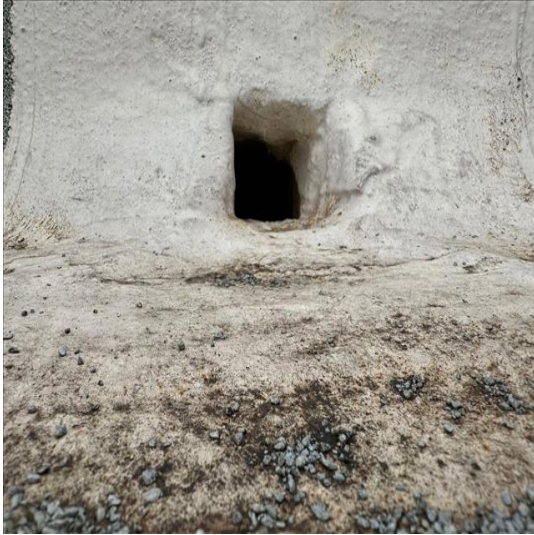
**Image Number: 49**

**Determination:** Roof Replacement required for LeakFREE Roof Certification

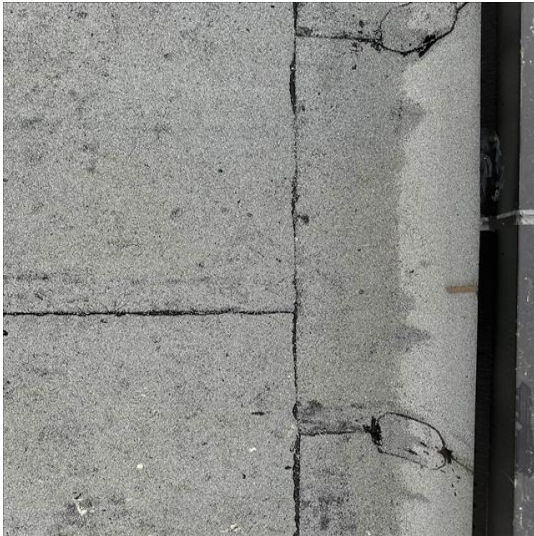
**Image Number: 50**

**Determination:** Roof Repair required for LeakFREE Roof Certification

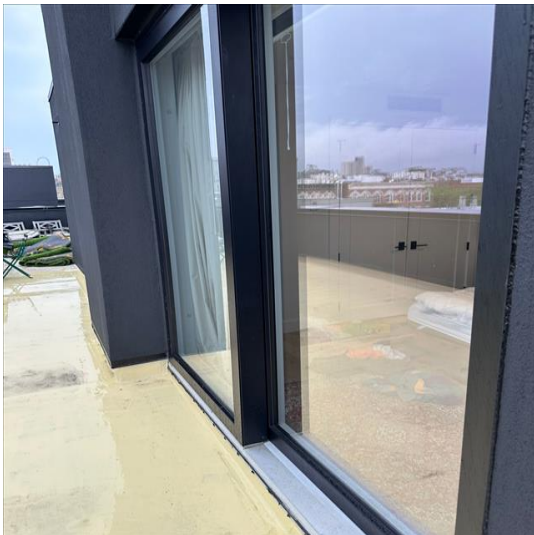
**Image Number: 53**

**Determination:** Roof Repair required for LeakFREE Roof Certification

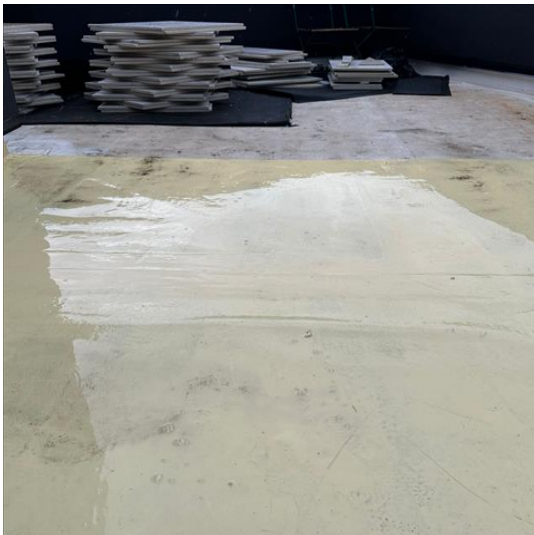
**Image Number: 56**

**Determination:** Roof Repair required for LeakFREE Roof Certification

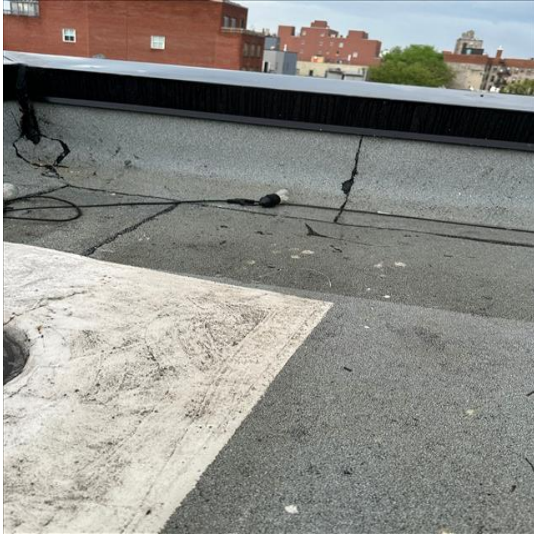
**Image Number: 64**

**Determination:** Roof Repair required for LeakFREE Roof Certification

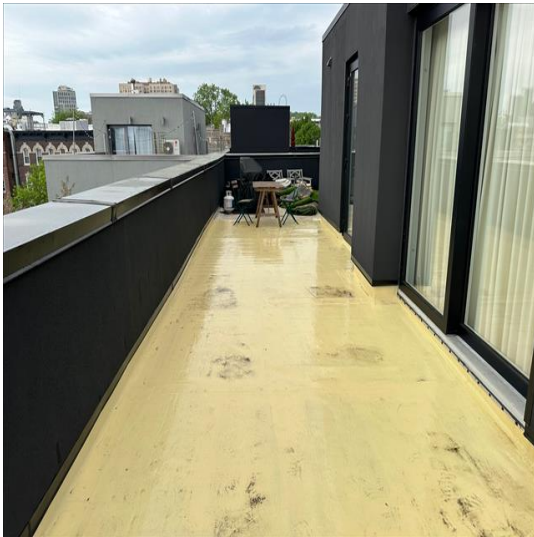
**Image Number: 68**

**Determination:** Roof Repair required for LeakFREE Roof Certification

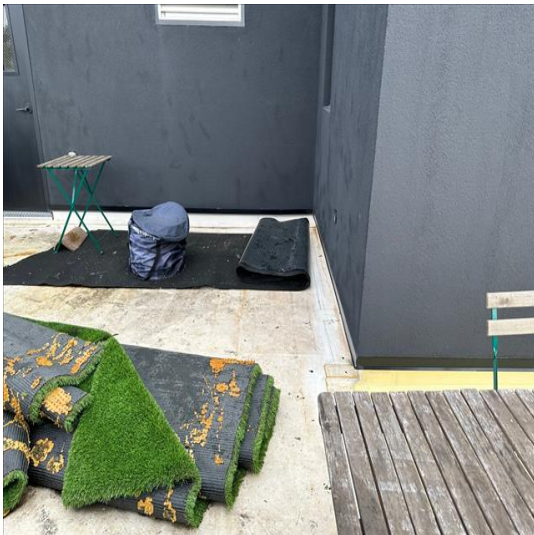
**Image Number:** 71

**Determination:** Roof Repair required for LeakFREE Roof Certification

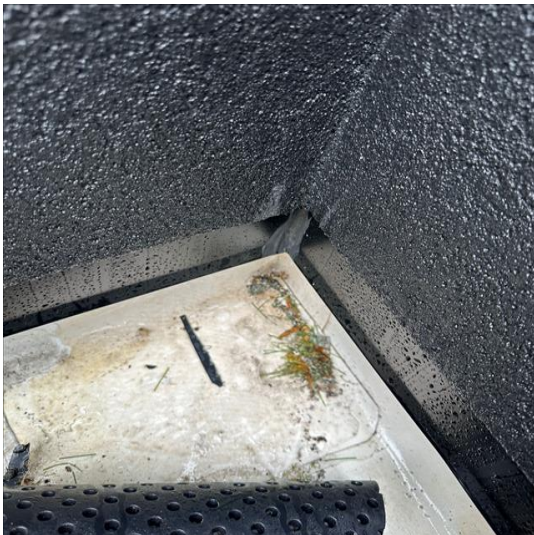
**Image Number:** 74

**Determination:** Roof Repair required for LeakFREE Roof Certification

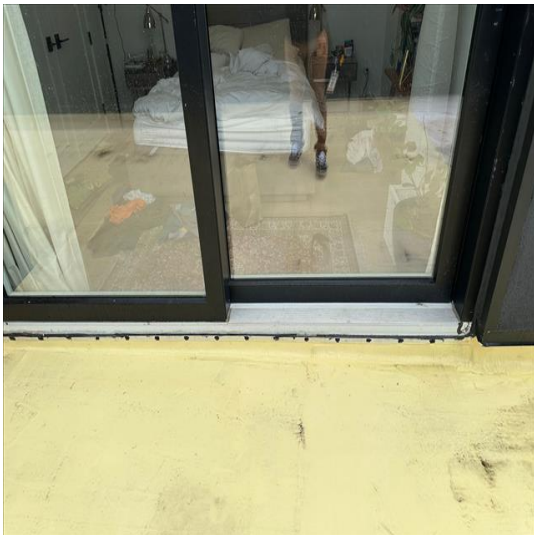
**Image Number: 77**

**Determination:** Roof Repair required for LeakFREE Roof Certification

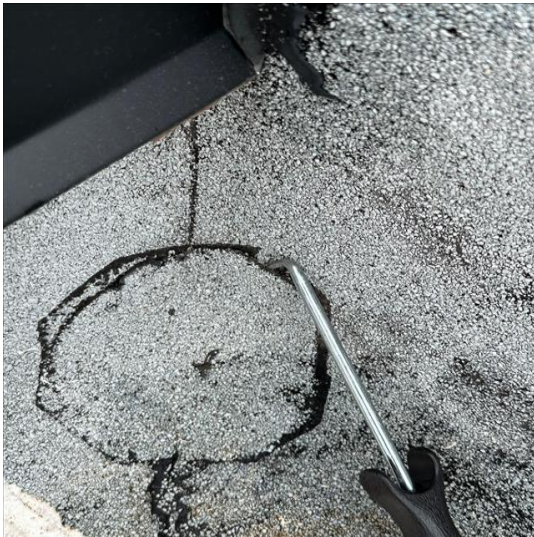
**Image Number:** 83

**Determination:** Roof Repair required for LeakFREE Roof Certification

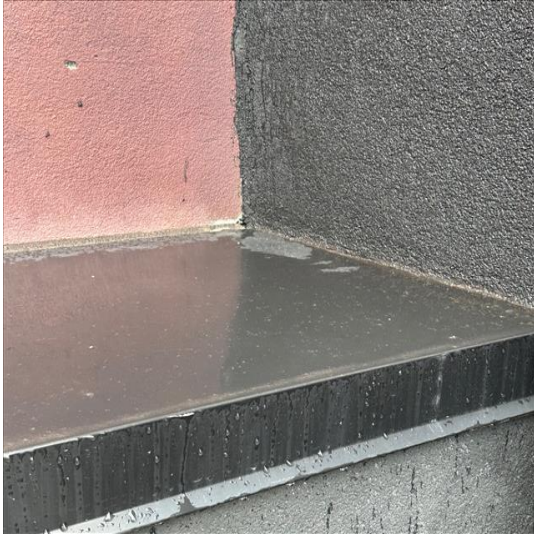
**Image Number:** 88

**Determination:** Roof Repair required for LeakFREE Roof Certification

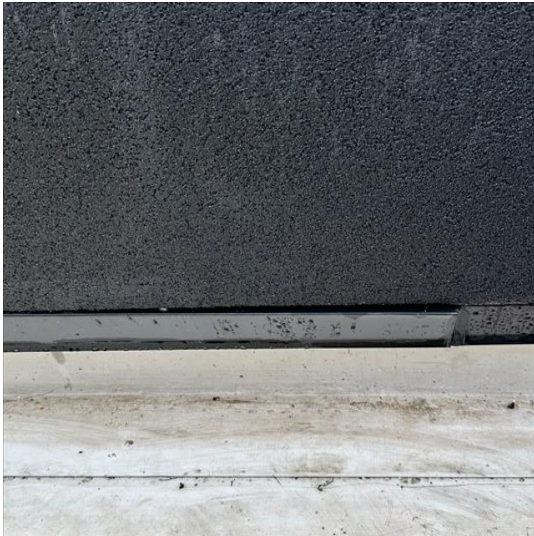
**Image Number:** 89

**Determination:** Roof Repair required for LeakFREE Roof Certification

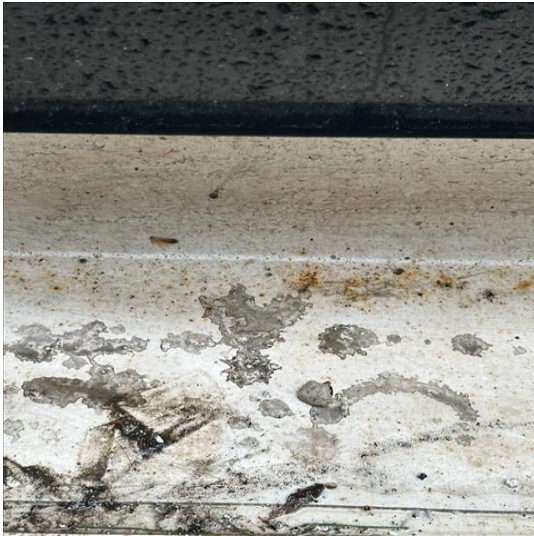
**Image Number:** 97

**Determination:** Roof Repair required for LeakFREE Roof Certification

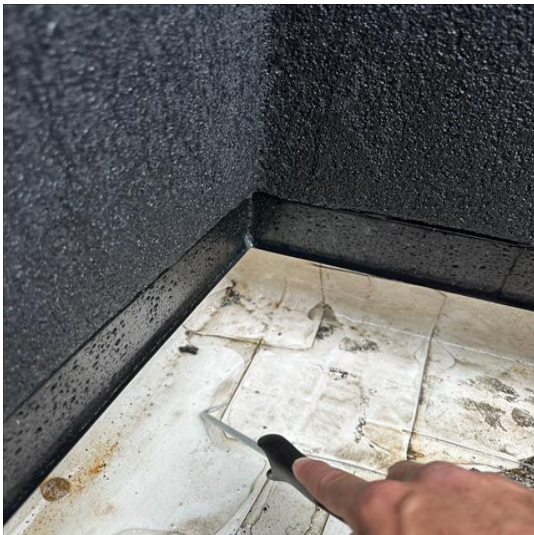
**Image Number:** 98

**Determination:** Roof Repair required for LeakFREE Roof Certification

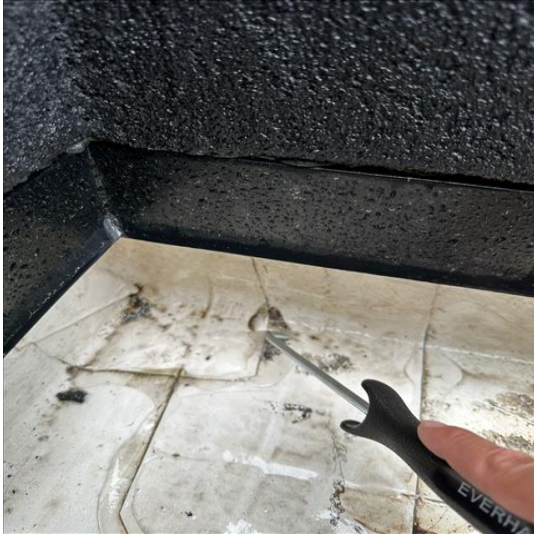
**Image Number:** 100

**Determination:** Roof Repair required for LeakFREE Roof Certification
