Inspection Date: 11/14/2023

LeakFREE® Roof Inspection

Report No :
129180

Property Inspected :
[REDACTED]
[REDACTED]

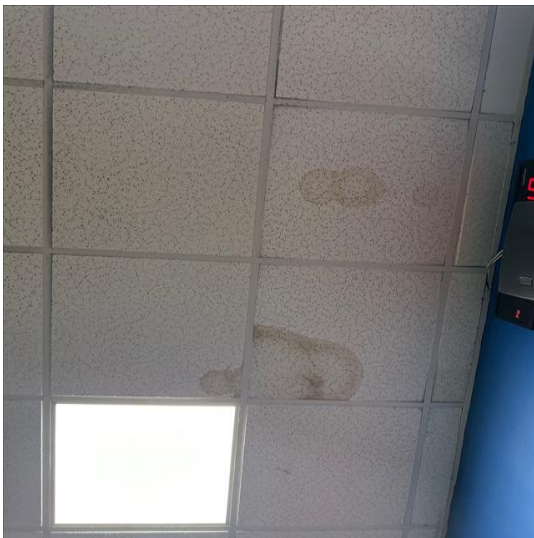
Image Number: 6

Observation: 1. Multiple moisture stains found within interior of structure. These stains were primarily found on the false ceiling tiles. Upon further investigation it was revealed that the moisture stains were consistent with roof penetrations in most areas. 2. Some areas of moisture staining that did not have roof penetrations nearby were most likely the result of condensation from HVAC tubing which was observed to be ripped in one area. 3. Efflorescence was observed on the upper part of the wall on the main entrance. This is indicative of the presence of moisture within the masonry.

Cause: 1. The moisture staining on the ceiling tiles were observed to be from the roof penetrations that were not properly sealed or flashed, and in some cases incorrectly installed on the roof. 2. The HVAC tubing in some areas was observed to be ripped or not insulated correctly, which results in condensation and can mimic roof leaks in some cases. 3. The efflorescence was observed to be consistent with the parapet wall and coping that was damaged or in need of repair, directly above the staining.

Remedy: 1. Before any remediation or restoration can commence, the repairs discussed in this report must first be performed. 2. Possible HVAC condensation staining must first be verified by a licensed HVAC tech before any replacement of damaged tiles. 3. Muriatic acid is sometimes effective with removing efflorescence staining. While the staining does not pose a structural issue, it does indicate the source of the problem on the roof.

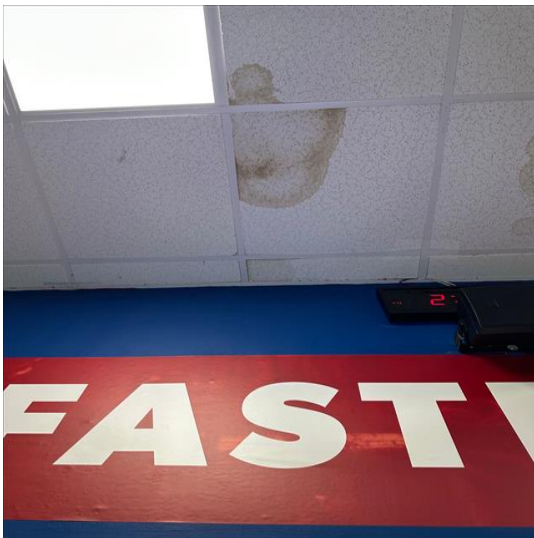
Image Number: 8

Observation: 1. Multiple moisture stains found within interior of structure. These stains were primarily found on the false ceiling tiles. Upon further investigation it was revealed that the moisture stains were consistent with roof penetrations in most areas. 2. Some areas of moisture staining that did not have roof penetrations nearby were most likely the result of condensation from HVAC tubing which was observed to be ripped in one area. 3. Efflorescence was observed on the upper part of the wall on the main entrance. This is indicative of the presence of moisture within the masonry.

Cause: 1. The moisture staining on the ceiling tiles were observed to be from the roof penetrations that were not properly sealed or flashed, and in some cases incorrectly installed on the roof. 2. The HVAC tubing in some areas was observed to be ripped or not insulated correctly, which results in condensation and can mimic roof leaks in some cases. 3. The efflorescence was observed to be consistent with the parapet wall and coping that was damaged or in need of repair, directly above the staining.

Remedy: 1. Before any remediation or restoration can commence, the repairs discussed in this report must first be performed. 2. Possible HVAC condensation staining must first be verified by a licensed HVAC tech before any replacement of damaged tiles. 3. Muriatic acid is sometimes effective with removing efflorescence staining. While the staining does not pose a structural issue, it does indicate the source of the problem on the roof.

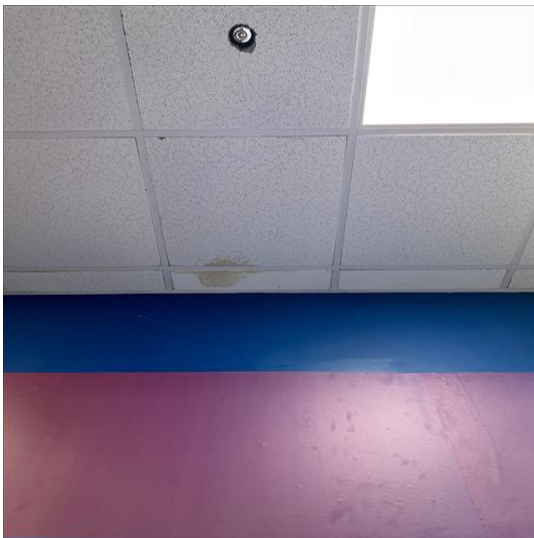
Image Number: 10

Observation: 1. Multiple moisture stains found within interior of structure. These stains were primarily found on the false ceiling tiles. Upon further investigation it was revealed that the moisture stains were consistent with roof penetrations in most areas. 2. Some areas of moisture staining that did not have roof penetrations nearby were most likely the result of condensation from HVAC tubing which was observed to be ripped in one area. 3. Efflorescence was observed on the upper part of the wall on the main entrance. This is indicative of the presence of moisture within the masonry.

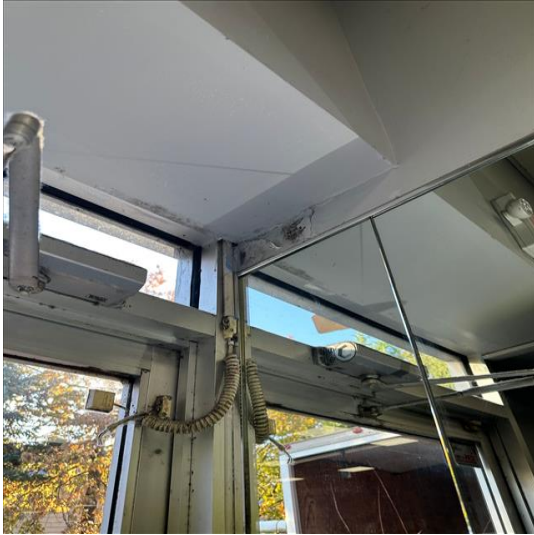
Image Number: 13

Observation: 1. Multiple moisture stains found within interior of structure. These stains were primarily found on the false ceiling tiles. Upon further investigation it was revealed that the moisture stains were consistent with roof penetrations in most areas. 2. Some areas of moisture staining that did not have roof penetrations nearby were most likely the result of condensation from HVAC tubing which was observed to be ripped in one area. 3. Efflorescence was observed on the upper part of the wall on the main entrance. This is indicative of the presence of moisture within the masonry.

Remedy: 1. Before any remediation or restoration can commence, the repairs discussed in this report must first be performed. 2. Possible HVAC condensation staining must first be verified by a licensed HVAC tech before any replacement of damaged tiles. 3. Muriatic acid is sometimes effective with removing efflorescence staining. While the staining does not pose a structural issue, it does indicate the source of the problem on the roof.

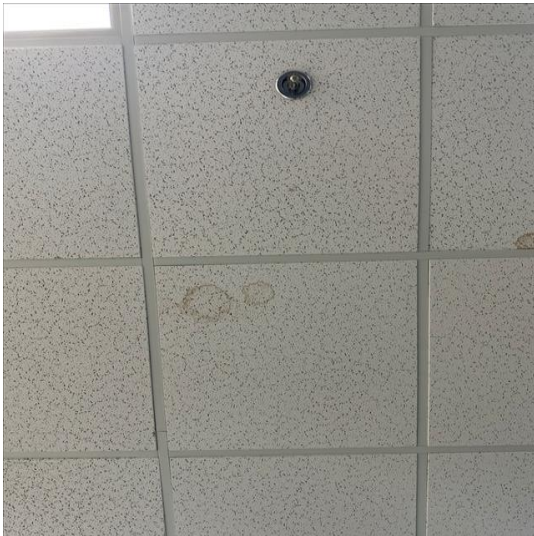
Image Number: 14

Observation: 1. Multiple moisture stains found within interior of structure. These stains were primarily found on the false ceiling tiles. Upon further investigation it was revealed that the moisture stains were consistent with roof penetrations in most areas. 2. Some areas of moisture staining that did not have roof penetrations nearby were most likely the result of condensation from HVAC tubing which was observed to be ripped in one area. 3. Efflorescence was observed on the upper part of the wall on the main entrance. This is indicative of the presence of moisture within the masonry.

Remedy: 1. Before any remediation or restoration can commence, the repairs discussed in this report must first be performed. 2. Possible HVAC condensation staining must first be verified by a licensed HVAC tech before any replacement of damaged tiles. 3. Muriatic acid is sometimes effective with removing efflorescence staining. While the staining does not pose a structural issue, it does indicate the source of the problem on the roof.

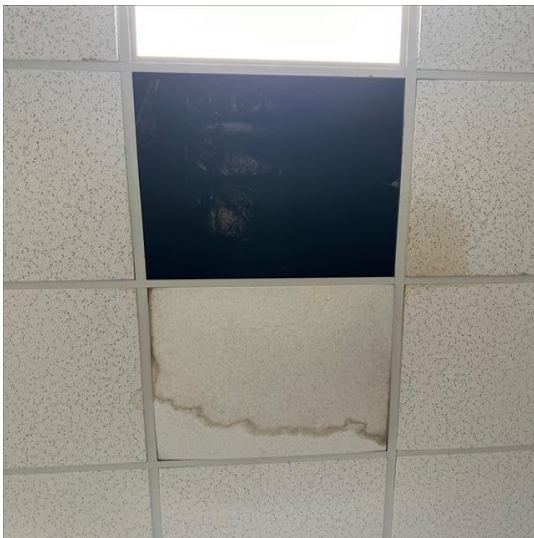
Image Number: 16

Observation: 1. Multiple moisture stains found within interior of structure. These stains were primarily found on the false ceiling tiles. Upon further investigation it was revealed that the moisture stains were consistent with roof penetrations in most areas. 2. Some areas of moisture staining that did not have roof penetrations nearby were most likely the result of condensation from HVAC tubing which was observed to be ripped in one area. 3. Efflorescence was observed on the upper part of the wall on the main entrance. This is indicative of the presence of moisture within the masonry.

Remedy: 1. Before any remediation or restoration can commence, the repairs discussed in this report must first be performed. 2. Possible HVAC condensation staining must first be verified by a licensed HVAC tech before any replacement of damaged tiles. 3. Muriatic acid is sometimes effective with removing efflorescence staining. While the staining does not pose a structural issue, it does indicate the source of the problem on the roof.

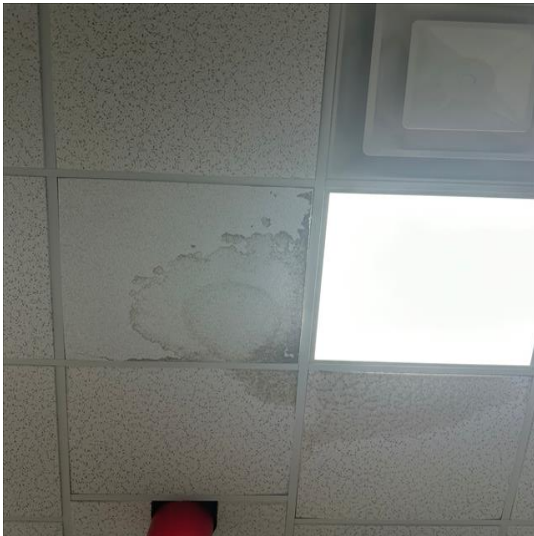
Image Number: 18

Observation: 1. Multiple moisture stains found within interior of structure. These stains were primarily found on the false ceiling tiles. Upon further investigation it was revealed that the moisture stains were consistent with roof penetrations in most areas. 2. Some areas of moisture staining that did not have roof penetrations nearby were most likely the result of condensation from HVAC tubing which was observed to be ripped in one area. 3. Efflorescence was observed on the upper part of the wall on the main entrance. This is indicative of the presence of moisture within the masonry.

Remedy: 1. Before any remediation or restoration can commence, the repairs discussed in this report must first be performed. 2. Possible HVAC condensation staining must first be verified by a licensed HVAC tech before any replacement of damaged tiles. 3. Muriatic acid is sometimes effective with removing efflorescence staining. While the staining does not pose a structural issue, it does indicate the source of the problem on the roof.

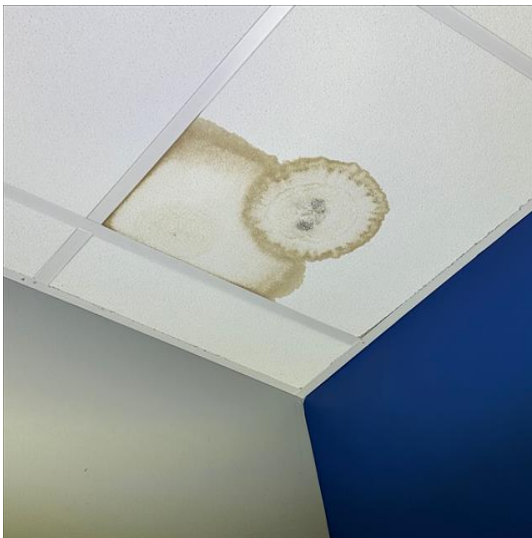
Image Number: 22

Observation: 1. Multiple moisture stains found within interior of structure. These stains were primarily found on the false ceiling tiles. Upon further investigation it was revealed that the moisture stains were consistent with roof penetrations in most areas. 2. Some areas of moisture staining that did not have roof penetrations nearby were most likely the result of condensation from HVAC tubing which was observed to be ripped in one area. 3. Efflorescence was observed on the upper part of the wall on the main entrance. This is indicative of the presence of moisture within the masonry.

Remedy: 1. Before any remediation or restoration can commence, the repairs discussed in this report must first be performed. 2. Possible HVAC condensation staining must first be verified by a licensed HVAC tech before any replacement of damaged tiles. 3. Muriatic acid is sometimes effective with removing efflorescence staining. While the staining does not pose a structural issue, it does indicate the source of the problem on the roof.

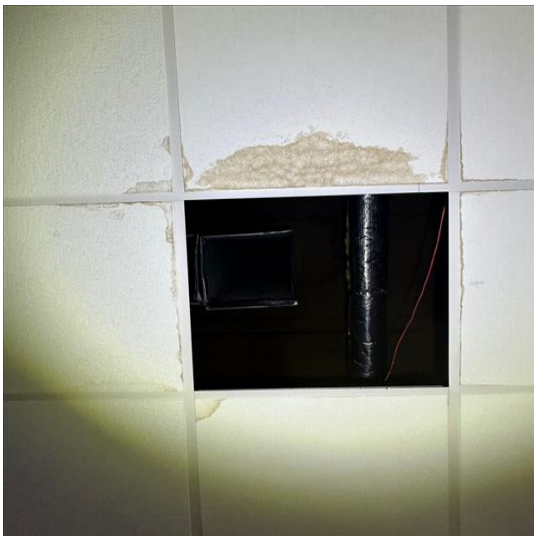
Image Number: 26

Observation: 1. Multiple moisture stains found within interior of structure. These stains were primarily found on the false ceiling tiles. Upon further investigation it was revealed that the moisture stains were consistent with roof penetrations in most areas. 2. Some areas of moisture staining that did not have roof penetrations nearby were most likely the result of condensation from HVAC tubing which was observed to be ripped in one area. 3. Efflorescence was observed on the upper part of the wall on the main entrance. This is indicative of the presence of moisture within the masonry.

Remedy: 1. Before any remediation or restoration can commence, the repairs discussed in this report must first be performed. 2. Possible HVAC condensation staining must first be verified by a licensed HVAC tech before any replacement of damaged tiles. 3. Muriatic acid is sometimes effective with removing efflorescence staining. While the staining does not pose a structural issue, it does indicate the source of the problem on the roof.

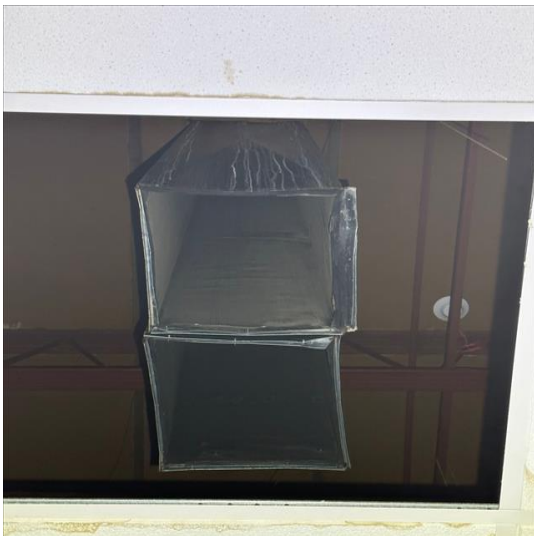
Image Number: 28

Observation: 1. Multiple moisture stains found within interior of structure. These stains were primarily found on the false ceiling tiles. Upon further investigation it was revealed that the moisture stains were consistent with roof penetrations in most areas. 2. Some areas of moisture staining that did not have roof penetrations nearby were most likely the result of condensation from HVAC tubing which was observed to be ripped in one area. 3. Efflorescence was observed on the upper part of the wall on the main entrance. This is indicative of the presence of moisture within the masonry.

Remedy: 1. Before any remediation or restoration can commence, the repairs discussed in this report must first be performed. 2. Possible HVAC condensation staining must first be verified by a licensed HVAC tech before any replacement of damaged tiles. 3. Muriatic acid is sometimes effective with removing efflorescence staining. While the staining does not pose a structural issue, it does indicate the source of the problem on the roof.

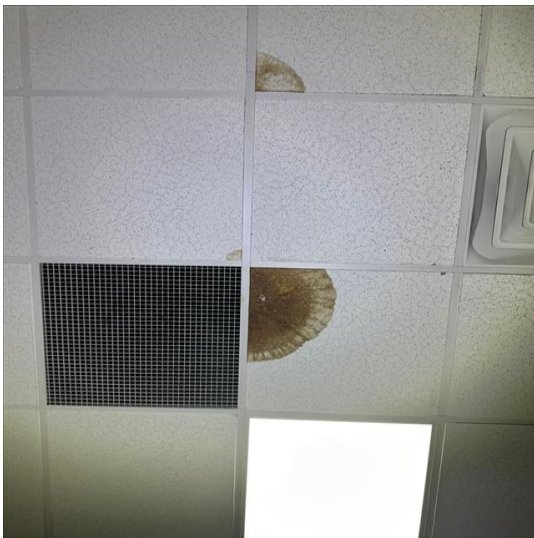
Image Number: 30

Observation: 1. Multiple moisture stains found within interior of structure. These stains were primarily found on the false ceiling tiles. Upon further investigation it was revealed that the moisture stains were consistent with roof penetrations in most areas. 2. Some areas of moisture staining that did not have roof penetrations nearby were most likely the result of condensation from HVAC tubing which was observed to be ripped in one area. 3. Efflorescence was observed on the upper part of the wall on the main entrance. This is indicative of the presence of moisture within the masonry.

Remedy: 1. Before any remediation or restoration can commence, the repairs discussed in this report must first be performed. 2. Possible HVAC condensation staining must first be verified by a licensed HVAC tech before any replacement of damaged tiles. 3. Muriatic acid is sometimes effective with removing efflorescence staining. While the staining does not pose a structural issue, it does indicate the source of the problem on the roof.

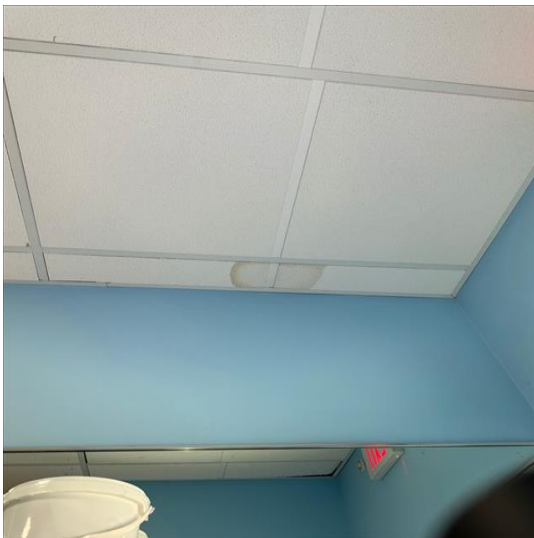
Image Number: 32

Observation: 1. Multiple moisture stains found within interior of structure. These stains were primarily found on the false ceiling tiles. Upon further investigation it was revealed that the moisture stains were consistent with roof penetrations in most areas. 2. Some areas of moisture staining that did not have roof penetrations nearby were most likely the result of condensation from HVAC tubing which was observed to be ripped in one area. 3. Efflorescence was observed on the upper part of the wall on the main entrance. This is indicative of the presence of moisture within the masonry.

Remedy: 1. Before any remediation or restoration can commence, the repairs discussed in this report must first be performed. 2. Possible HVAC condensation staining must first be verified by a licensed HVAC tech before any replacement of damaged tiles. 3. Muriatic acid is sometimes effective with removing efflorescence staining. While the staining does not pose a structural issue, it does indicate the source of the problem on the roof.

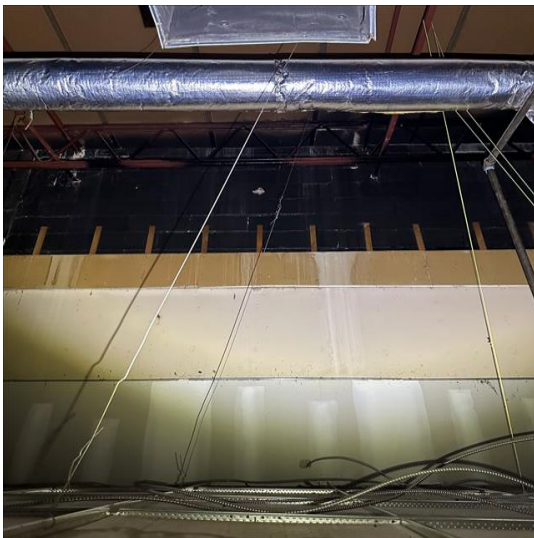
Image Number: 34

Observation: 1. Multiple moisture stains found within interior of structure. These stains were primarily found on the false ceiling tiles. Upon further investigation it was revealed that the moisture stains were consistent with roof penetrations in most areas. 2. Some areas of moisture staining that did not have roof penetrations nearby were most likely the result of condensation from HVAC tubing which was observed to be ripped in one area. 3. Efflorescence was observed on the upper part of the wall on the main entrance. This is indicative of the presence of moisture within the masonry.

Remedy: 1. Before any remediation or restoration can commence, the repairs discussed in this report must first be performed. 2. Possible HVAC condensation staining must first be verified by a licensed HVAC tech before any replacement of damaged tiles. 3. Muriatic acid is sometimes effective with removing efflorescence staining. While the staining does not pose a structural issue, it does indicate the source of the problem on the roof.

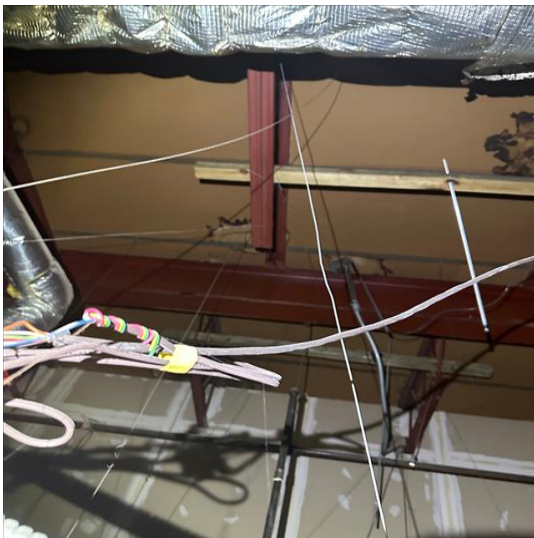
Image Number: 36

Observation: 1. Multiple moisture stains found within interior of structure. These stains were primarily found on the false ceiling tiles. Upon further investigation it was revealed that the moisture stains were consistent with roof penetrations in most areas. 2. Some areas of moisture staining that did not have roof penetrations nearby were most likely the result of condensation from HVAC tubing which was observed to be ripped in one area. 3. Efflorescence was observed on the upper part of the wall on the main entrance. This is indicative of the presence of moisture within the masonry.

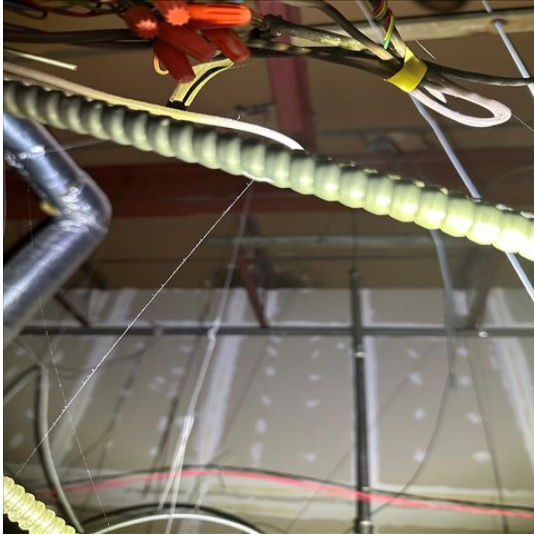
Image Number: 37

Observation: 1. Multiple moisture stains found within interior of structure. These stains were primarily found on the false ceiling tiles. Upon further investigation it was revealed that the moisture stains were consistent with roof penetrations in most areas. 2. Some areas of moisture staining that did not have roof penetrations nearby were most likely the result of condensation from HVAC tubing which was observed to be ripped in one area. 3. Efflorescence was observed on the upper part of the wall on the main entrance. This is indicative of the presence of moisture within the masonry.

Remedy: 1. Before any remediation or restoration can commence, the repairs discussed in this report must first be performed. 2. Possible HVAC condensation staining must first be verified by a licensed HVAC tech before any replacement of damaged tiles. 3. Muriatic acid is sometimes effective with removing efflorescence staining. While the staining does not pose a structural issue, it does indicate the source of the problem on the roof.

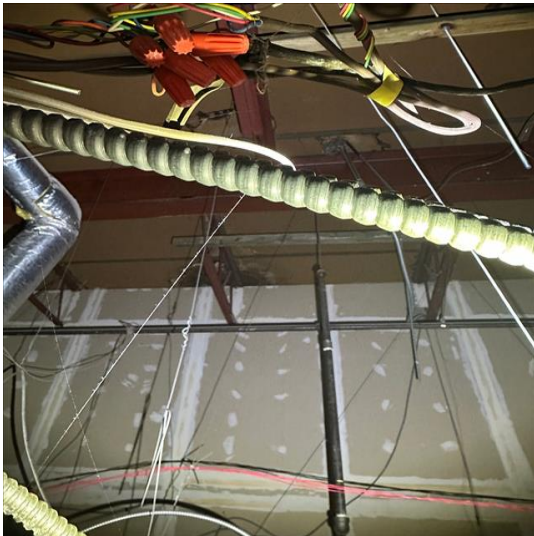
Image Number: 38

Observation: 1. Multiple moisture stains found within interior of structure. These stains were primarily found on the false ceiling tiles. Upon further investigation it was revealed that the moisture stains were consistent with roof penetrations in most areas. 2. Some areas of moisture staining that did not have roof penetrations nearby were most likely the result of condensation from HVAC tubing which was observed to be ripped in one area. 3. Efflorescence was observed on the upper part of the wall on the main entrance. This is indicative of the presence of moisture within the masonry.

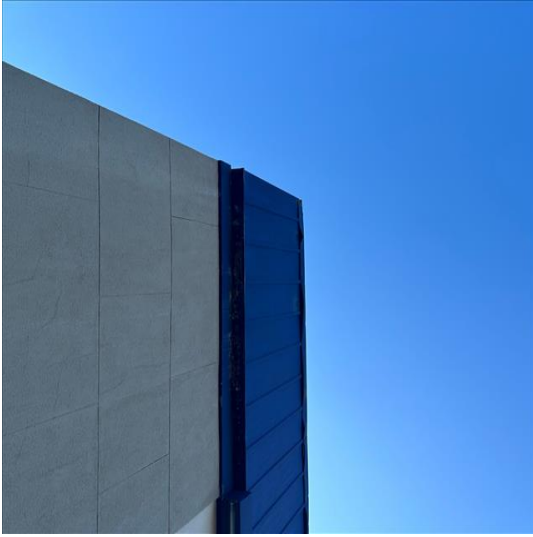
Image Number: 45

Observation: Perimeter photos of damaged coping of parapet walls.

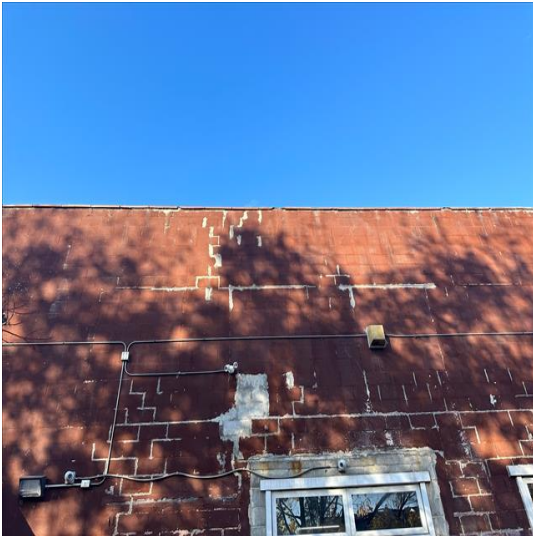
Image Number: 46

Observation: Perimeter photos of damaged coping of parapet walls.

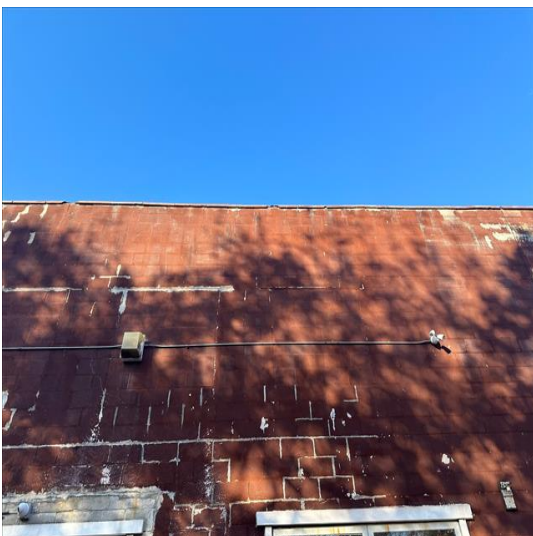
Image Number: 47

Observation: Perimeter photos of damaged coping of parapet walls.

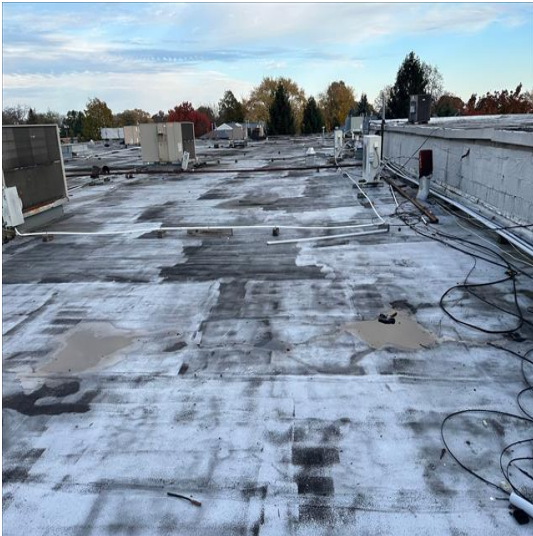
Image Number: 74

Observation: Overview photos of roof.

Determination: Roof Replacement required for LeakFREE Roof Certification

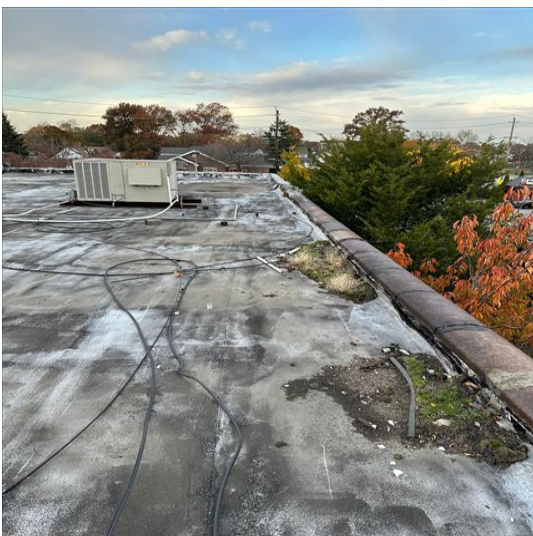
Image Number: 81

Observation: Overview photos of roof.
