LeakFREE® Roof Inspection

Report No :
130075

Property Inspected :
[REDACTED]
[REDACTED]

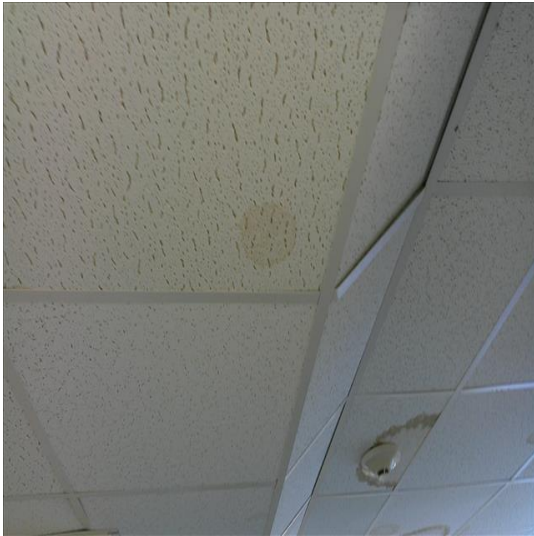
Image Number: 1

Observation: Moisture staining was observed and consistent among the following areas; (1) the windows in the upstairs office (2) the area directly below the transition of the roof from the headwall to the flat roof (3) areas below plumbing (4) areas with cut outs in drop ceilings for equipment

Cause: (1) windows have deficient flashing. Windows were observed to have thermal seals failing at some locations indicating serviceable expectancy. (2) The roof was discovered to have improper installation and is later discussed in the report (3) Plumbing may be causing condensation in some areas and presents a leak appearance in ceilings (4) Cut outs are never properly sealed and weathertight, condensation is forming in these areas and appearing as a leak. The mixture of conditioned and unconditioned spaces create condensation at these recessions.

Remedy: (1) Replace windows and flashing that require attention (2) Roof needs to be properly integrated into the headwalls and requires replacement (3) Licensed plumber needs to evaluate the plumbing system and determine if leaks are present or if the material of the pipe is creating condensation with thermal elements (4) Monitor these cut outs for any changes.

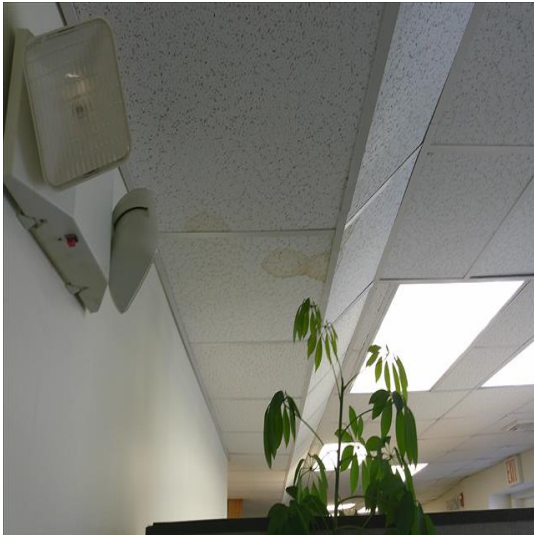
Image Number: 2

Observation: Moisture staining was observed and consistent among the following areas; (1) the windows in the upstairs office (2) the area directly below the transition of the roof from the headwall to the flat roof (3) areas below plumbing (4) areas with cut outs in drop ceilings for equipment

Cause: (1) windows have deficient flashing. Windows were observed to have thermal seals failing at some locations indicating serviceable expectancy. (2) The roof was discovered to have improper installation and is later discussed in the report (3) Plumbing may be causing condensation in some areas and presents a leak appearance in ceilings (4) Cut outs are never properly sealed and weathertight, condensation is forming in these areas and appearing as a leak. The mixture of conditioned and unconditioned spaces create condensation at these recessions.

Remedy: (1) Replace windows and flashing that require attention (2) Roof needs to be properly integrated into the headwalls and requires replacement (3) Licensed plumber needs to evaluate the plumbing system and determine if leaks are present or if the material of the pipe is creating condensation with thermal elements (4) Monitor these cut outs for any changes.

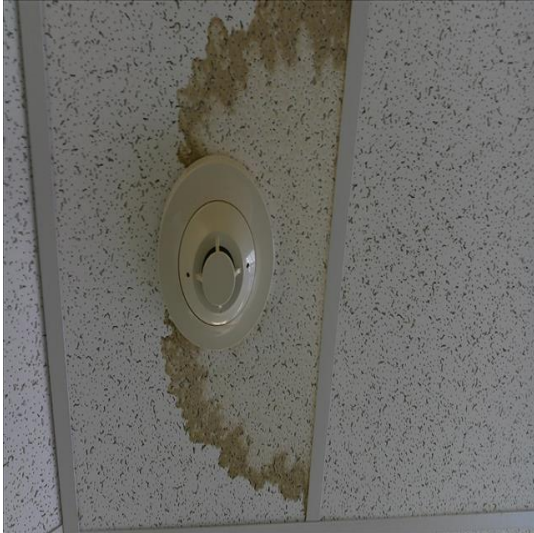
Image Number: 3

Observation: Moisture staining was observed and consistent among the following areas; (1) the windows in the upstairs office (2) the area directly below the transition of the roof from the headwall to the flat roof (3) areas below plumbing (4) areas with cut outs in drop ceilings for equipment

Cause: (1) windows have deficient flashing. Windows were observed to have thermal seals failing at some locations indicating serviceable expectancy. (2) The roof was discovered to have improper installation and is later discussed in the report (3) Plumbing may be causing condensation in some areas and presents a leak appearance in ceilings (4) Cut outs are never properly sealed and weathertight, condensation is forming in these areas and appearing as a leak. The mixture of conditioned and unconditioned spaces create condensation at these recessions.

Remedy: (1) Replace windows and flashing that require attention (2) Roof needs to be properly integrated into the headwalls and requires replacement (3) Licensed plumber needs to evaluate the plumbing system and determine if leaks are present or if the material of the pipe is creating condensation with thermal elements (4) Monitor these cut outs for any changes.

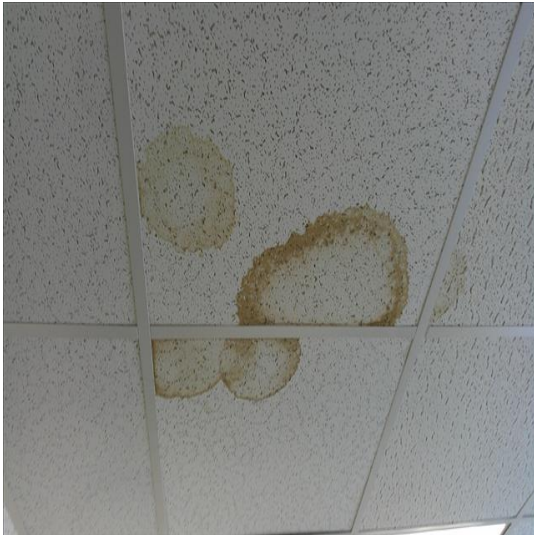
Image Number: 4

Observation: Moisture staining was observed and consistent among the following areas; (1) the windows in the upstairs office (2) the area directly below the transition of the roof from the headwall to the flat roof (3) areas below plumbing (4) areas with cut outs in drop ceilings for equipment

Cause: (1) windows have deficient flashing. Windows were observed to have thermal seals failing at some locations indicating serviceable expectancy. (2) The roof was discovered to have improper installation and is later discussed in the report (3) Plumbing may be causing condensation in some areas and presents a leak appearance in ceilings (4) Cut outs are never properly sealed and weathertight, condensation is forming in these areas and appearing as a leak. The mixture of conditioned and unconditioned spaces create condensation at these recessions.

Remedy: (1) Replace windows and flashing that require attention (2) Roof needs to be properly integrated into the headwalls and requires replacement (3) Licensed plumber needs to evaluate the plumbing system and determine if leaks are present or if the material of the pipe is creating condensation with thermal elements (4) Monitor these cut outs for any changes.

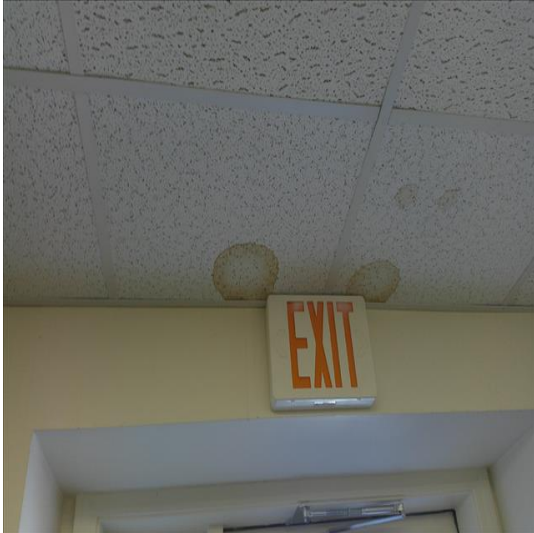
Image Number: 5

Observation: Moisture staining was observed and consistent among the following areas; (1) the windows in the upstairs office (2) the area directly below the transition of the roof from the headwall to the flat roof (3) areas below plumbing (4) areas with cut outs in drop ceilings for equipment

Cause: (1) windows have deficient flashing. Windows were observed to have thermal seals failing at some locations indicating serviceable expectancy. (2) The roof was discovered to have improper installation and is later discussed in the report (3) Plumbing may be causing condensation in some areas and presents a leak appearance in ceilings (4) Cut outs are never properly sealed and weathertight, condensation is forming in these areas and appearing as a leak. The mixture of conditioned and unconditioned spaces create condensation at these recessions.

Remedy: (1) Replace windows and flashing that require attention (2) Roof needs to be properly integrated into the headwalls and requires replacement (3) Licensed plumber needs to evaluate the plumbing system and determine if leaks are present or if the material of the pipe is creating condensation with thermal elements (4) Monitor these cut outs for any changes.

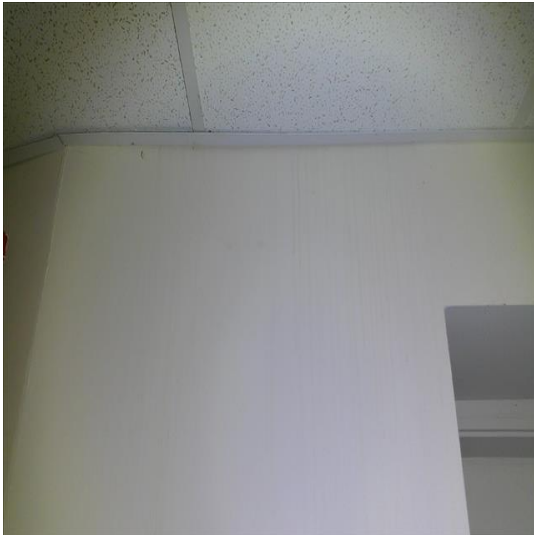
Image Number: 6

Observation: Moisture staining was observed and consistent among the following areas; (1) the windows in the upstairs office (2) the area directly below the transition of the roof from the headwall to the flat roof (3) areas below plumbing (4) areas with cut outs in drop ceilings for equipment

Cause: (1) windows have deficient flashing. Windows were observed to have thermal seals failing at some locations indicating serviceable expectancy. (2) The roof was discovered to have improper installation and is later discussed in the report (3) Plumbing may be causing condensation in some areas and presents a leak appearance in ceilings (4) Cut outs are never properly sealed and weathertight, condensation is forming in these areas and appearing as a leak. The mixture of conditioned and unconditioned spaces create condensation at these recessions.

Remedy: (1) Replace windows and flashing that require attention (2) Roof needs to be properly integrated into the headwalls and requires replacement (3) Licensed plumber needs to evaluate the plumbing system and determine if leaks are present or if the material of the pipe is creating condensation with thermal elements (4) Monitor these cut outs for any changes.

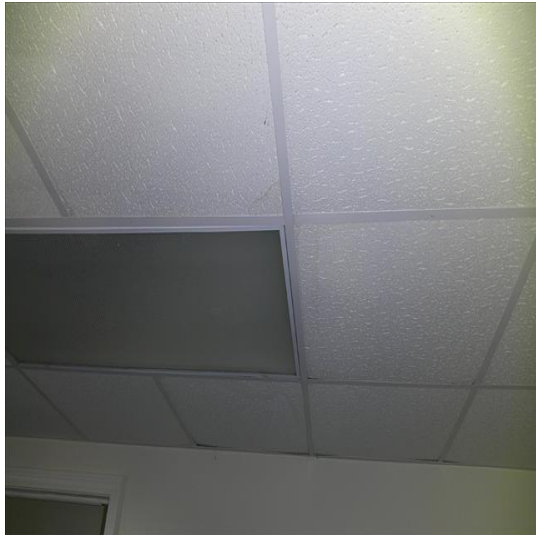
Image Number: 7

Observation: Moisture staining was observed and consistent among the following areas; (1) the windows in the upstairs office (2) the area directly below the transition of the roof from the headwall to the flat roof (3) areas below plumbing (4) areas with cut outs in drop ceilings for equipment

Cause: (1) windows have deficient flashing. Windows were observed to have thermal seals failing at some locations indicating serviceable expectancy. (2) The roof was discovered to have improper installation and is later discussed in the report (3) Plumbing may be causing condensation in some areas and presents a leak appearance in ceilings (4) Cut outs are never properly sealed and weathertight, condensation is forming in these areas and appearing as a leak. The mixture of conditioned and unconditioned spaces create condensation at these recessions.

Remedy: (1) Replace windows and flashing that require attention (2) Roof needs to be properly integrated into the headwalls and requires replacement (3) Licensed plumber needs to evaluate the plumbing system and determine if leaks are present or if the material of the pipe is creating condensation with thermal elements (4) Monitor these cut outs for any changes.

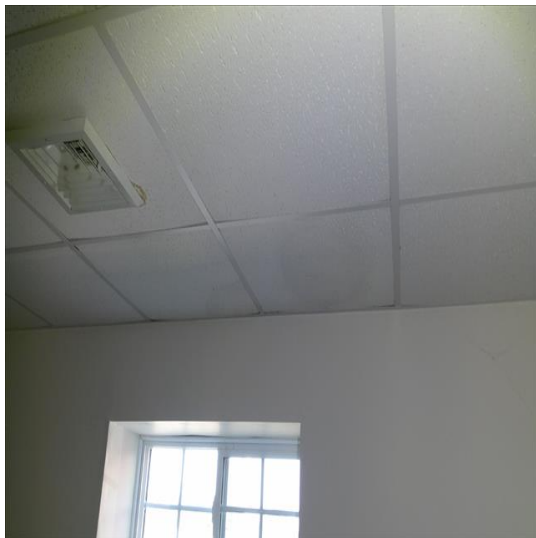
Image Number: 8

Observation: Moisture staining was observed and consistent among the following areas; (1) the windows in the upstairs office (2) the area directly below the transition of the roof from the headwall to the flat roof (3) areas below plumbing (4) areas with cut outs in drop ceilings for equipment

Cause: (1) windows have deficient flashing. Windows were observed to have thermal seals failing at some locations indicating serviceable expectancy. (2) The roof was discovered to have improper installation and is later discussed in the report (3) Plumbing may be causing condensation in some areas and presents a leak appearance in ceilings (4) Cut outs are never properly sealed and weathertight, condensation is forming in these areas and appearing as a leak. The mixture of conditioned and unconditioned spaces create condensation at these recessions.

Remedy: (1) Replace windows and flashing that require attention (2) Roof needs to be properly integrated into the headwalls and requires replacement (3) Licensed plumber needs to evaluate the plumbing system and determine if leaks are present or if the material of the pipe is creating condensation with thermal elements (4) Monitor these cut outs for any changes.

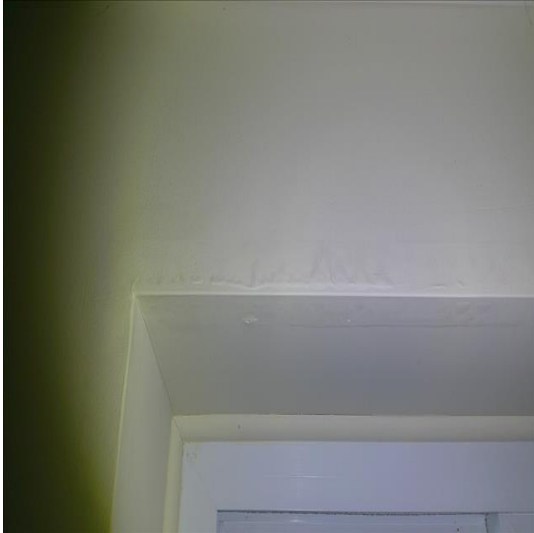
Image Number: 9

Observation: Moisture staining was observed and consistent among the following areas; (1) the windows in the upstairs office (2) the area directly below the transition of the roof from the headwall to the flat roof (3) areas below plumbing (4) areas with cut outs in drop ceilings for equipment

Cause: (1) windows have deficient flashing. Windows were observed to have thermal seals failing at some locations indicating serviceable expectancy. (2) The roof was discovered to have improper installation and is later discussed in the report (3) Plumbing may be causing condensation in some areas and presents a leak appearance in ceilings (4) Cut outs are never properly sealed and weathertight, condensation is forming in these areas and appearing as a leak. The mixture of conditioned and unconditioned spaces create condensation at these recessions.

Remedy: (1) Replace windows and flashing that require attention (2) Roof needs to be properly integrated into the headwalls and requires replacement (3) Licensed plumber needs to evaluate the plumbing system and determine if leaks are present or if the material of the pipe is creating condensation with thermal elements (4) Monitor these cut outs for any changes.

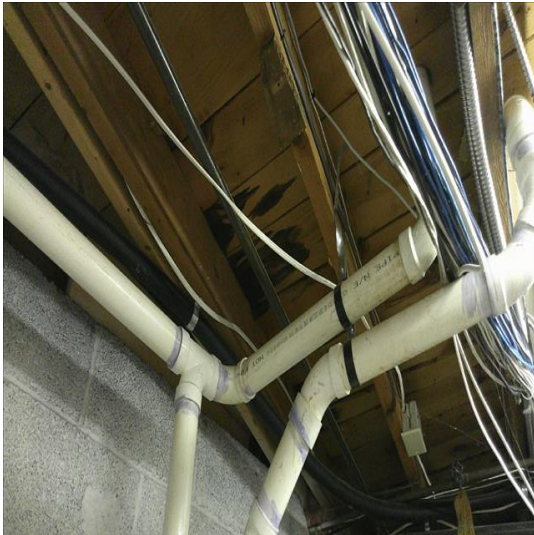
Image Number: 10

Observation: Moisture staining was observed and consistent among the following areas; (1) the windows in the upstairs office (2) the area directly below the transition of the roof from the headwall to the flat roof (3) areas below plumbing (4) areas with cut outs in drop ceilings for equipment

Cause: (1) windows have deficient flashing. Windows were observed to have thermal seals failing at some locations indicating serviceable expectancy. (2) The roof was discovered to have improper installation and is later discussed in the report (3) Plumbing may be causing condensation in some areas and presents a leak appearance in ceilings (4) Cut outs are never properly sealed and weathertight, condensation is forming in these areas and appearing as a leak. The mixture of conditioned and unconditioned spaces create condensation at these recessions.

Remedy: (1) Replace windows and flashing that require attention (2) Roof needs to be properly integrated into the headwalls and requires replacement (3) Licensed plumber needs to evaluate the plumbing system and determine if leaks are present or if the material of the pipe is creating condensation with thermal elements (4) Monitor these cut outs for any changes.

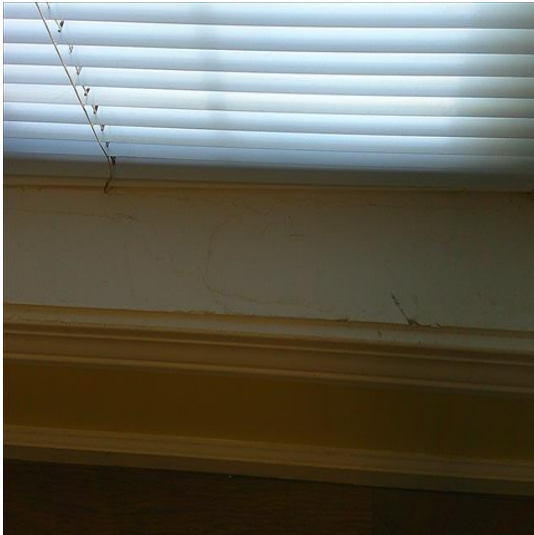
Image Number: 12

Observation: Moisture staining was observed and consistent among the following areas; (1) the windows in the upstairs office (2) the area directly below the transition of the roof from the headwall to the flat roof (3) areas below plumbing (4) areas with cut outs in drop ceilings for equipment

Cause: (1) windows have deficient flashing. Windows were observed to have thermal seals failing at some locations indicating serviceable expectancy. (2) The roof was discovered to have improper installation and is later discussed in the report (3) Plumbing may be causing condensation in some areas and presents a leak appearance in ceilings (4) Cut outs are never properly sealed and weathertight, condensation is forming in these areas and appearing as a leak. The mixture of conditioned and unconditioned spaces create condensation at these recessions.

Remedy: (1) Replace windows and flashing that require attention (2) Roof needs to be properly integrated into the headwalls and requires replacement (3) Licensed plumber needs to evaluate the plumbing system and determine if leaks are present or if the material of the pipe is creating condensation with thermal elements (4) Monitor these cut outs for any changes.

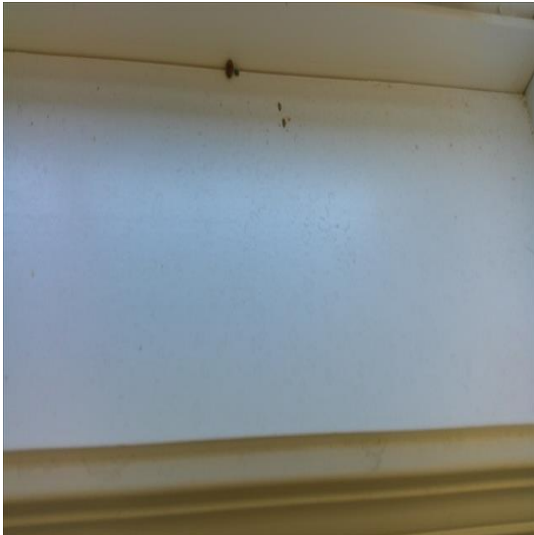
Image Number: 14

Observation: Moisture staining was observed and consistent among the following areas; (1) the windows in the upstairs office (2) the area directly below the transition of the roof from the headwall to the flat roof (3) areas below plumbing (4) areas with cut outs in drop ceilings for equipment

Cause: (1) windows have deficient flashing. Windows were observed to have thermal seals failing at some locations indicating serviceable expectancy. (2) The roof was discovered to have improper installation and is later discussed in the report (3) Plumbing may be causing condensation in some areas and presents a leak appearance in ceilings (4) Cut outs are never properly sealed and weathertight, condensation is forming in these areas and appearing as a leak. The mixture of conditioned and unconditioned spaces create condensation at these recessions.

Remedy: (1) Replace windows and flashing that require attention (2) Roof needs to be properly integrated into the headwalls and requires replacement (3) Licensed plumber needs to evaluate the plumbing system and determine if leaks are present or if the material of the pipe is creating condensation with thermal elements (4) Monitor these cut outs for any changes.

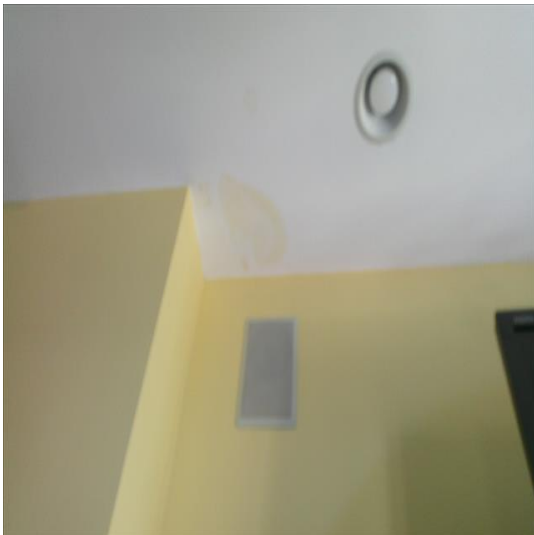
Image Number: 16

Observation: The interior was inspected and determined to have multiple locations with previous and current leaks. The meeting room downstairs was observed to have moisture staining indicating that water is gaining entry above. It was determined that (2) locations are creating moisture intrusion issues. (1) location is the toilet directly above (2) location is the floor and wall intersection where there were small spaces that were not sealed. Building owner stated that water gets in by the door and puddles.

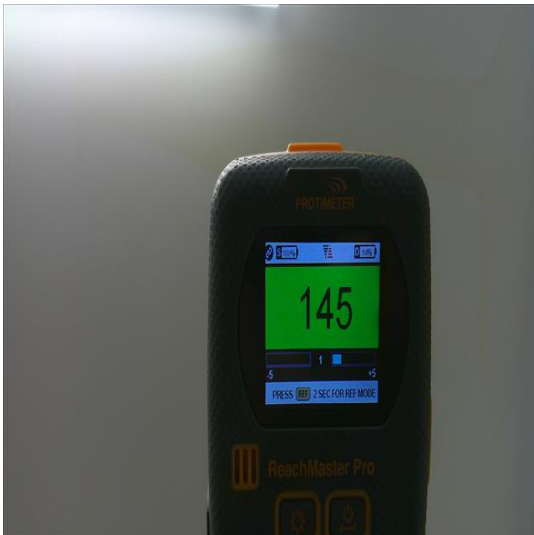
Image Number: 19

Observation: The interior was inspected and determined to have multiple locations with previous and current leaks. The meeting room downstairs was observed to have moisture staining indicating that water is gaining entry above. It was determined that (2) locations are creating moisture intrusion issues. (1) location is the toilet directly above (2) location is the floor and wall intersection where there were small spaces that were not sealed. Building owner stated that water gets in by the door and puddles.

Remedy: Contact a licensed plumber to analyze and replace the defective wax ring. Install a weather strip for the door bottom.

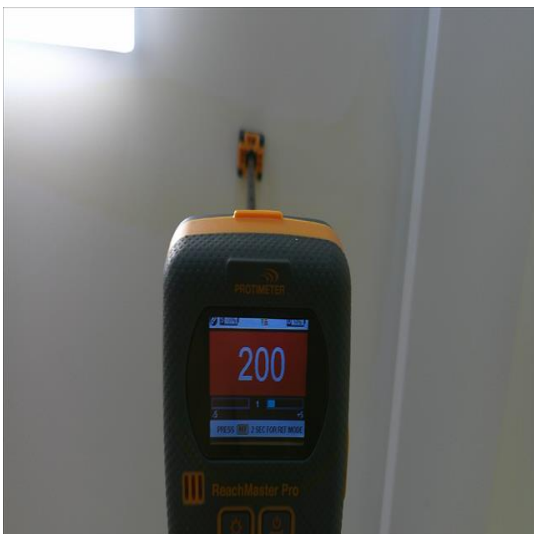
Image Number: 20

Observation: The interior was inspected and determined to have multiple locations with previous and current leaks. The meeting room downstairs was observed to have moisture staining indicating that water is gaining entry above. It was determined that (2) locations are creating moisture intrusion issues. (1) location is the toilet directly above (2) location is the floor and wall intersection where there were small spaces that were not sealed. Building owner stated that water gets in by the door and puddles.

Remedy: Contact a licensed plumber to analyze and replace the defective wax wring. Install a weather strip for the door bottom.

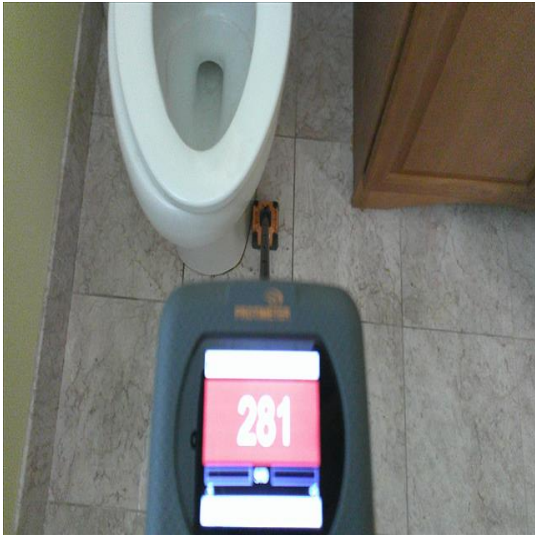
Image Number: 27
Observation: The interior was inspected and determined to have multiple locations with previous and current leaks. The meeting room downstairs was observed to have moisture staining indicating that water is gaining entry above. It was determined that (2) locations are creating moisture intrusion issues. (1) location is the toilet directly above (2) location is the floor and wall intersection where there were small spaces that were not sealed. Building owner stated that water gets in by the door and puddles.
Cause: Wax ring at the toilet is defective and needs to be replaced. The doorway is allowing water to puddle.
Remedy: Contact a licensed plumber to analyze and replace the defective wax wring. Install a weather strip for the door bottom.

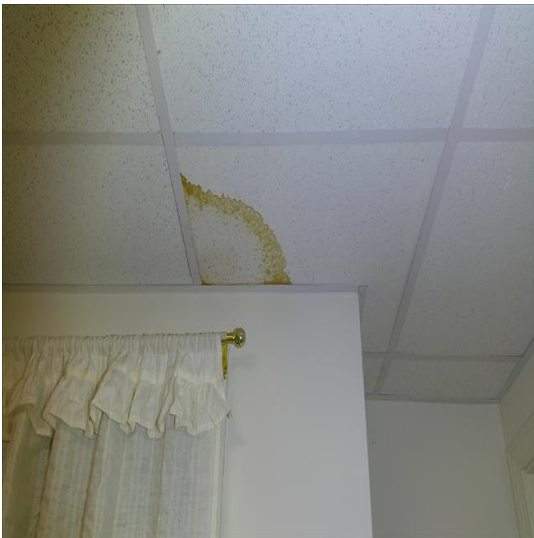
Image Number: 35
Observation: Moisture stains were observed within the interior at a closet and office.
Cause: It was determined that the condensation from the plumbing pipe is causing this water pattern and damage.
Remedy: Contact a licensed plumber to determine a remedy for this issue.

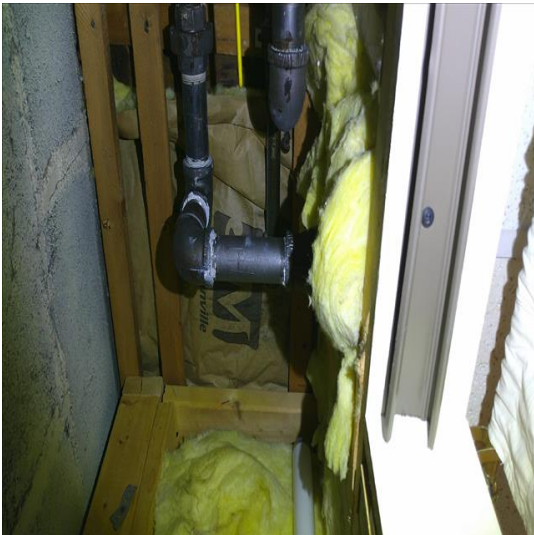
Image Number: 36
Observation: Moisture stains were observed within the interior at a closet and office.
Cause: It was determined that the condensation from the plumbing pipe is causing this water pattern and damage.
Remedy: Contact a licensed plumber to determine a remedy for this issue.

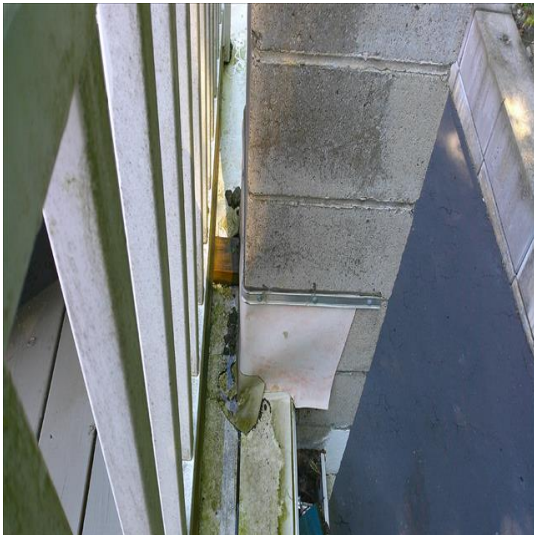
Image Number: 46

Cause: Improper installation.

Remedy: Roof replacement is recommended. This roof was not properly installed and appeared to be loose laid in many locations due to adhesion failure.

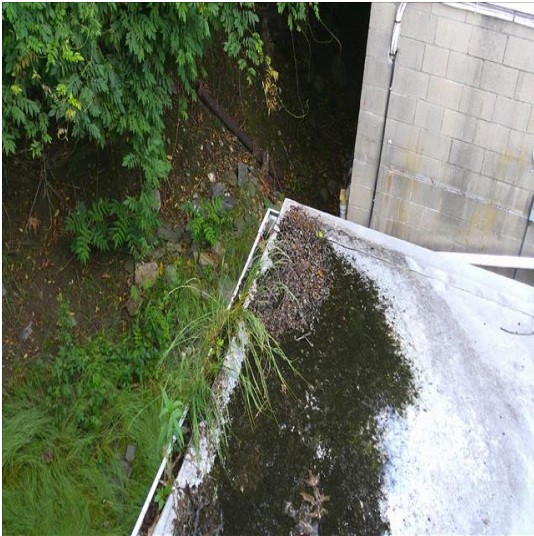
Image Number: 48
Observation: The gutter system for the flat roof system was observed to have debris and damage that is resulting in a leak at (1) location.
Cause: Deferred maintenance.
Remedy: Clean gutters and repair damaged section that is leaking.

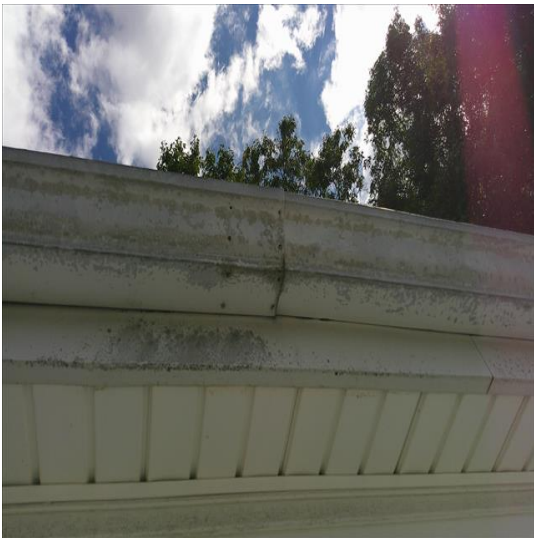
Image Number: 49
Observation: The gutter system for the flat roof system was observed to have debris and damage that is resulting in a leak at (1) location.
Cause: Deferred maintenance.
Remedy: Clean gutters and repair damaged section that is leaking.

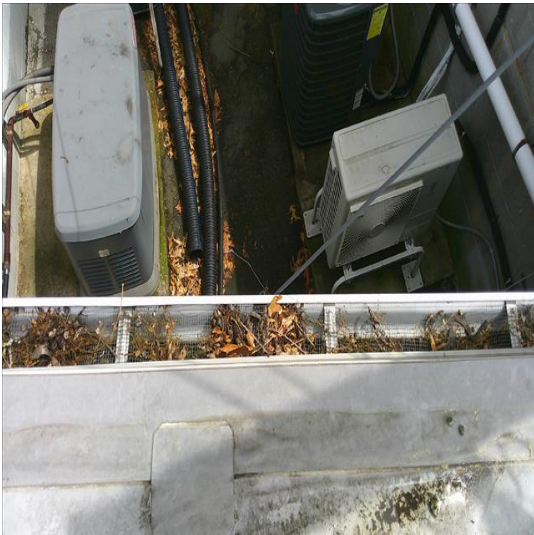
Image Number: 50
Observation: The gutter system for the flat roof system was observed to have debris and damage that is resulting in a leak at (1) location.
Cause: Deferred maintenance.
Remedy: Clean gutters and repair damaged section that is leaking.

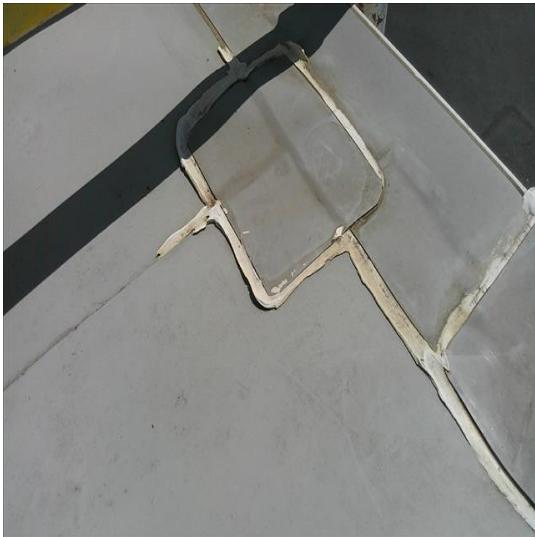
Image Number: 57
Observation: Joining flashings at some locations were observed to have adhesion failure or be improperly installed with incorrect materials. One joint flashing was observed to have adhesion failure, and another was observed to have incorrect sealant (caulk) used instead of recommended adhesive for this roof material. Caulk is not a valid form of flashing and has a general serviceable expectancy of 5 years.
Cause: Improper installation.
Remedy: Replace the joint flashings and properly adhere.
Determination: Repair required

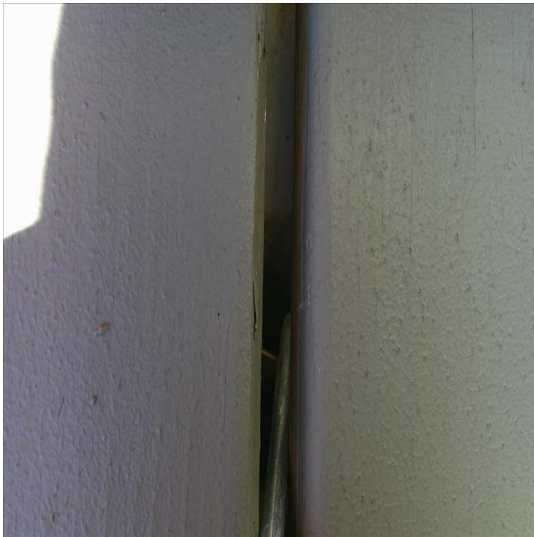
Image Number: 59

Determination: Replacement required

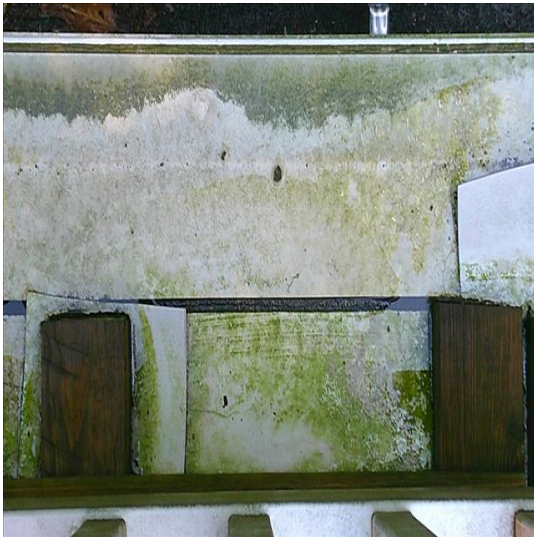
Image Number: 84

Determination: Replacement required

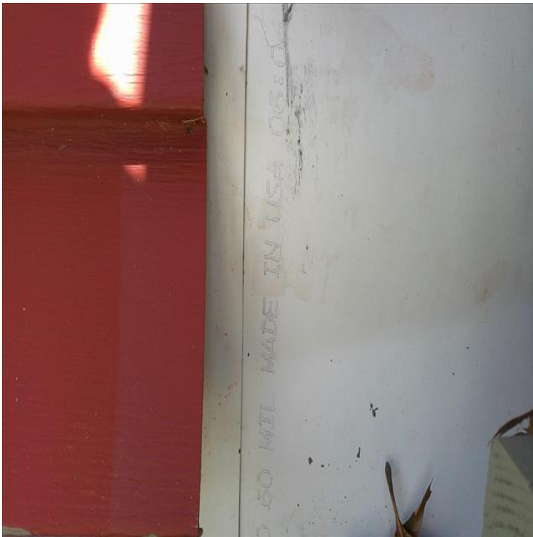
Image Number: 90

Observation: The roof material observed was a TPO 60 Mil thickness covering.
