# Forensic ROOF® Inspection

**Report No :**  
129263

**Published On :**  
01/14/2024

**Inspection Date :**  
12/26/2023

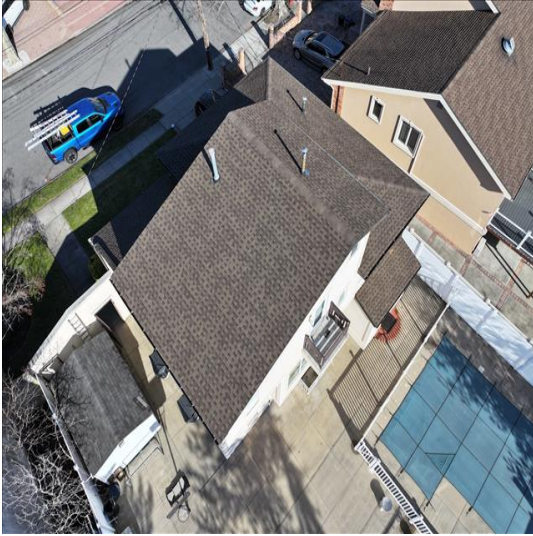
**Image Number:** 25

**Observation:** Overview photos of roof. Aerial image with red arrows indicates areas of concern and should be corrected.

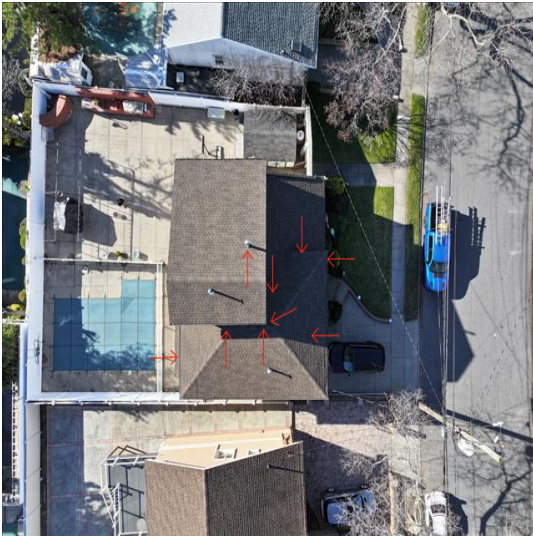
**Image Number:** 29

**Observation:** Overview photos of roof. Aerial image with red arrows indicates areas of concern and should be corrected.

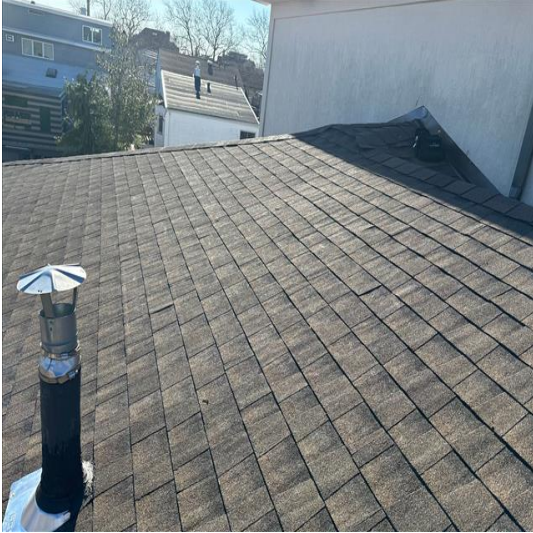
**Image Number:** 34

**Observation:** Overview photos of roof. Aerial image with red arrows indicates areas of concern and should be corrected.

**Determination:** Roof Repair required for LeakFREE Roof Certification

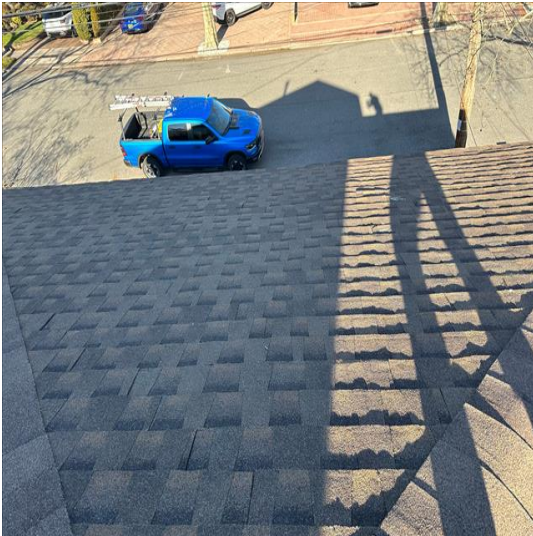
**Image Number:** 35

**Observation:** Overview photos of roof. Aerial image with red arrows indicates areas of concern and should be corrected.

**Determination:** Roof Repair required for LeakFREE Roof Certification

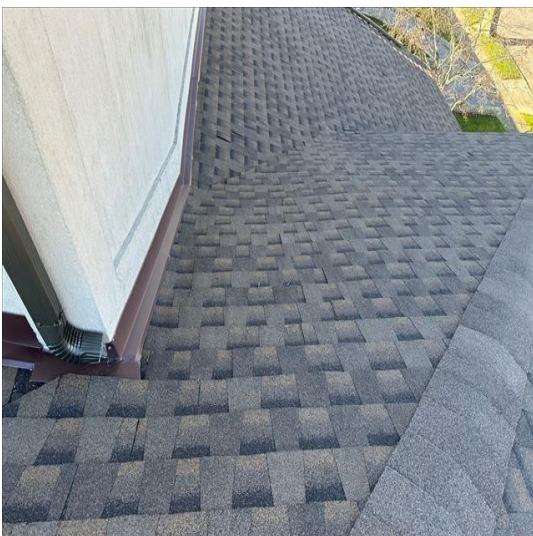
**Image Number:** 36

**Observation:** Overview photos of roof. Aerial image with red arrows indicates areas of concern and should be corrected.

**Determination:** Roof Repair required for LeakFREE Roof Certification

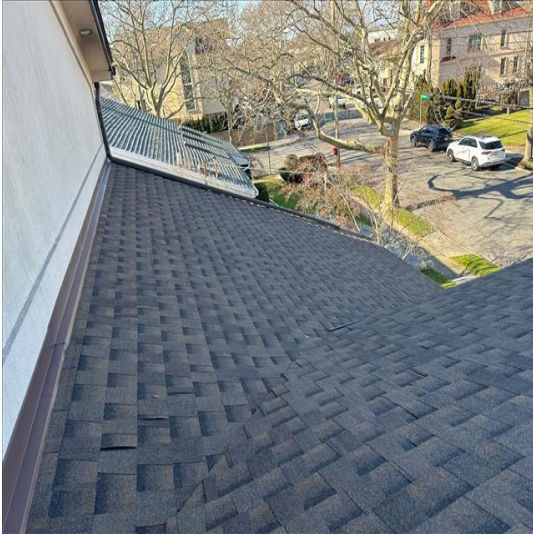
**Image Number:** 37

**Observation:** Overview photos of roof. Aerial image with red arrows indicates areas of concern and should be corrected.

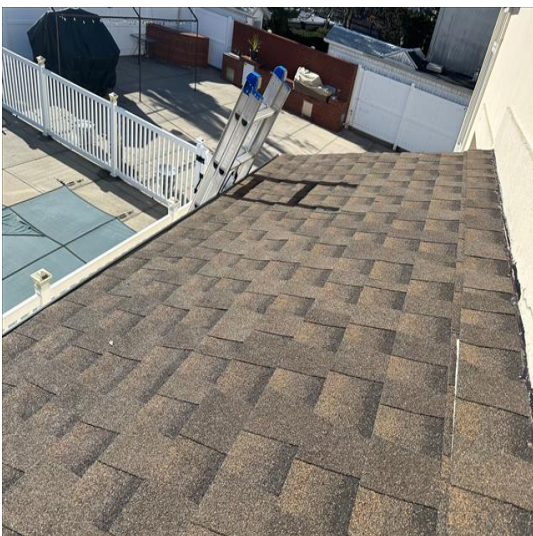
**Image Number:** 39

**Observation:** Overview photos of roof. Aerial image with red arrows indicates areas of concern and should be corrected.

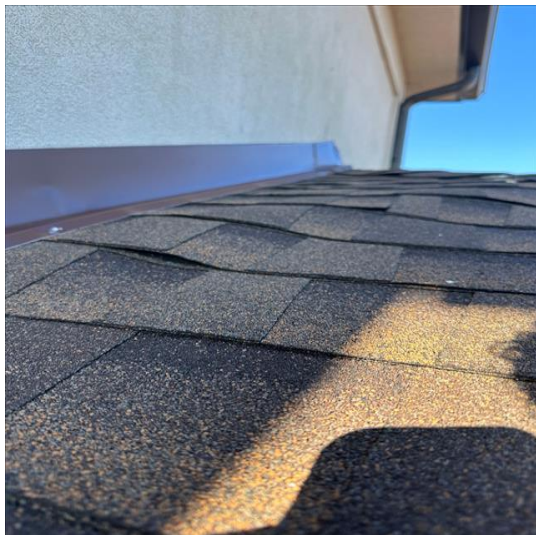
**Image Number:** 49

**Observation:** One area of the roof was observed to have buckling and lifting of shingles and possibly the sheathing material. A further analysis of this area is needed to determine cause and effect. Interior was not accessible for further inspection.

**Cause:** To be determined.

**Determination:** Roof Repair required for LeakFREE Roof Certification

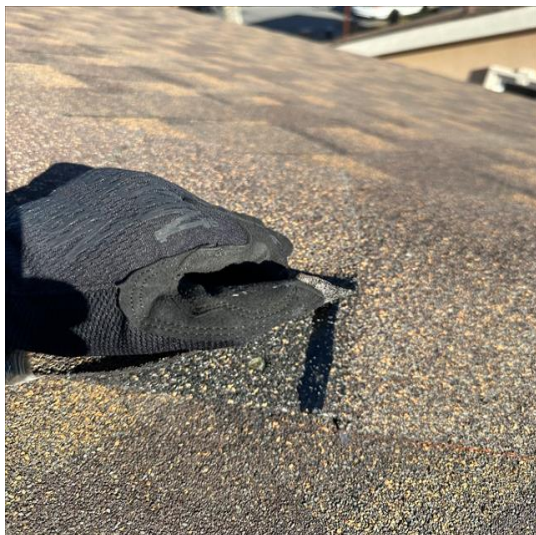
**Image Number:** 50

**Observation:** Inconsistent and/or improper nailing procedure was observed at time of inspection. Page 2 of the manufacturers installation manual indicates that when using 4 nails for installation, nails must be 1/2" from the edge of each shingle. Nails were observed to be missing, over driven and under driven at time of inspection in multiple areas that were readily accessible and possible to inspect without causing damage or invasive testing. It was also observed that nails were installed within the tar strip of some shingles, or multiple nails within a small area which is not within the manufacturers target zone that is indicated in the installation manual. Please note, some photos indicate proper nailing procedure where observed.

**Determination:** Roof Repair required for LeakFREE Roof Certification

**Remedy:** Shingles should be replaced and properly installed with the correct nailing procedure. These shingles have a higher likelihood of leaking or blowing off in high wind events,

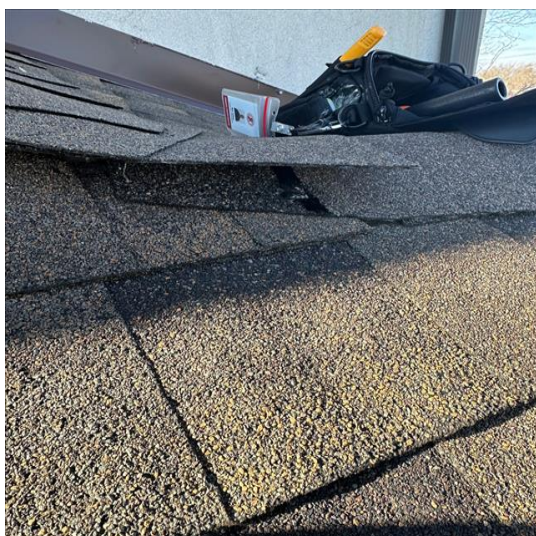
**Image Number:** 51

**Observation:** Inconsistent and/or improper nailing procedure was observed at time of inspection. Page 2 of the manufacturers installation manual indicates that when using 4 nails for installation, nails must be 1/2" from the edge of each shingle. Nails were observed to be missing, over driven and under driven at time of inspection in multiple areas that were readily accessible and possible to inspect without causing damage or invasive testing. It was also observed that nails were installed within the tar strip of some shingles, or multiple nails within a small area which is not within the manufacturers target zone that is indicated in the installation manual. Please note, some photos indicate proper nailing procedure where observed.

**Determination:** Roof Repair required for LeakFREE Roof Certification

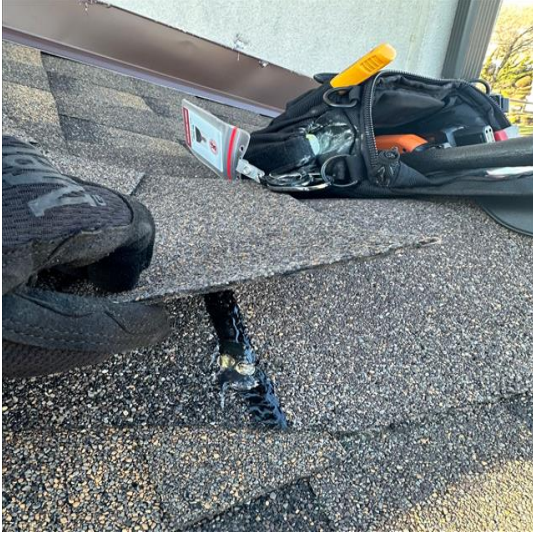
**Image Number: 52**

**Observation:** Inconsistent and/or improper nailing procedure was observed at time of inspection. Page 2 of the manufacturers installation manual indicates that when using 4 nails for installation, nails must be 1/2" from the edge of each shingle. Nails were observed to be missing, over driven and under driven at time of inspection in multiple areas that were readily accessible and possible to inspect without causing damage or invasive testing. It was also observed that nails were installed within the tar strip of some shingles, or multiple nails within a small area which is not within the manufacturers target zone that is indicated in the installation manual. Please note, some photos indicate proper nailing procedure where observed.

**Determination:** Roof Repair required for LeakFREE Roof Certification

**Remedy:** Shingles should be replaced and properly installed with the correct nailing procedure. These shingles have a higher likelihood of leaking or blowing off in high wind events,

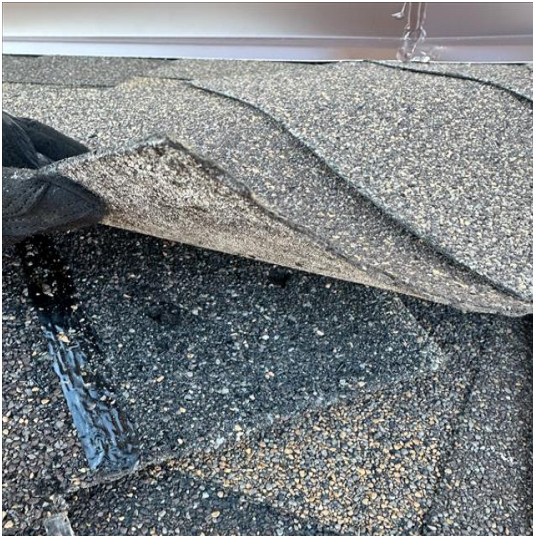
**Image Number: 53**

**Observation:** Inconsistent and/or improper nailing procedure was observed at time of inspection. Page 2 of the manufacturers installation manual indicates that when using 4 nails for installation, nails must be 1/2" from the edge of each shingle. Nails were observed to be missing, over driven and under driven at time of inspection in multiple areas that were readily accessible and possible to inspect without causing damage or invasive testing. It was also observed that nails were installed within the tar strip of some shingles, or multiple nails within a small area which is not within the manufacturers target zone that is indicated in the installation manual. Please note, some photos indicate proper nailing procedure where observed.

**Determination:** Roof Repair required for LeakFREE Roof Certification

**Remedy:** Shingles should be replaced and properly installed with the correct nailing procedure. These shingles have a higher likelihood of leaking or blowing off in high wind events,

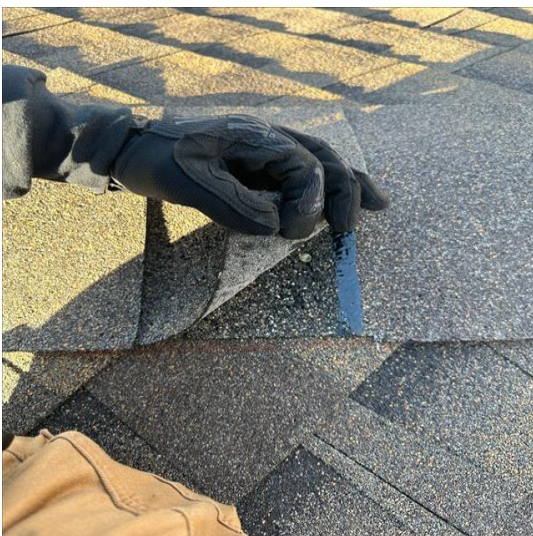
**Image Number: 54**

**Observation:** Inconsistent and/or improper nailing procedure was observed at time of inspection. Page 2 of the manufacturers installation manual indicates that when using 4 nails for installation, nails must be 1/2" from the edge of each shingle. Nails were observed to be missing, over driven and under driven at time of inspection in multiple areas that were readily accessible and possible to inspect without causing damage or invasive testing. It was also observed that nails were installed within the tar strip of some shingles, or multiple nails within a small area which is not within the manufacturers target zone that is indicated in the installation manual. Please note, some photos indicate proper nailing procedure where observed.

**Determination:** Roof Repair required for LeakFREE Roof Certification

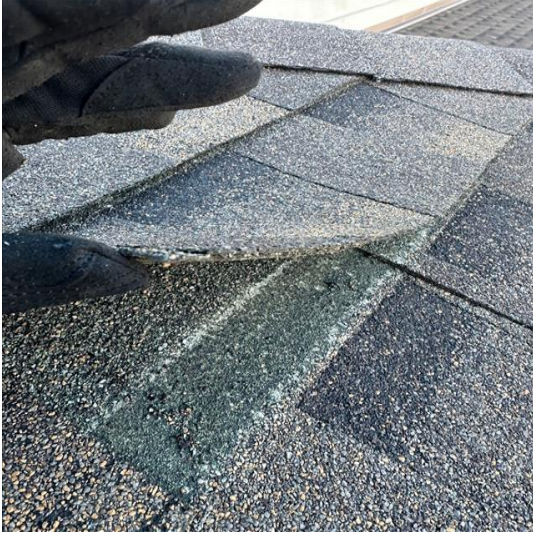
**Image Number:** 55

**Observation:** Inconsistent and/or improper nailing procedure was observed at time of inspection. Page 2 of the manufacturers installation manual indicates that when using 4 nails for installation, nails must be 1/2" from the edge of each shingle. Nails were observed to be missing, over driven and under driven at time of inspection in multiple areas that were readily accessible and possible to inspect without causing damage or invasive testing. It was also observed that nails were installed within the tar strip of some shingles, or multiple nails within a small area which is not within the manufacturers target zone that is indicated in the installation manual. Please note, some photos indicate proper nailing procedure where observed.

**Determination:** Roof Repair required for LeakFREE Roof Certification

**Remedy:** Shingles should be replaced and properly installed with the correct nailing procedure. These shingles have a higher likelihood of leaking or blowing off in high wind events,

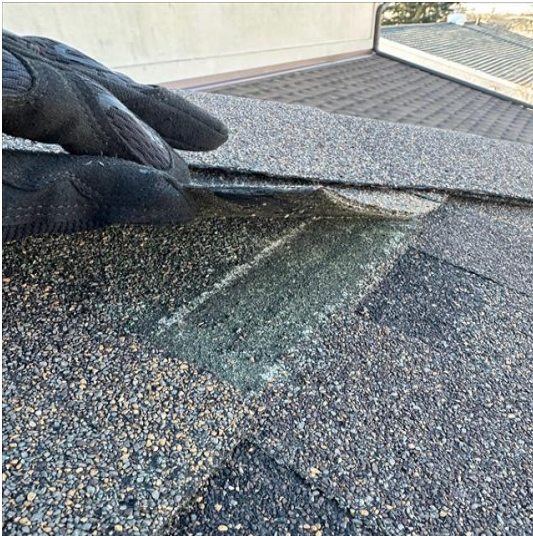
**Image Number:** 56

**Observation:** Inconsistent and/or improper nailing procedure was observed at time of inspection. Page 2 of the manufacturers installation manual indicates that when using 4 nails for installation, nails must be 1/2" from the edge of each shingle. Nails were observed to be missing, over driven and under driven at time of inspection in multiple areas that were readily accessible and possible to inspect without causing damage or invasive testing. It was also observed that nails were installed within the tar strip of some shingles, or multiple nails within a small area which is not within the manufacturers target zone that is indicated in the installation manual. Please note, some photos indicate proper nailing procedure where observed.

**Determination:** Roof Repair required for LeakFREE Roof Certification

**Remedy:** Shingles should be replaced and properly installed with the correct nailing procedure. These shingles have a higher likelihood of leaking or blowing off in high wind events,

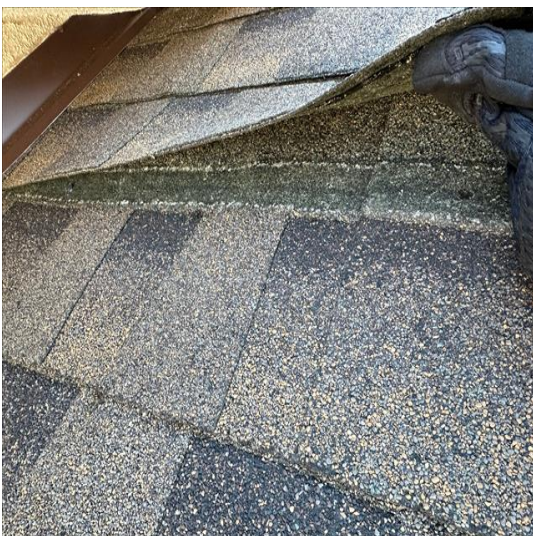
**Image Number:** 57

**Observation:** Inconsistent and/or improper nailing procedure was observed at time of inspection. Page 2 of the manufacturers installation manual indicates that when using 4 nails for installation, nails must be 1/2" from the edge of each shingle. Nails were observed to be missing, over driven and under driven at time of inspection in multiple areas that were readily accessible and possible to inspect without causing damage or invasive testing. It was also observed that nails were installed within the tar strip of some shingles, or multiple nails within a small area which is not within the manufacturers target zone that is indicated in the installation manual. Please note, some photos indicate proper nailing procedure where observed.

**Determination:** Roof Repair required for LeakFREE Roof Certification

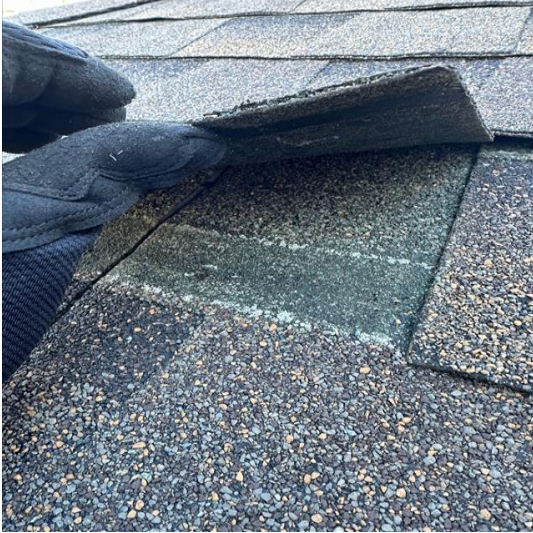
**Image Number: 58**

**Observation:** Inconsistent and/or improper nailing procedure was observed at time of inspection. Page 2 of the manufacturers installation manual indicates that when using 4 nails for installation, nails must be 1/2" from the edge of each shingle. Nails were observed to be missing, over driven and under driven at time of inspection in multiple areas that were readily accessible and possible to inspect without causing damage or invasive testing. It was also observed that nails were installed within the tar strip of some shingles, or multiple nails within a small area which is not within the manufacturers target zone that is indicated in the installation manual. Please note, some photos indicate proper nailing procedure where observed.

**Determination:** Roof Repair required for LeakFREE Roof Certification

**Remedy:** Shingles should be replaced and properly installed with the correct nailing procedure. These shingles have a higher likelihood of leaking or blowing off in high wind events,

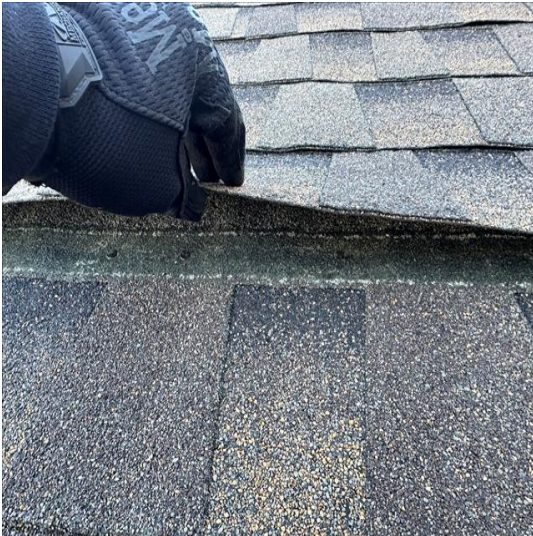
**Image Number: 59**

**Observation:** Inconsistent and/or improper nailing procedure was observed at time of inspection. Page 2 of the manufacturers installation manual indicates that when using 4 nails for installation, nails must be 1/2" from the edge of each shingle. Nails were observed to be missing, over driven and under driven at time of inspection in multiple areas that were readily accessible and possible to inspect without causing damage or invasive testing. It was also observed that nails were installed within the tar strip of some shingles, or multiple nails within a small area which is not within the manufacturers target zone that is indicated in the installation manual. Please note, some photos indicate proper nailing procedure where observed.

**Determination:** Roof Repair required for LeakFREE Roof Certification

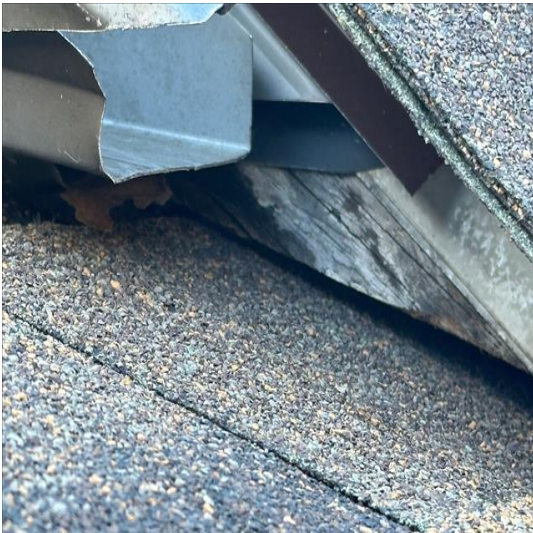
**Image Number: 60**

**Observation:** Missing flashing or fascia board cover was observed at time of inspection. Exposed fascia was noted. The location of this deficiency presents an issue for accelerated moisture intrusion at this is at the area of a gutter missing an end cap, and being at the beginning of a pitch. Moisture has the opportunity to make direct contact with this exposure.

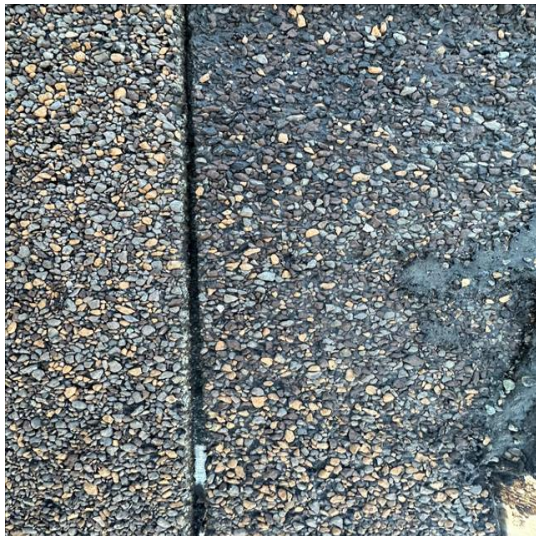
**Image Number:** 61

**Observation:** Small areas of underlayment were exposed at time of inspection. While underlayment could be verified as synthetic, it should not be exposed.

**Determination:** Roof Repair required for LeakFREE Roof Certification

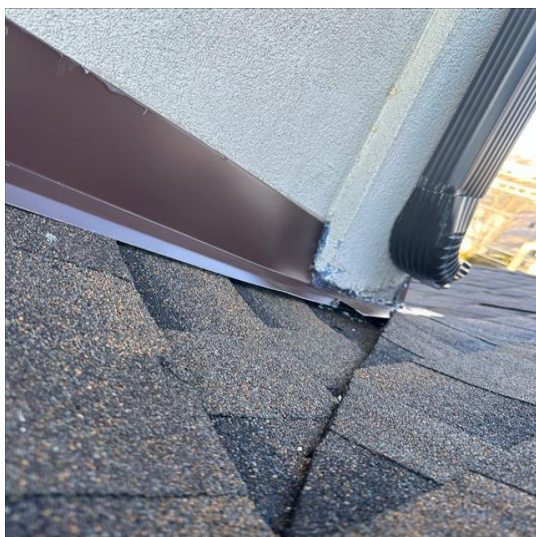
**Image Number:** 62

**Observation:** A valley was observed to be improperly laid out at time of inspection. Moisture can make direct contact with the home during water runoff from rain. There was a gap of about 2 cm that could be seen at the sidewall flashing and termination of the valley. A gutter also directly terminates at this location, which may accelerate moisture intrusion at this wall.

**Determination:** Roof Repair required for LeakFREE Roof Certification

**Remedy:** Install a saddle or cricket flashing to divert moisture from this location.

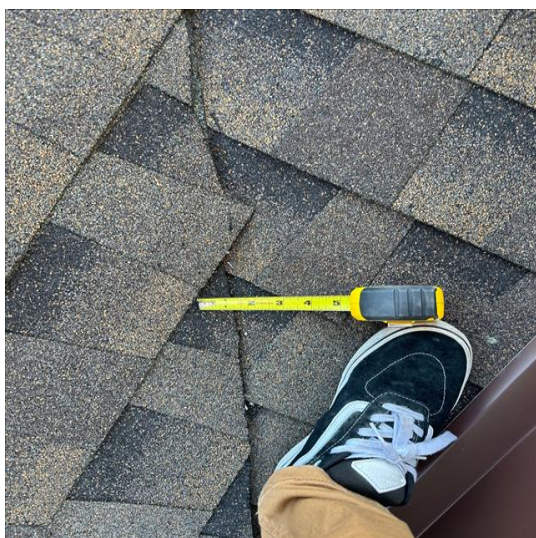
**Image Number:** 63

**Observation:** Valley style was a closed cut style and is acceptable to manufacturer specifications. A) Valley flashing was visibly verified at time of inspection B) Valleys were cut according to manufacturer spec in all but one valley, in which the cut was 1/2" off, at 1 1/2" instead of the recommended 2" which can be found in the manufacturer installation manual on page 10. The purpose of the closed cut valley being cut 2" from the center of the valley is to prevent moisture from running under shingles during water run off from rain.

**Determination:** Roof Repair required for LeakFREE Roof Certification

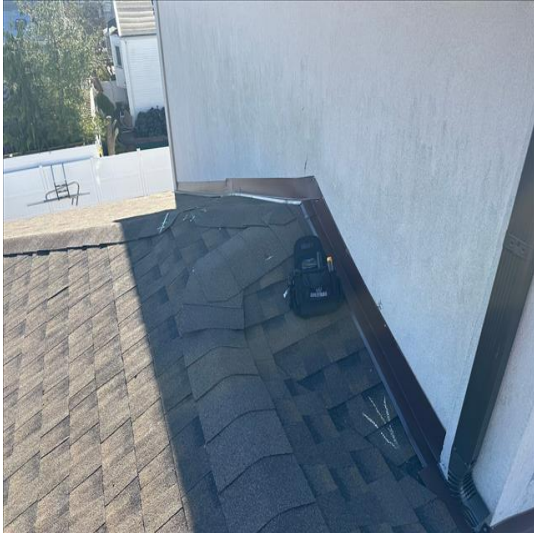
**Image Number:** 64

**Observation:** A valley was observed to be improperly laid out at time of inspection. Moisture can make direct contact with the home during water runoff from rain. There was a gap of about 2 cm that could be seen at the sidewall flashing and termination of the valley. A gutter also directly terminates at this location, which may accelerate moisture intrusion at this wall.

**Determination:** Roof Repair required for LeakFREE Roof Certification

**Remedy:** Install a saddle or cricket flashing to divert moisture from this location.

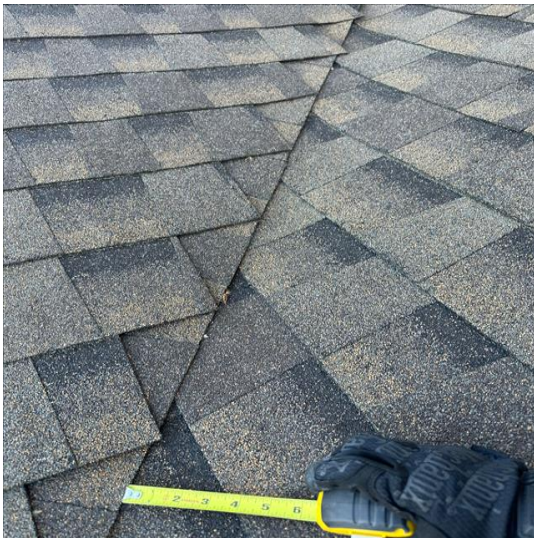
**Image Number:** 65

**Observation:** Valley style was a closed cut style and is acceptable to manufacturer specifications. A) Valley flashing was visibly verified at time of inspection B) Valleys were cut according to manufacturer spec in all but one valley, in which the cut was 1/2" off, at 1 1/2" instead of the recommended 2" which can be found in the manufacturer installation manual on page 10. The purpose of the closed cut valley being cut 2" from the center of the valley is to prevent moisture from running under shingles during water run off from rain.

**Determination:** Roof Repair required for LeakFREE Roof Certification

**Remedy:** Cut back valley 1/2" to recommended 2" measurement.

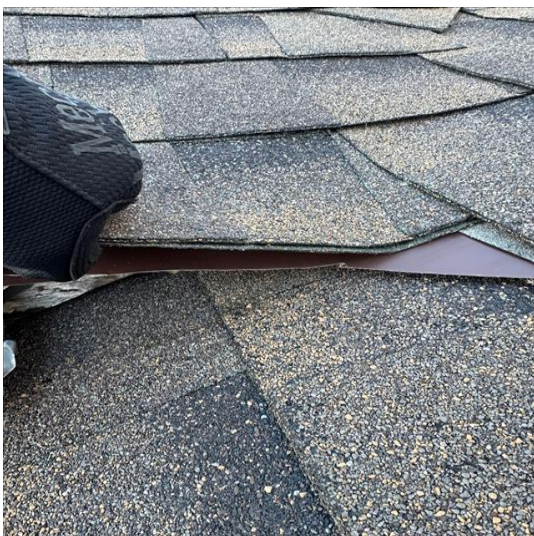
**Image Number:** 66

**Observation:** Valley style was a closed cut style and is acceptable to manufacturer specifications. A) Valley flashing was visibly verified at time of inspection B) Valleys were cut according to manufacturer spec in all but one valley, in which the cut was 1/2" off, at 1 1/2" instead of the recommended 2" which can be found in the manufacturer installation manual on page 10. The purpose of the closed cut valley being cut 2" from the center of the valley is to prevent moisture from running under shingles during water run off from rain.
