# Forensic ROOF® Inspection

**Report No :**  
129959

**Property Inspected :**  
373 Prospect Pl  
Brooklyn, NY, 11238

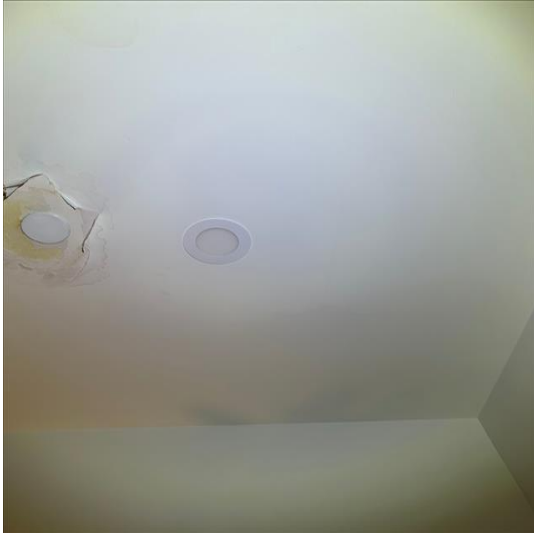
**Image Number: 4**

**Observation:** Multiple moisture stains and damage were observed on the lower floor of the unit at time of inspection. These areas of concern were located near windows and sidewall transitions.

**Cause:** Improper roof installation and maybe improper EIFS installation.

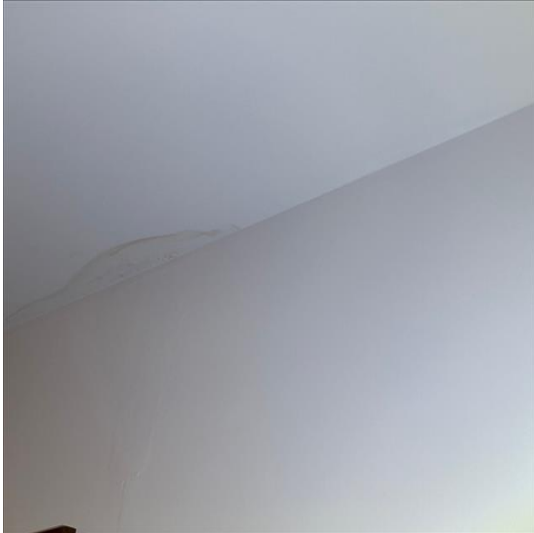
**Image Number: 7**

**Observation:** Multiple moisture stains and damage were observed on the lower floor of the unit at time of inspection. These areas of concern were located near windows and sidewall transitions.

**Cause:** Improper roof installation and maybe improper EIFS installation.

**Remedy:** Contact a qualified EIFS professional to further evaluate the exterior system.

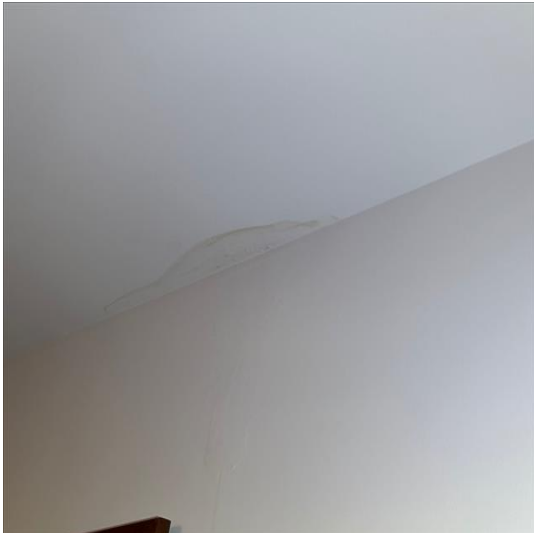
**Image Number: 8**

**Observation:** Multiple moisture stains and damage were observed on the lower floor of the unit at time of inspection. These areas of concern were located near windows and sidewall transitions.

**Cause:** Improper roof installation and maybe improper EIFS installation.

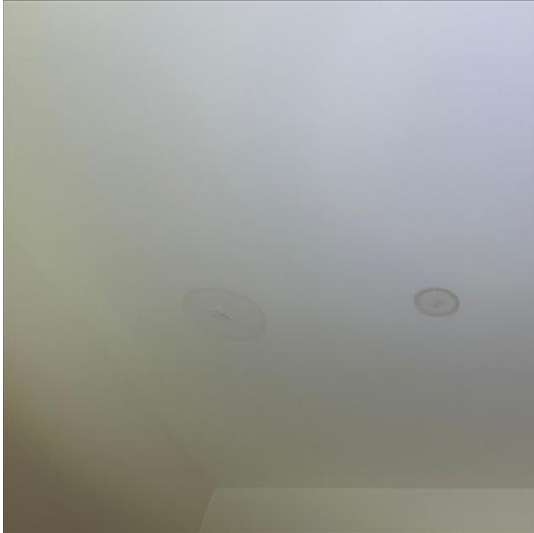
**Image Number:** 10

**Observation:** Multiple moisture stains and damage were observed on the lower floor of the unit at time of inspection. These areas of concern were located near windows and sidewall transitions.

**Cause:** Improper roof installation and maybe improper EIFS installation.

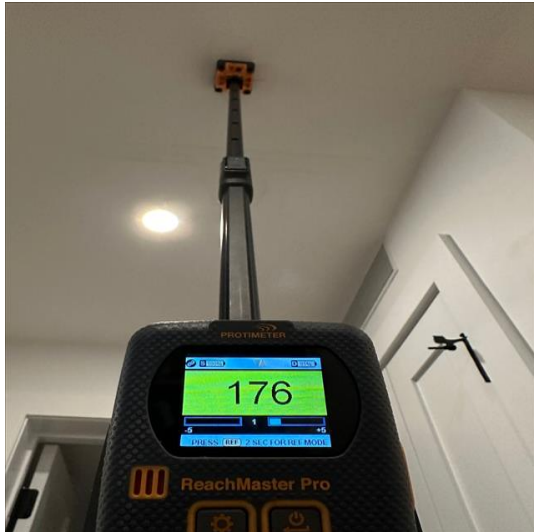
**Image Number: 13**

**Observation:** All areas with moisture staining were gauged with a moisture meter at time of inspection. Readings indicating lower numbers and green or amber colors are areas that are not active leaks or do not possess high moisture content. Readings with red numbers in the 200's indicate areas of concern with active leaking and higher than acceptable moisture readings.

**Cause:** This may be a result of moisture making contact with roof insulation and substrate, causing the moisture to create leaks. The property contained a flat roof with TPO material and soft spots along the roof. These areas are consistent with the soft spots observed above.

**Remedy:** A core sample is required for further analysis to determine extent of damage and level of moisture intrusion.

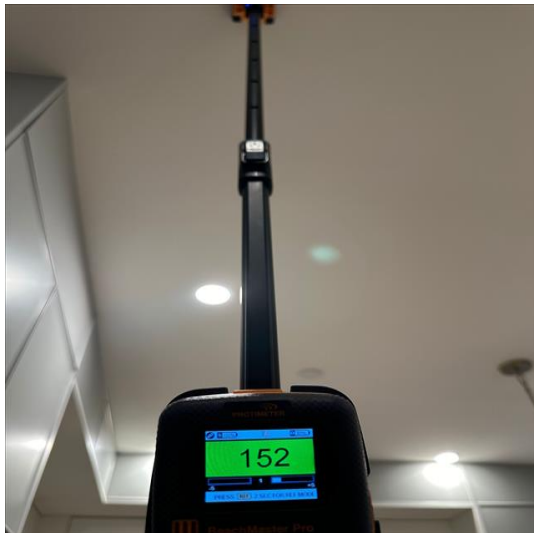
**Image Number: 14**

**Observation:** All areas with moisture staining were gauged with a moisture meter at time of inspection. Readings indicating lower numbers and green or amber colors are areas that are not active leaks or do not possess high moisture content. Readings with red numbers in the 200's indicate areas of concern with active leaking and higher than acceptable moisture readings.

**Cause:** This may be a result of moisture making contact with roof insulation and substrate, causing the moisture to create leaks. The property contained a flat roof with TPO material and soft spots along the roof. These areas are consistent with the soft spots observed above.

**Remedy:** A core sample is required for further analysis to determine extent of damage and level of moisture intrusion.

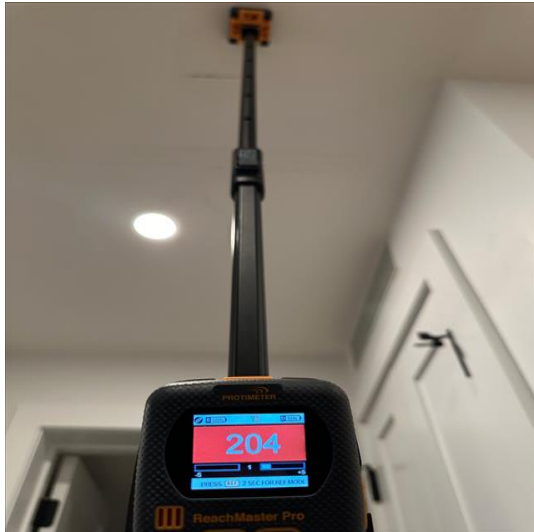
**Image Number: 16**

**Observation:** All areas with moisture staining were gauged with a moisture meter at time of inspection. Readings indicating lower numbers and green or amber colors are areas that are not active leaks or do not possess high moisture content. Readings with red numbers in the 200's indicate areas of concern with active leaking and higher than acceptable moisture readings.

**Cause:** This may be a result of moisture making contact with roof insulation and substrate, causing the moisture to create leaks. The property contained a flat roof with TPO material and soft spots along the roof. These areas are consistent with the soft spots observed above.

**Remedy:** A core sample is required for further analysis to determine extent of damage and level of moisture intrusion.

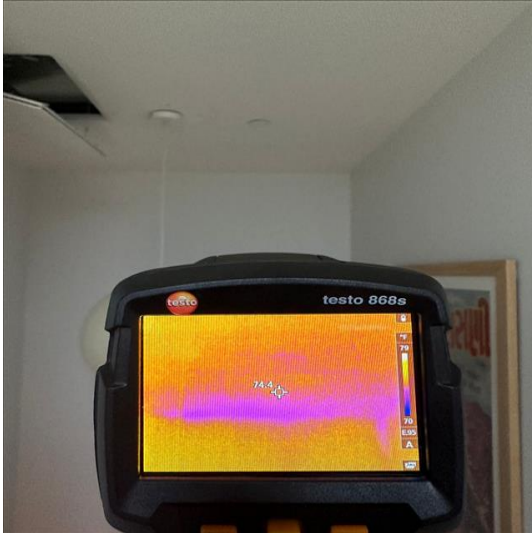
**Image Number: 22**

**Observation:** Thermal imaging was conducted and yielded results within the stairwell that were consistent with moisture damage, which is evident by the puddle like appearance and colder temperature difference at this location.

**Cause:** Area in question does not have exterior access.

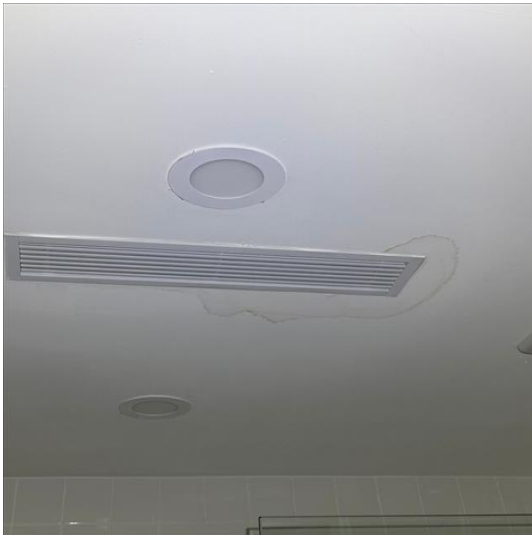
**Image Number: 23**

**Observation:** Moisture staining/damage was observed at 2 different bathrooms at time of inspection. One bathroom contained moisture staining consistent with condensation which was backed by thermal imaging and moisture meter readings. The other bathroom had staining consistent with condensation and the location (vent) further backed this hypothesis.

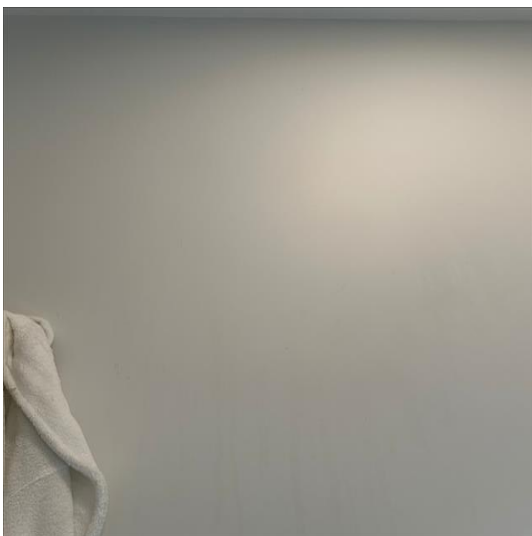
**Image Number: 24**

**Observation:** Moisture staining/damage was observed at 2 different bathrooms at time of inspection. One bathroom contained moisture staining consistent with condensation which was backed by thermal imaging and moisture meter readings. The other bathroom had staining consistent with condensation and the location (vent) further backed this hypothesis.

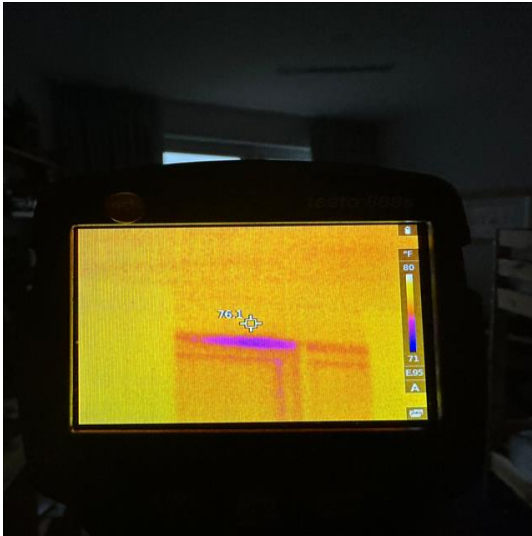
### Image Number: 25

**Observation:** A bedroom window was observed to have high moisture content which was backed by thermal imaging. The 212 reading indicates moisture content. The other readings under this observation were baseline readings to show the difference in the moisture content within the same material.

**Cause:** Improper window flashing and EIFS installation.

**Remedy:** Contact a qualified EIFS professional to further evaluate.

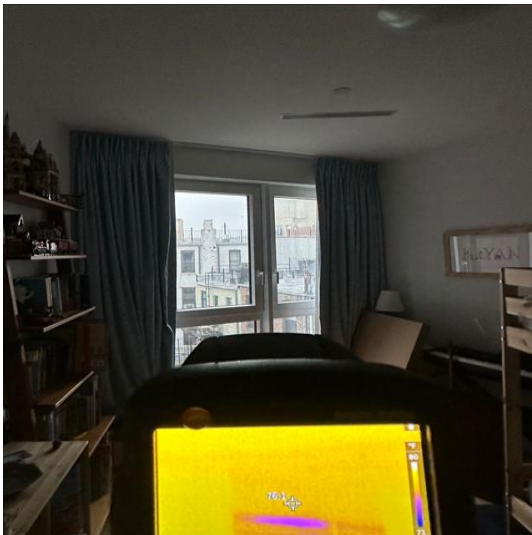
### Image Number: 26

**Observation:** A bedroom window was observed to have high moisture content which was backed by thermal imaging. The 212 reading indicates moisture content. The other readings under this observation were baseline readings to show the difference in the moisture content within the same material.

**Cause:** Improper window flashing and EIFS installation.

**Remedy:** Contact a qualified EIFS professional to further evaluate.

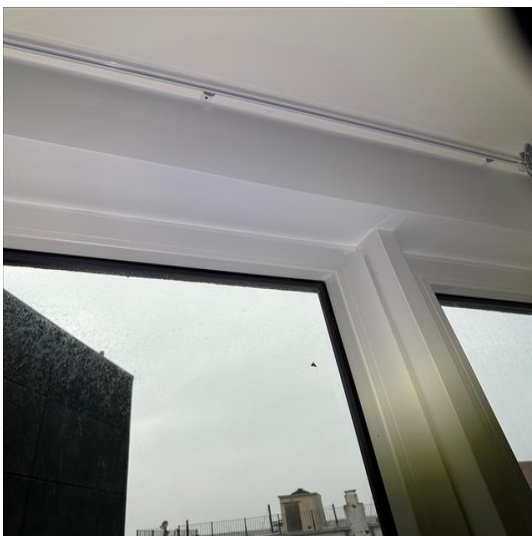
### Image Number: 27

**Observation:** A bedroom window was observed to have high moisture content which was backed by thermal imaging. The 212 reading indicates moisture content. The other readings under this observation were baseline readings to show the difference in the moisture content within the same material.

**Cause:** Improper window flashing and EIFS installation.

**Remedy:** Contact a qualified EIFS professional to further evaluate.

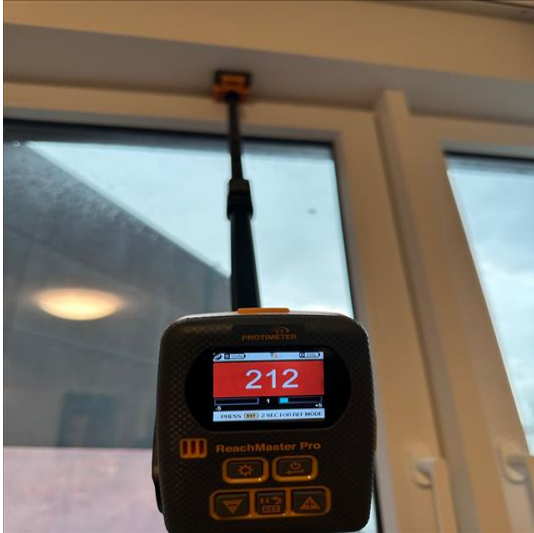
**Image Number: 28**

**Observation:** A bedroom window was observed to have high moisture content which was backed by thermal imaging. The 212 reading indicates moisture content. The other readings under this observation were baseline readings to show the difference in the moisture content within the same material.

**Cause:** Improper window flashing and EIFS installation.

**Remedy:** Contact a qualified EIFS professional to further evaluate.

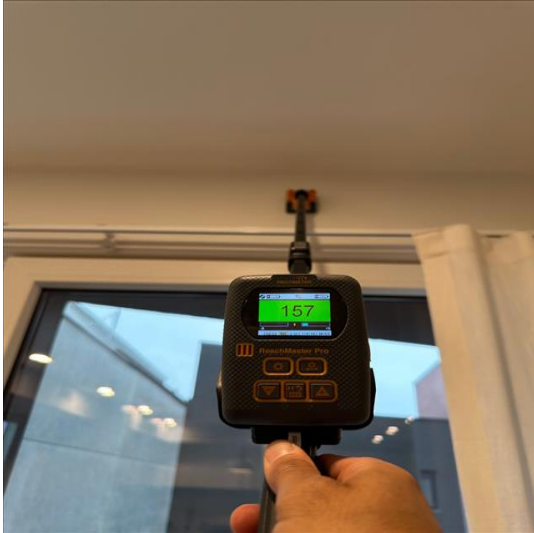
**Image Number: 31**

**Observation:** A bedroom window was observed to have high moisture content which was backed by thermal imaging. The 212 reading indicates moisture content. The other readings under this observation were baseline readings to show the difference in the moisture content within the same material.

**Cause:** Improper window flashing and EIFS installation.

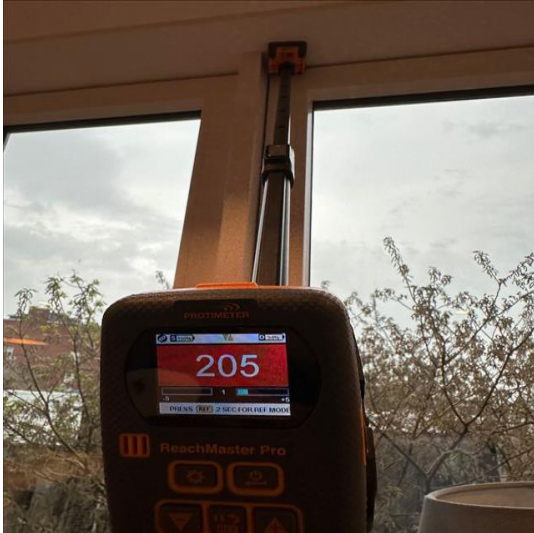
**Image Number: 34**

**Observation:** High moisture content levels were observed at time of inspection at the window near the living room. 205 represents the high moisture content reading and the other 2 moisture content readings under this observation represent the general moisture content in this area.

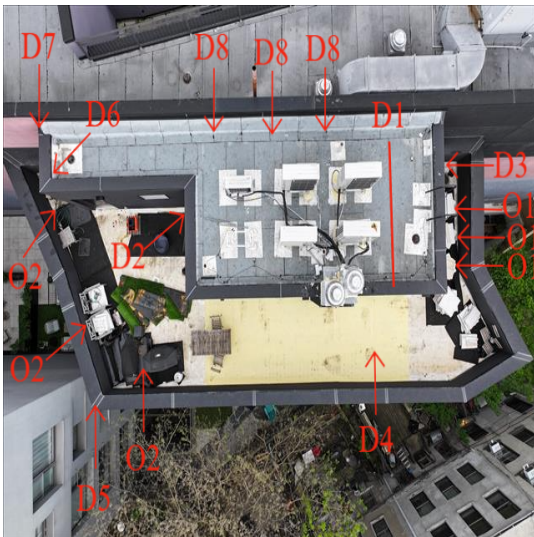
**Image Number: 38**

**Observation:** General overview of the roof. The roof observed on the lower portion of the building was a TPO roof and the upper portion was a modified bitumen roll out roof system. Items beginning with a "D" are deficiencies and items beginning with "O" are observations that require attention. Be advised, D1 or Deficiency 1, is a lap seam that is overlapped against the pitch that directs water to the drain on that side of the roof. This is a concern because this may deteriorate this lap seam at an accelerated rate, and is also incorrect general procedure when installing this roof system.

**Determination:** Roof Repair required for LeakFREE Roof Certification

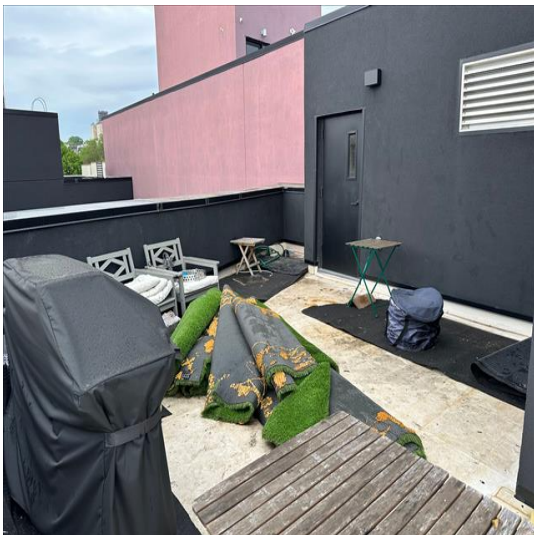
**Image Number: 39**

**Observation:** Debris and other roof material were observed on the lower roof and obstructed parts of the visual inspection.

**Determination:** Roof Repair required for LeakFREE Roof Certification

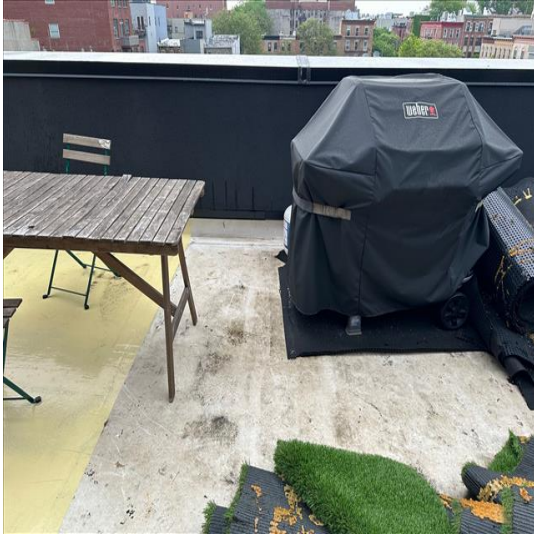
**Image Number:** 40

**Observation:** Debris and other roof material were observed on the lower roof and obstructed parts of the visual inspection.

**Determination:** Roof Repair required for LeakFREE Roof Certification

**Remedy:** Material for the roof and furniture should not be stored for long periods of time making direct contact with the roof covering as they can damage and puncture the covering.

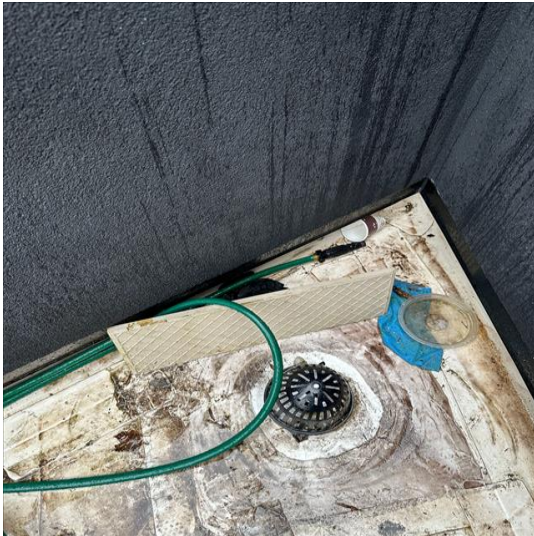
**Image Number:** 41

**Observation:** Debris and other roof material were observed on the lower roof and obstructed parts of the visual inspection.

**Determination:** Roof Repair required for LeakFREE Roof Certification

**Remedy:** Material for the roof and furniture should not be stored for long periods of time making direct contact with the roof covering as they can damage and puncture the covering.

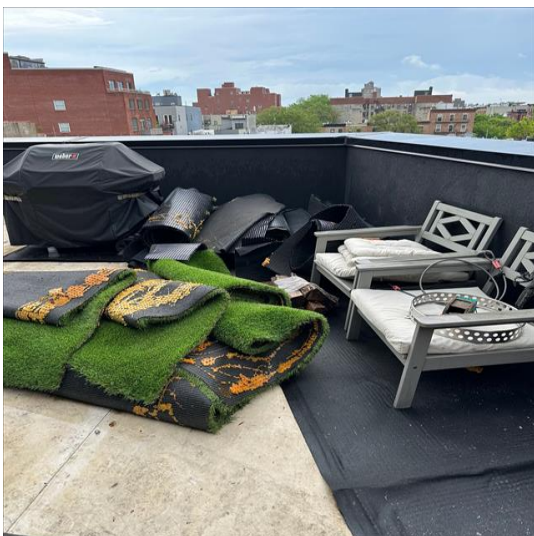
**Image Number:** 42

**Observation:** Debris and other roof material were observed on the lower roof and obstructed parts of the visual inspection.

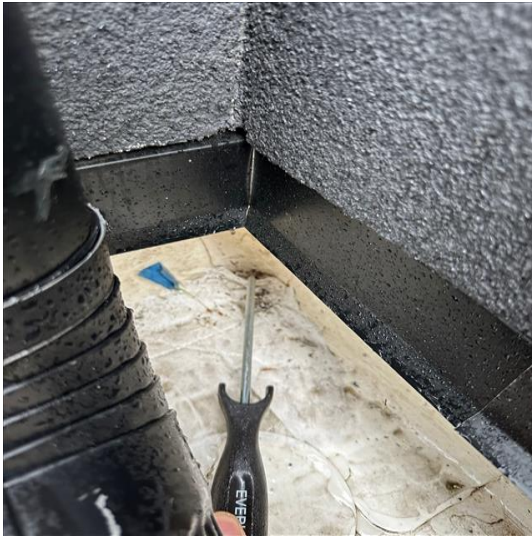
**Image Number:** 43

**Observation:** D3 (Deficiency 3) - Curbs were observed to be improperly installed or damaged at time of inspection. Improper curb flashing exposure and unadhered curb flashing were observed.

**Determination:** Roof Repair required for LeakFREE Roof Certification

**Remedy:** Re-adhere these areas and correct flashing exposures to prevent moisture intrusion within the roof system.

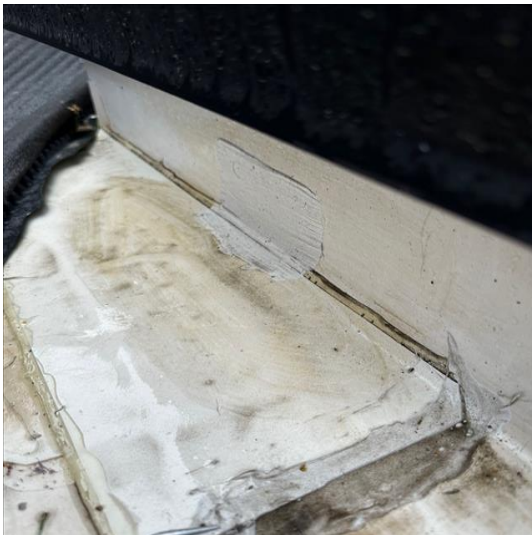
**Image Number:** 44

**Observation:** D3 (Deficiency 3) - Curbs were observed to be improperly installed or damaged at time of inspection. Improper curb flashing exposure and unadhered curb flashing were observed.

**Determination:** Roof Repair required for LeakFREE Roof Certification

**Remedy:** Re-adhere these areas and correct flashing exposures to prevent moisture intrusion within the roof system.

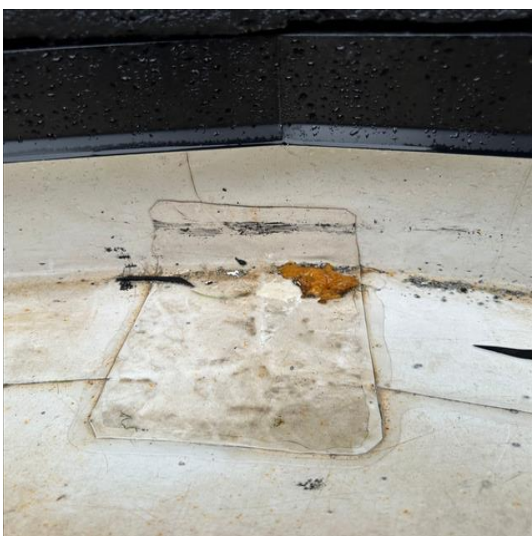
**Image Number:** 45

**Observation:** D3 (Deficiency 3) - Curbs were observed to be improperly installed or damaged at time of inspection. Improper curb flashing exposure and unadhered curb flashing were observed.

**Determination:** Roof Repair required for LeakFREE Roof Certification

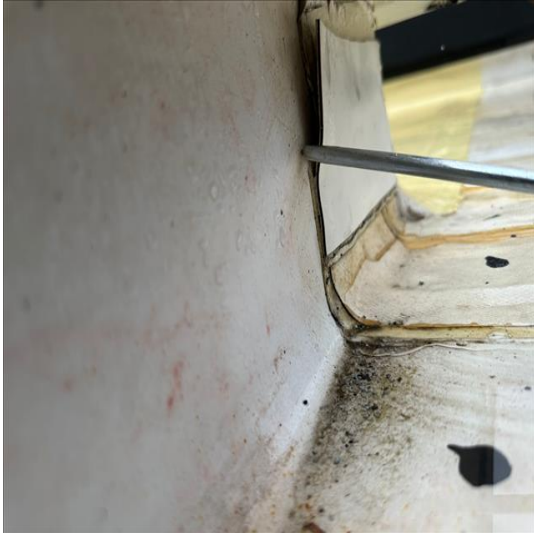
**Image Number:** 46

**Observation:** D3 (Deficiency 3) - Curbs were observed to be improperly installed or damaged at time of inspection. Improper curb flashing exposure and unadhered curb flashing were observed.

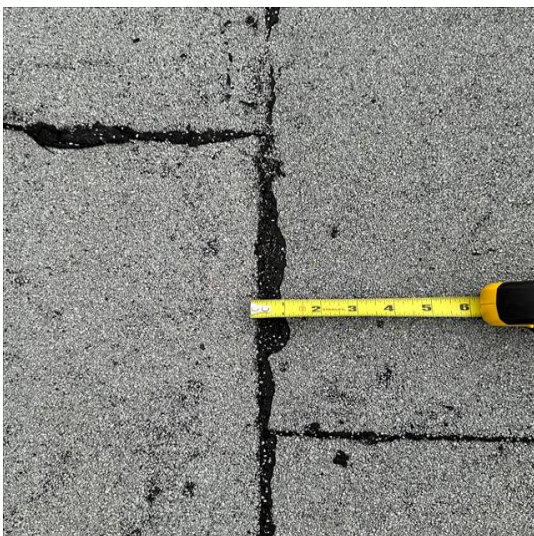
**Image Number: 51**

**Observation:** The lap seams in almost all areas of the top roof, consisting of modified bitumen appeared to have inconsistent or improper "bleed out" or tar exposure. The universal exposure for this material is typically 1/4" minimum and 1/2" maximum. This ensures that the lap seams will be weather tight.

**Cause:** Improper installation.

**Determination:** Roof Repair required for LeakFREE Roof Certification

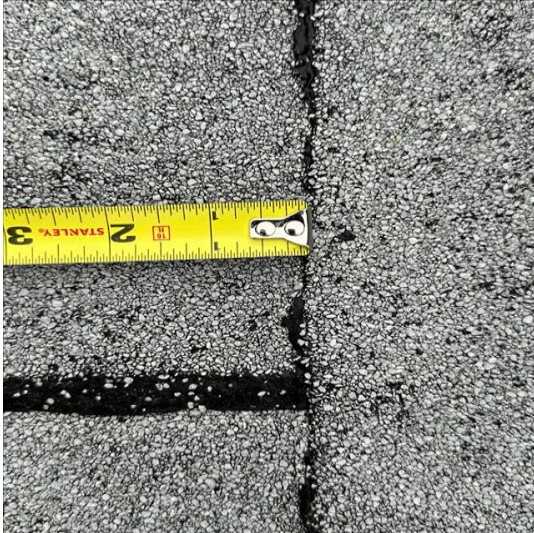
**Image Number: 52**

**Observation:** The lap seams in almost all areas of the top roof, consisting of modified bitumen appeared to have inconsistent or improper "bleed out" or tar exposure. The universal exposure for this material is typically 1/4" minimum and 1/2" maximum. This ensures that the lap seams will be weather tight.

**Cause:** Improper installation.

**Determination:** Roof Repair required for LeakFREE Roof Certification

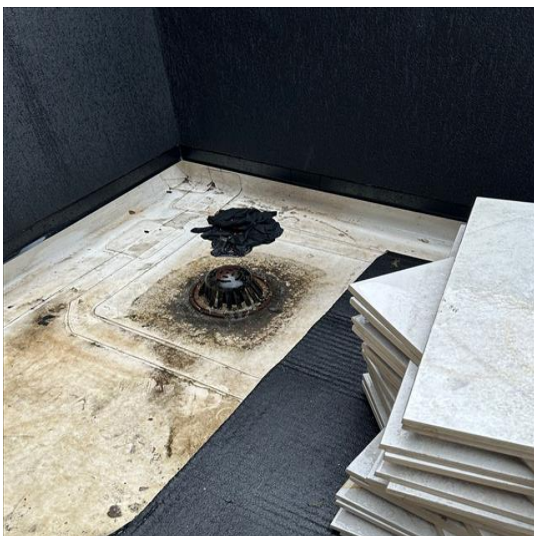
**Image Number: 54**

**Observation:** The drains for the roof at 373 Prospect PI were observed to be functional and properly installed at time of inspection. A scupper system was observed as the secondary drainage system for the top modified bitumen roof. All but (2) drain screens were free of debris. Drainage systems appeared to divert water away from walls towards the drains that were present, with the roof tapered to accommodate proper drainage.

**Determination:** Roof Replacement required for LeakFREE Roof Certification

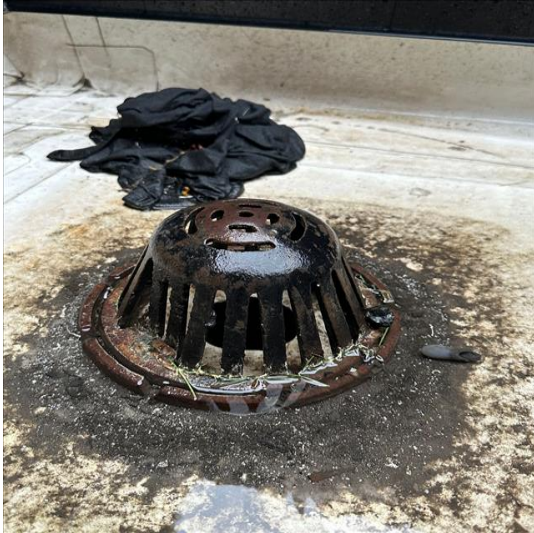
**Image Number: 55**

**Observation:** The drains for the roof at 373 Prospect PI were observed to be functional and properly installed at time of inspection. A scupper system was observed as the secondary drainage system for the top modified bitumen roof. All but (2) drain screens were free of debris. Drainage systems appeared to divert water away from walls towards the drains that were present, with the roof tapered to accommodate proper drainage.

**Determination:** Roof Replacement required for LeakFREE Roof Certification

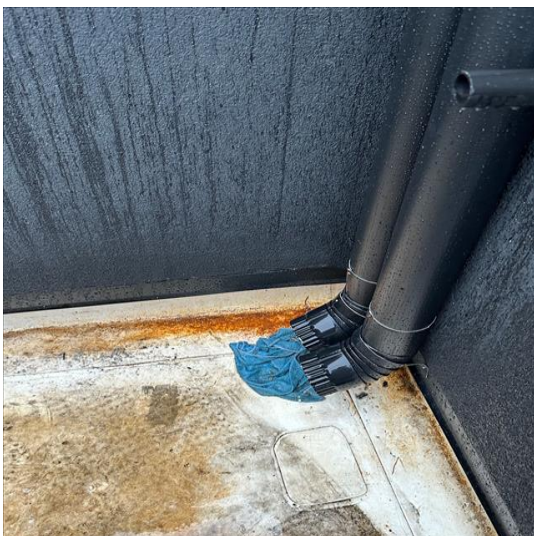
**Image Number: 57**

**Observation:** The drains for the roof at 373 Prospect PI were observed to be functional and properly installed at time of inspection. A scupper system was observed as the secondary drainage system for the top modified bitumen roof. All but (2) drain screens were free of debris. Drainage systems appeared to divert water away from walls towards the drains that were present, with the roof tapered to accommodate proper drainage.

**Determination:** Roof Replacement required for LeakFREE Roof Certification

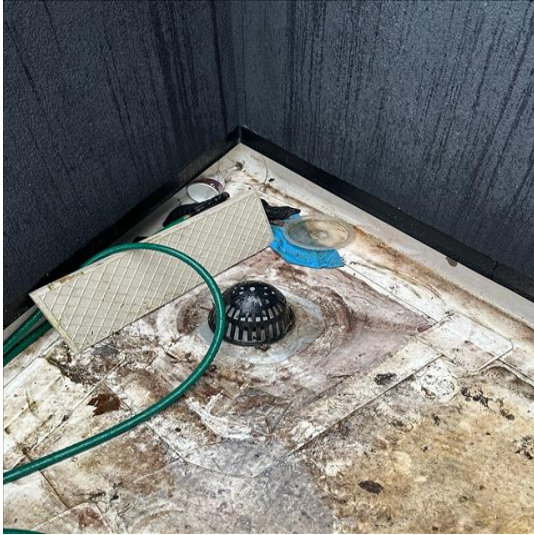
**Image Number: 58**

**Observation:** The drains for the roof at 373 Prospect Pl were observed to be functional and properly installed at time of inspection. A scupper system was observed as the secondary drainage system for the top modified bitumen roof. All but (2) drain screens were free of debris. Drainage systems appeared to divert water away from walls towards the drains that were present, with the roof tapered to accommodate proper drainage.

**Determination:** Roof Replacement required for LeakFREE Roof Certification

**Remedy:** Clear debris around the (2) drain screens to prevent any ponding.

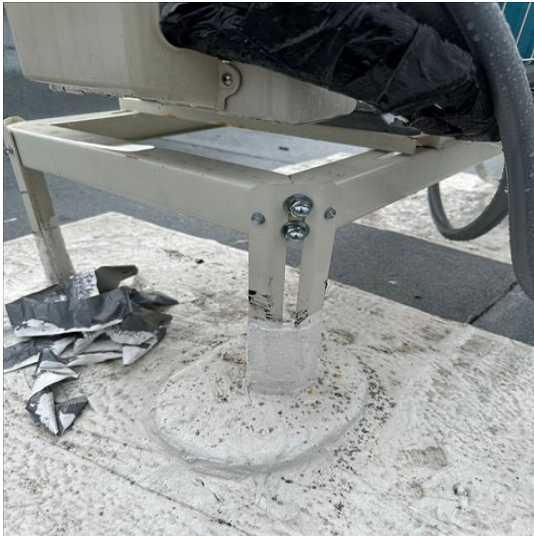
**Image Number: 59**

**Observation:** Roof top units were observed to be properly installed at time of inspection. The flashings, curbs and mounts appeared to be adequate and properly installed. It should be noted that two different types of liquid flashing were used, which is evident by the differing colors of the material (one being yellow the other being white).

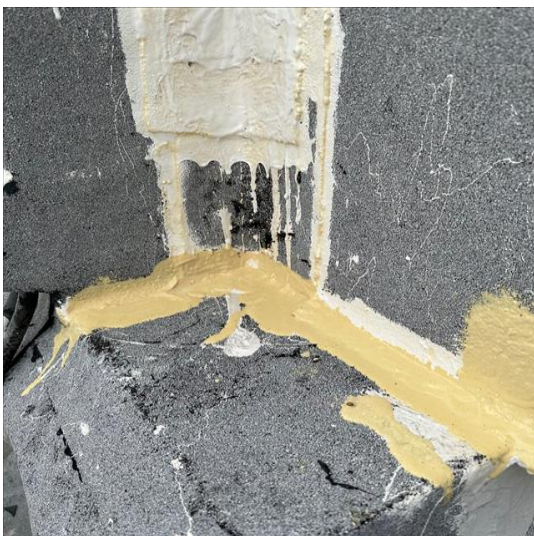
**Image Number: 60**

**Observation:** Roof top units were observed to be properly installed at time of inspection. The flashings, curbs and mounts appeared to be adequate and properly installed. It should be noted that two different types of liquid flashing were used, which is evident by the differing colors of the material (one being yellow the other being white).

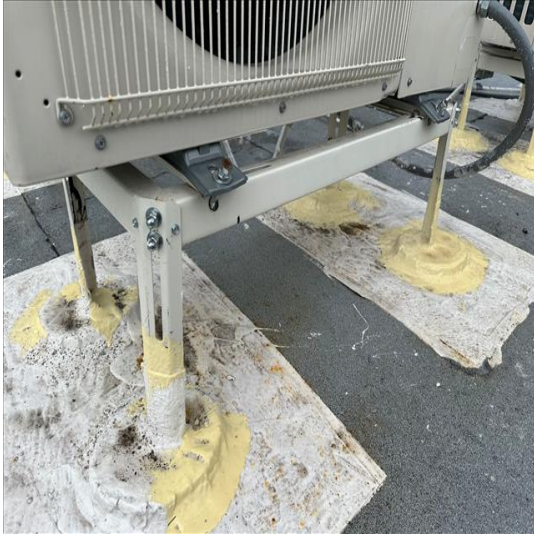
**Image Number: 61**

**Observation:** Roof top units were observed to be properly installed at time of inspection. The flashings, curbs and mounts appeared to be adequate and properly installed. It should be noted that two different types of liquid flashing were used, which is evident by the differing colors of the material (one being yellow the other being white).

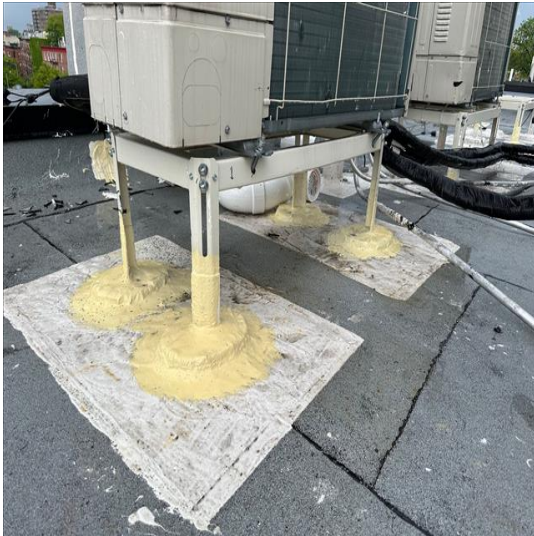
**Image Number: 62**

**Observation:** Roof top units were observed to be properly installed at time of inspection. The flashings, curbs and mounts appeared to be adequate and properly installed. It should be noted that two different types of liquid flashing were used, which is evident by the differing colors of the material (one being yellow the other being white).

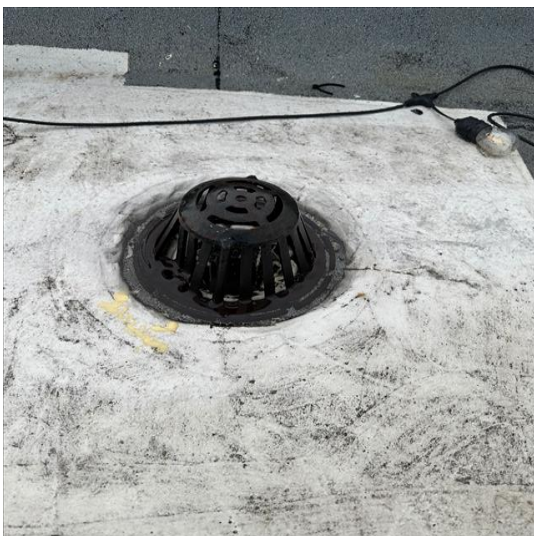
**Image Number: 63**

**Observation:** The drains for the roof at 373 Prospect PI were observed to be functional and properly installed at time of inspection. A scupper system was observed as the secondary drainage system for the top modified bitumen roof. All but (2) drain screens were free of debris. Drainage systems appeared to divert water away from walls towards the drains that were present, with the roof tapered to accommodate proper drainage.

**Determination:** Roof Replacement required for LeakFREE Roof Certification

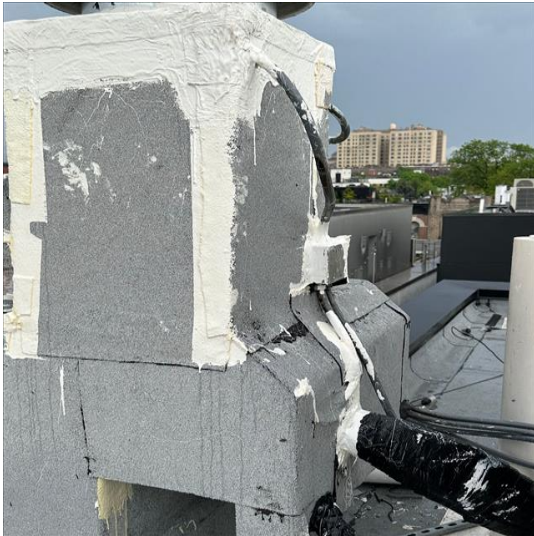
**Image Number: 65**

**Observation:** Roof top units were observed to be properly installed at time of inspection. The flashings, curbs and mounts appeared to be adequate and properly installed. It should be noted that two different types of liquid flashing were used, which is evident by the differing colors of the material (one being yellow the other being white).

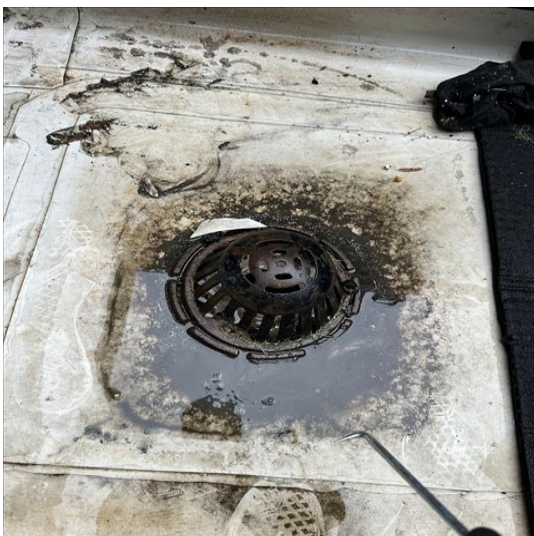
**Image Number: 66**

**Observation:** The drains for the roof at 373 Prospect PI were observed to be functional and properly installed at time of inspection. A scupper system was observed as the secondary drainage system for the top modified bitumen roof. All but (2) drain screens were free of debris. Drainage systems appeared to divert water away from walls towards the drains that were present, with the roof tapered to accommodate proper drainage.

**Determination:** Roof Replacement required for LeakFREE Roof Certification

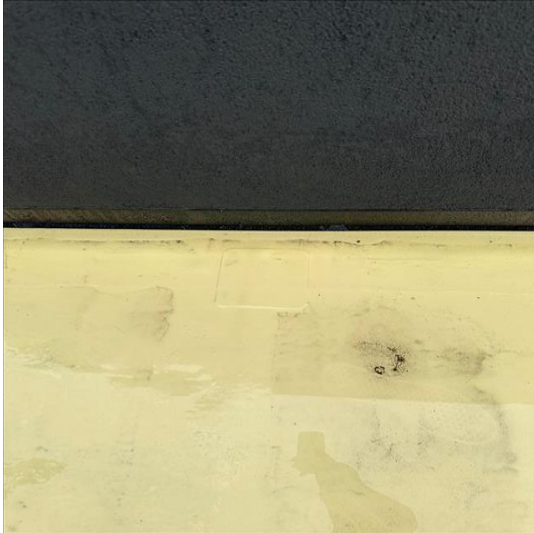
**Image Number: 67**

**Observation:** Blistering was observed on a part of the lower roof consisting of TPO 60 Mil material. The area in question was soft when walked on and appeared to have areas blistering. This is an indication that the roof was not correctly installed and moisture is making direct contact with the roof substrate and insulation.

**Cause:** Improper installation. Water has most likely made contact with the insulation under the roof covering material, resulting in damage, which would explain the soft spots in the roof.

**Determination:** Roof Repair required for LeakFREE Roof Certification

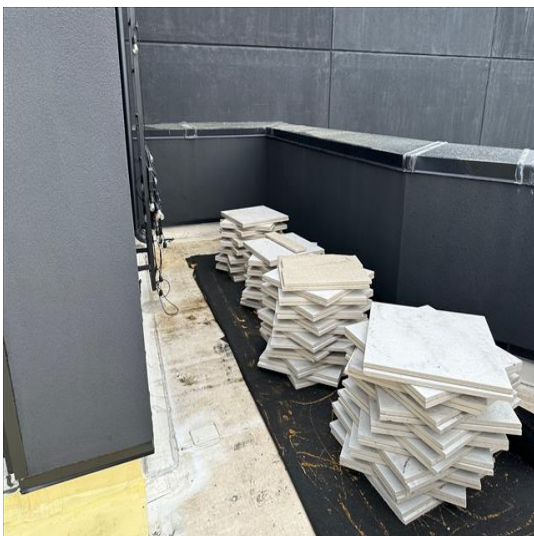
**Image Number: 69**

**Observation:** O1 (Observation 1) : Roof pavers were observed to be stored on a drain mat located on the lower TPO roof. The weight is concentrated in this particular area and may be an area of concern due to weight distribution and the potential to damage the roof covering material.

**Cause:** Poor workmanship.

**Determination:** Roof Repair required for LeakFREE Roof Certification

**Remedy:** Materials should be stored correctly, evenly dispersed and stored either on a pallet or foam board to prevent damage to the roof covering.

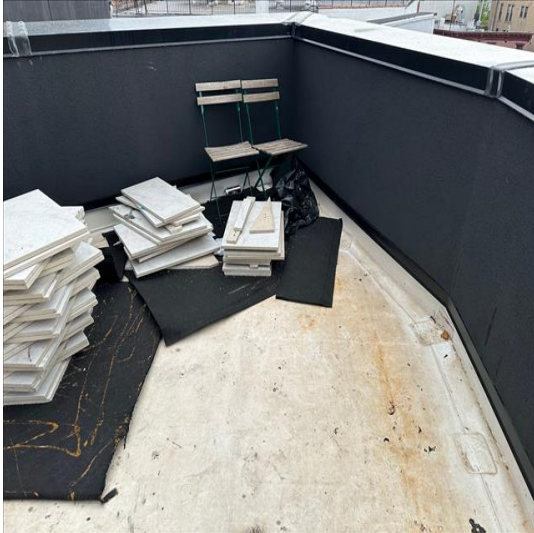
**Image Number:** 70

**Observation:** O1 (Observation 1) : Roof pavers were observed to be stored on a drain mat located on the lower TPO roof. The weight is concentrated in this particular area and may be an area of concern due to weight distribution and the potential to damage the roof covering material.

**Cause:** Poor workmanship.

**Determination:** Roof Repair required for LeakFREE Roof Certification

**Remedy:** Materials should be stored correctly, evenly dispersed and stored either on a pallet or foam board to prevent damage to the roof covering.

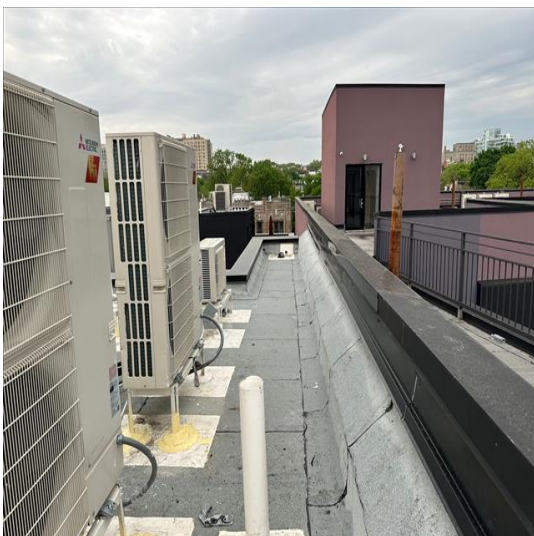
**Image Number:** 72

**Observation:** Overview photos of the roof at 373 Prospect Pl. The roof covering was observed to be TPO.

**Determination:** Roof Repair required for LeakFREE Roof Certification

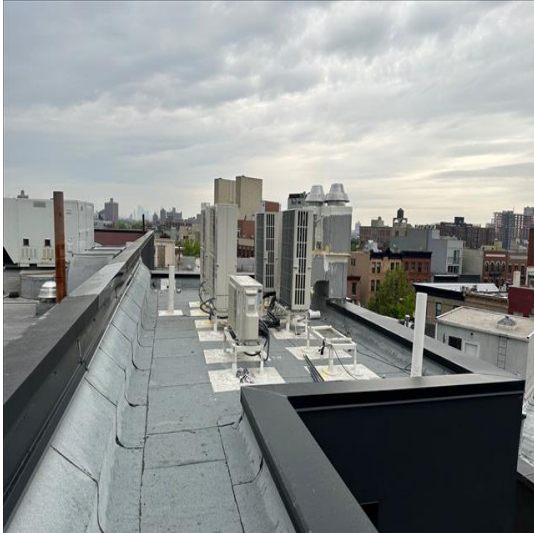
**Image Number:** 73

**Observation:** Overview photos of the roof at 373 Prospect Pl. The roof covering was observed to be TPO.

**Determination:** Roof Repair required for LeakFREE Roof Certification

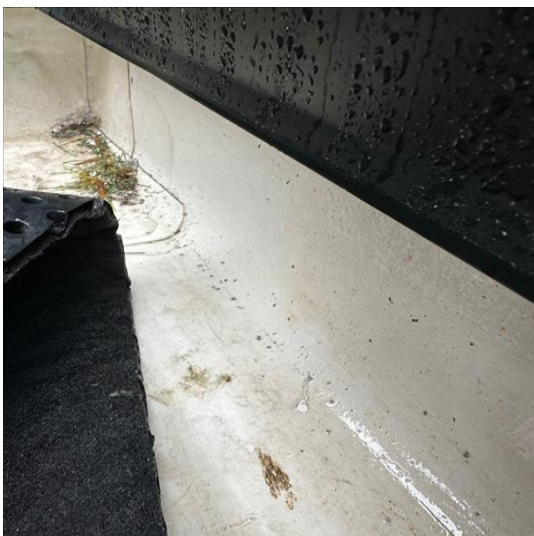
**Image Number:** 75

**Observation:** General overview of curb and wall flashings/terminations. It should be noted that the exposure of the TPO wall flashing was observed to have a 5" exposure from the wall to the seam. It should also be noted that (2) different TPO membranes were used, as is evident by the color difference.

**Determination:** Roof Repair required for LeakFREE Roof Certification

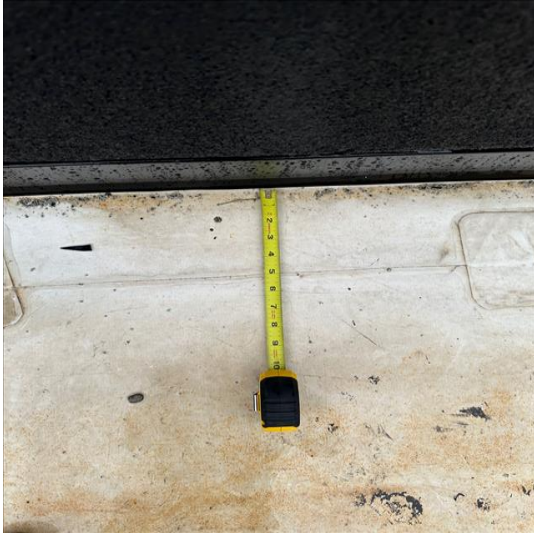
**Image Number: 76**

**Observation:** General overview of curb and wall flashings/terminations. It should be noted that the exposure of the TPO wall flashing was observed to have a 5" exposure from the wall to the seam. It should also be noted that (2) different TPO membranes were used, as is evident by the color difference.

**Determination:** Roof Repair required for LeakFREE Roof Certification

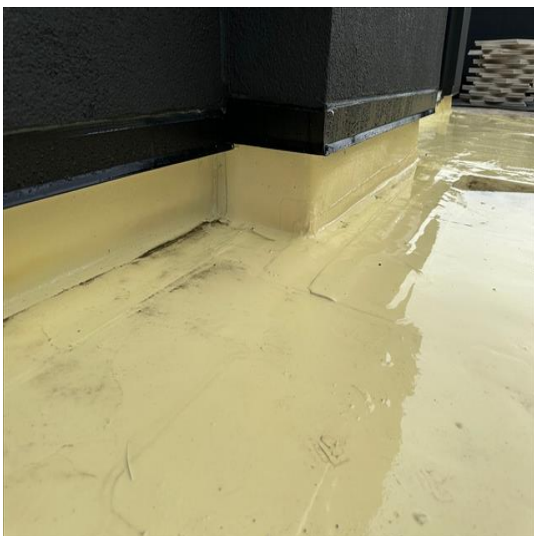
**Image Number: 78**

**Observation:** General overview of curb and wall flashings/terminations. It should be noted that the exposure of the TPO wall flashing was observed to have a 5" exposure from the wall to the seam. It should also be noted that (2) different TPO membranes were used, as is evident by the color difference.

**Determination:** Roof Repair required for LeakFREE Roof Certification

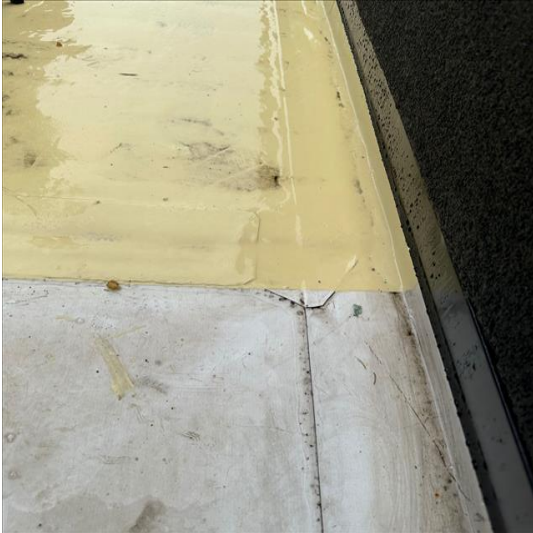
**Image Number:** 79

**Observation:** General overview of curb and wall flashings/terminations. It should be noted that the exposure of the TPO wall flashing was observed to have a 5" exposure from the wall to the seam. It should also be noted that (2) different TPO membranes were used, as is evident by the color difference.

**Determination:** Roof Repair required for LeakFREE Roof Certification

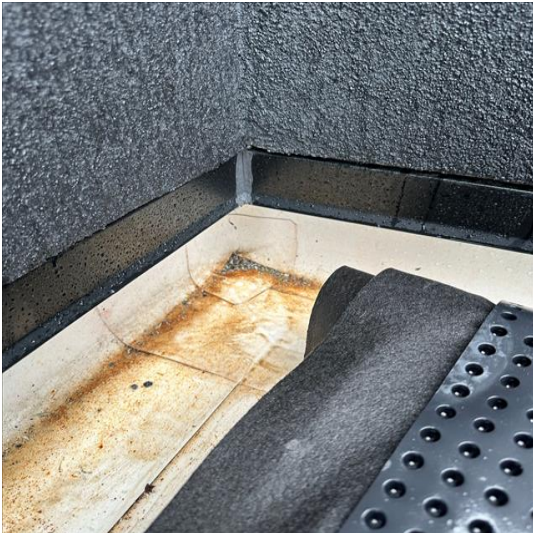
**Image Number:** 80

**Observation:** General overview of curb and wall flashings/terminations. It should be noted that the exposure of the TPO wall flashing was observed to have a 5" exposure from the wall to the seam. It should also be noted that (2) different TPO membranes were used, as is evident by the color difference.

**Determination:** Roof Repair required for LeakFREE Roof Certification

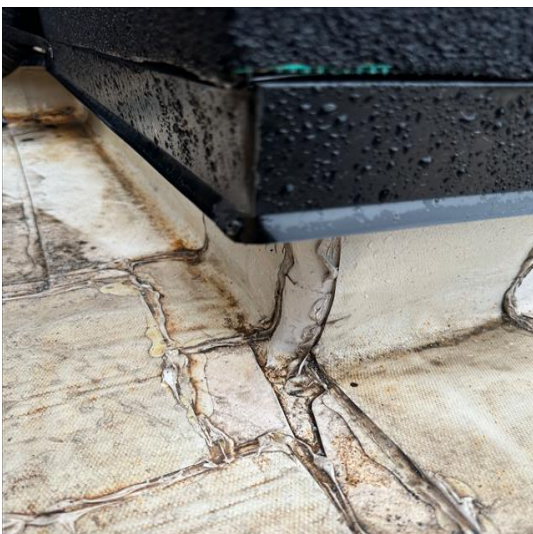
**Image Number:** 81

**Observation:** General overview of curb and wall flashings/terminations. It should be noted that the exposure of the TPO wall flashing was observed to have a 5" exposure from the wall to the seam. It should also be noted that (2) different TPO membranes were used, as is evident by the color difference.

**Determination:** Roof Repair required for LeakFREE Roof Certification

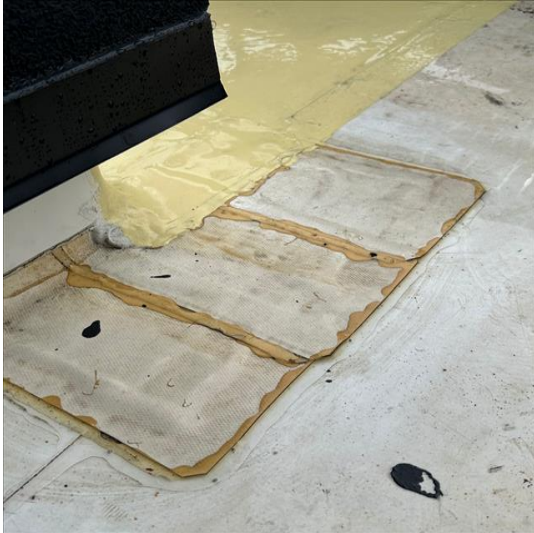
**Image Number:** 82

**Observation:** General overview of curb and wall flashings/terminations. It should be noted that the exposure of the TPO wall flashing was observed to have a 5" exposure from the wall to the seam. It should also be noted that (2) different TPO membranes were used, as is evident by the color difference.

**Determination:** Roof Repair required for LeakFREE Roof Certification

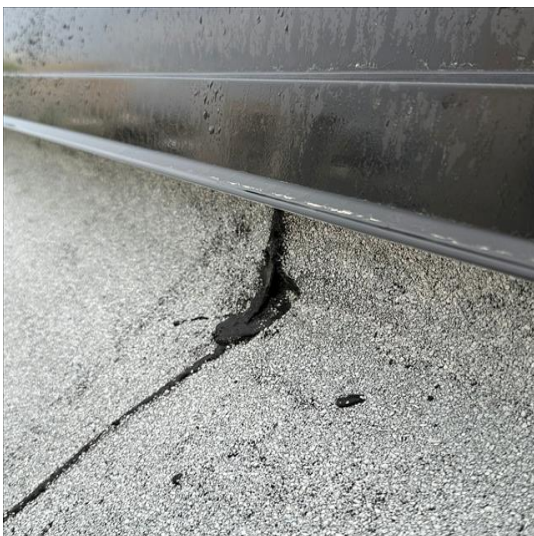
**Image Number:** 84

**Observation:** D8 (Deficiency 8) - (3) Lap seams at the wall and 1 corner patch were observed to not be sealed properly creating an exposure which may introduce moisture intrusion due to the lap seams creating an open space in these areas.

**Cause:** Improper installation.

**Determination:** Roof Repair required for LeakFREE Roof Certification

**Remedy:** Repair lap seams at forementioned areas.

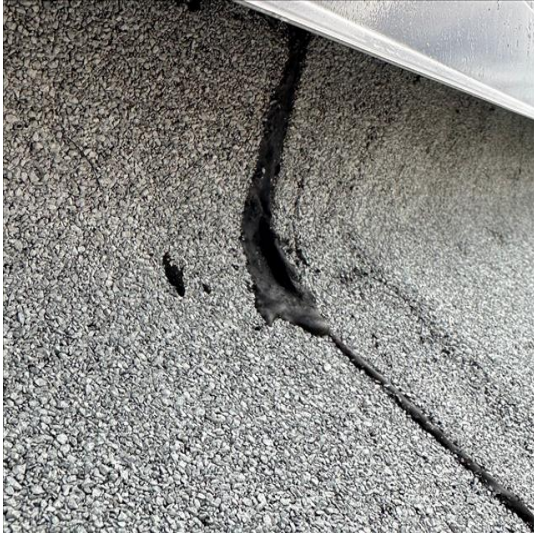
**Image Number:** 85

**Observation:** D8 (Deficiency 8) - (3) Lap seams at the wall and 1 corner patch were observed to not be sealed properly creating an exposure which may introduce moisture intrusion due to the lap seams creating an open space in these areas.

**Cause:** Improper installation.

**Determination:** Roof Repair required for LeakFREE Roof Certification

**Remedy:** Repair lap seams at forementioned areas.

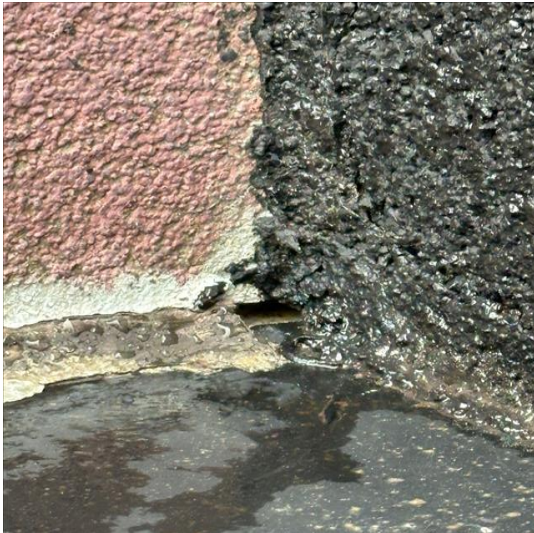
**Image Number:** 86

**Observation:** D2 (Deficiency 2) - A hole was observed at the corner of a parapet wall coping cap and wall. This is most definitely a source of moisture intrusion, as it gives water a direct avenue of access behind the EIFS system.

**Cause:** Improper installation.

**Determination:** Roof Repair required for LeakFREE Roof Certification

**Remedy:** Contact a EIFS specialist to determine extent of damage and exposure and to test if water is in the system. Properly seal this location.

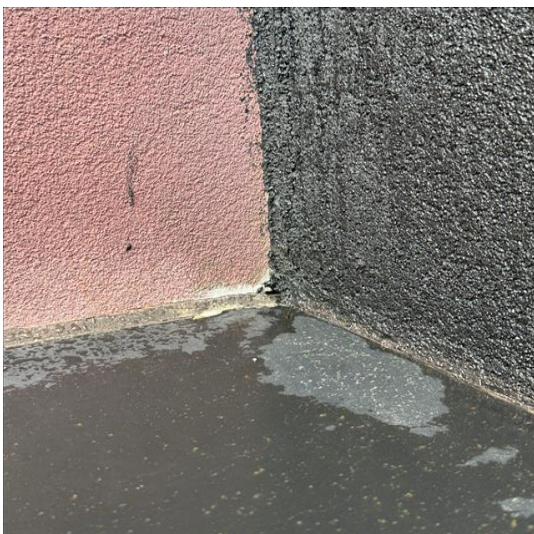
**Image Number:** 87

**Observation:** D2 (Deficiency 2) - A hole was observed at the corner of a parapet wall coping cap and wall. This is most definitely a source of moisture intrusion, as it gives water a direct avenue of access behind the EIFS system.

**Cause:** Improper installation.

**Remedy:** Contact a EIFS specialist to determine extent of damage and exposure and to test if water is in the system. Properly seal this location.

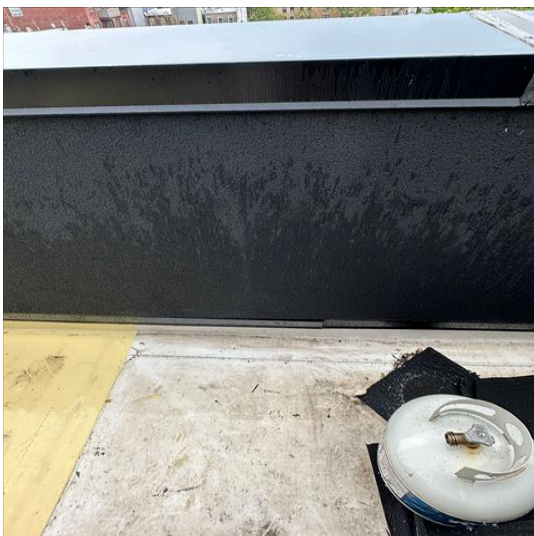
**Image Number:** 90

**Observation:** A section of metal flashing was observed to be loose and pulling away from the parapet wall at the time of inspection. This may become an area of concern as water may be able to divert behind this flashing and spread under the roofing material.

**Cause:** Improper installation.

**Remedy:** Repair this area.

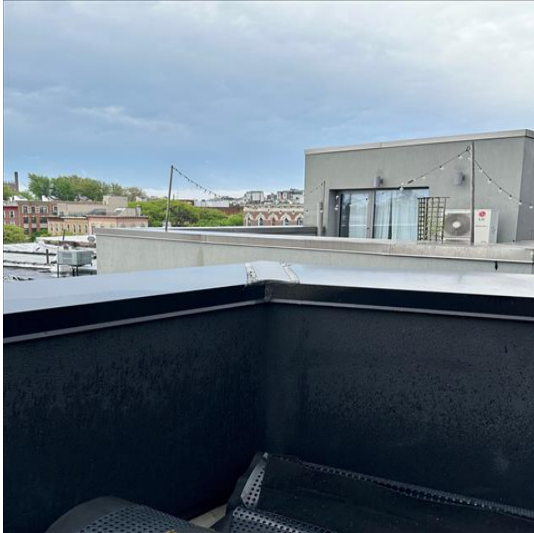
**Image Number:** 91

**Observation:** D5 (Deficiency 5) - Underdriven fasteners were observed at a corner of the parapet wall coping cap. These fasteners may be creating an exposure for moisture intrusion and may also become a concern in high wind events.

**Cause:** Improper installation.

**Remedy:** Fasten the coping caps. High winds may weaken this area and cause the coping cap to loosen, as it is aluminum and lightweight.
