# Forensic ROOF® Inspection

**Report No :**  
129959

**Property Inspected :**  
373 Prospect Pl  
Brooklyn, NY, 11238

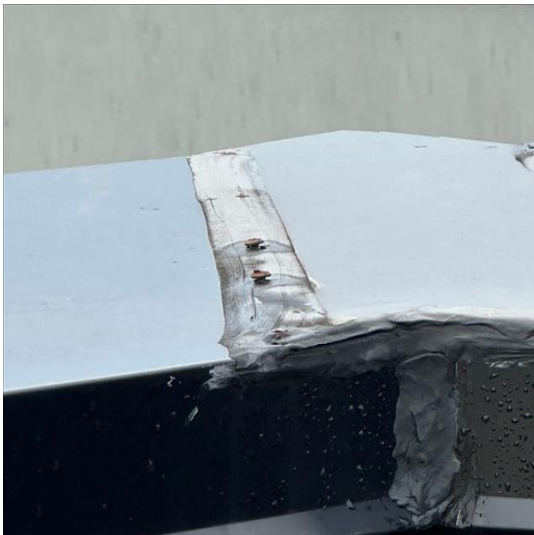
**Image Number:** 92

**Observation:** D5 (Deficiency 5) - Underdriven fasteners were observed at a corner of the parapet wall coping cap. These fasteners may be creating an exposure for moisture intrusion and may also become a concern in high wind events.

**Cause:** Improper installation.

**Remedy:** Fasten the coping caps. High winds may weaken this area and cause the coping cap to loosen, as it is aluminum and lightweight.

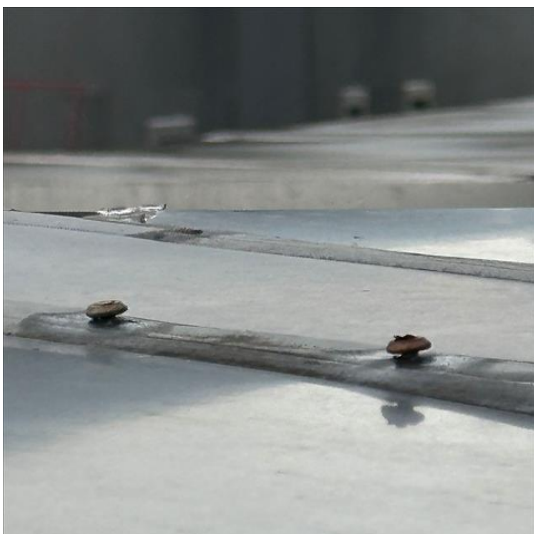
**Image Number:** 93

**Observation:** D5 (Deficiency 5) - Underdriven fasteners were observed at a corner of the parapet wall coping cap. These fasteners may be creating an exposure for moisture intrusion and may also become a concern in high wind events.

**Cause:** Improper installation.

**Remedy:** Fasten the coping caps. High winds may weaken this area and cause the coping cap to loosen, as it is aluminum and lightweight.

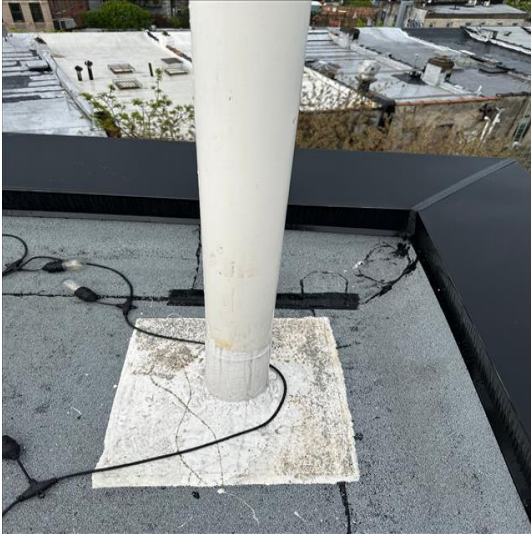
**Image Number:** 94

**Observation:** Roof penetrations on the top roof appeared to be properly flashed and installed in all but (1) area. This particular flashing was observed to be improperly sealed and is creating an exposure at the seam. This may cause moisture intrusion if not already.

**Cause:** Improper installation.

**Remedy:** Re-flash this area and create a water tight bond between the flashing material and roof covering.

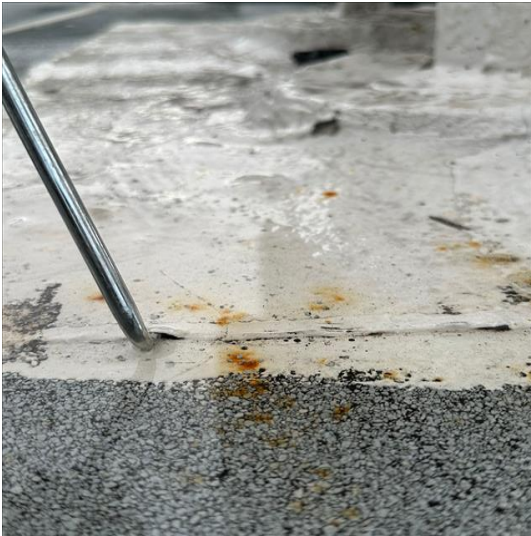
**Image Number:** 95

**Observation:** Roof penetrations on the top roof appeared to be properly flashed and installed in all but (1) area. This particular flashing was observed to be improperly sealed and is creating an exposure at the seam. This may cause moisture intrusion if not already.

**Cause:** Improper installation.

**Remedy:** Re-flash this area and create a water tight bond between the flashing material and roof covering.

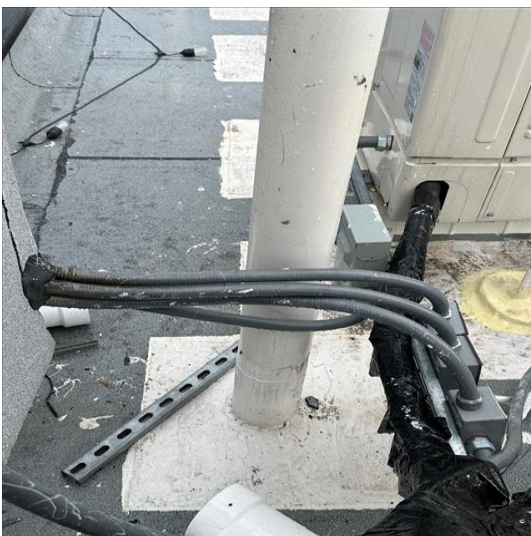
**Image Number:** 96

**Observation:** Roof penetrations on the top roof appeared to be properly flashed and installed in all but (1) area. This particular flashing was observed to be improperly sealed and is creating an exposure at the seam. This may cause moisture intrusion if not already.

**Cause:** Improper installation.

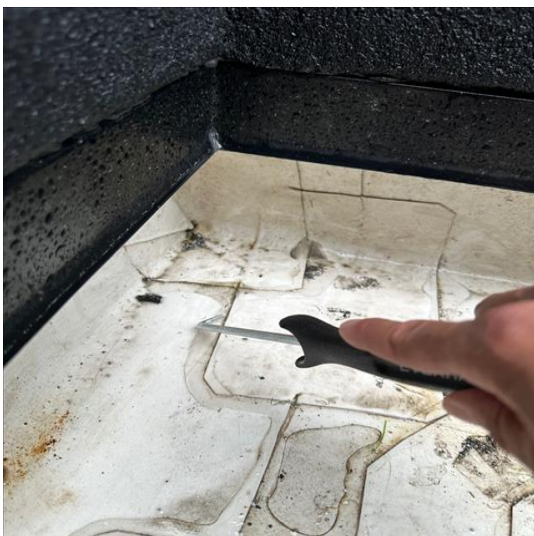
**Image Number:** 99

**Observation:** Previous repairs were observed at time of inspection. This is evident by TPO patches that were observed in random locations throughout the roof. There was also evidence of moisture being trapped along the borders of the patches under a plastic material.

**Cause:** Most likely damage caused by contractors on roof, stepping on objects that penetrate the roof material. This is a common occurrence with larger construction projects such as this.

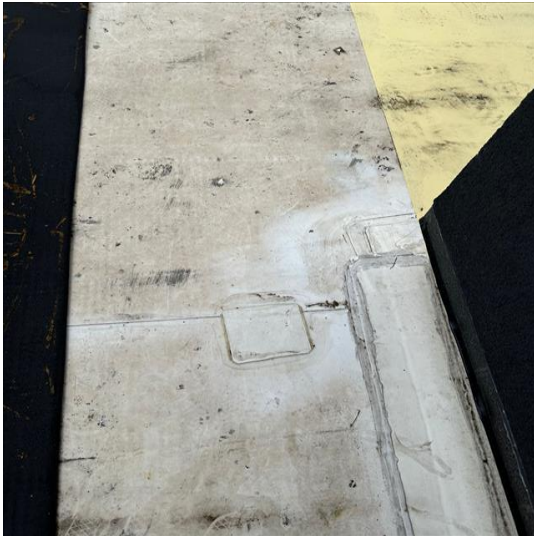
**Image Number:** 101

**Observation:** Previous repairs were observed at time of inspection. This is evident by TPO patches that were observed in random locations throughout the roof. There was also evidence of moisture being trapped along the borders of the patches under a plastic material.

**Cause:** Most likely damage caused by contractors on roof, stepping on objects that penetrate the roof material. This is a common occurrence with larger construction projects such as this.

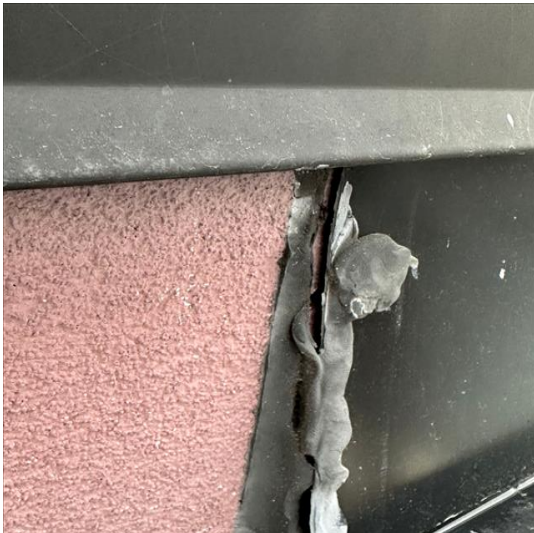
**Image Number:** 102

**Observation:** D7 (Deficiency 7) - Flashing/sealant at a wall was observed to be pulling apart and creating an exposure. If left unresolved, moisture intrusion may become an issue.

**Cause:** Sealant deterioration/Improper sealant application.

**Remedy:** Re-seal.
