Inspection Date: 11/14/2023

LeakFREE® Roof Inspection

Report No :
129180

Property Inspected :
[REDACTED]
[REDACTED]

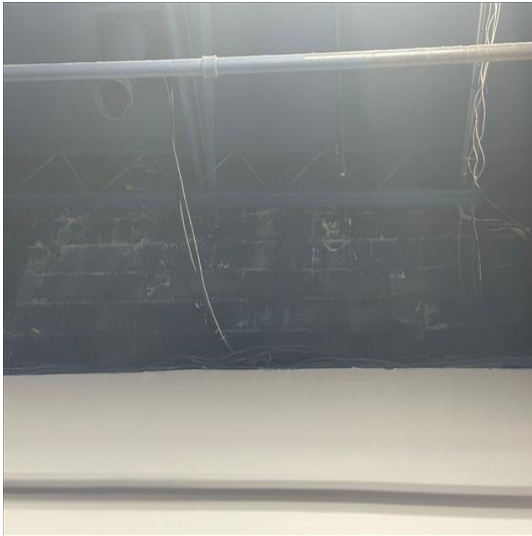
Image Number: 1

Observation: 1. Multiple moisture stains found within interior of structure. These stains were primarily found on the false ceiling tiles. Upon further investigation it was revealed that the moisture stains were consistent with roof penetrations in most areas. 2. Some areas of moisture staining that did not have roof penetrations nearby were most likely the result of condensation from HVAC tubing which was observed to be ripped in one area. 3. Efflorescence was observed on the upper part of the wall on the main entrance. This is indicative of the presence of moisture within the masonry.

Cause: 1. The moisture staining on the ceiling tiles were observed to be from the roof penetrations that were not properly sealed or flashed, and in some cases incorrectly installed on the roof. 2. The HVAC tubing in some areas was observed to be ripped or not insulated correctly, which results in condensation and can mimic roof leaks in some cases. 3. The efflorescence was observed to be consistent with the parapet wall and coping that was damaged or in need of repair, directly above the staining.

Remedy: 1. Before any remediation or restoration can commence, the repairs discussed in this report must first be performed. 2. Possible HVAC condensation staining must first be verified by a licensed HVAC tech before any replacement of damaged tiles. 3. Muriatic acid is sometimes effective with removing efflorescence staining. While the staining does not pose a structural issue, it does indicate the source of the problem on the roof.

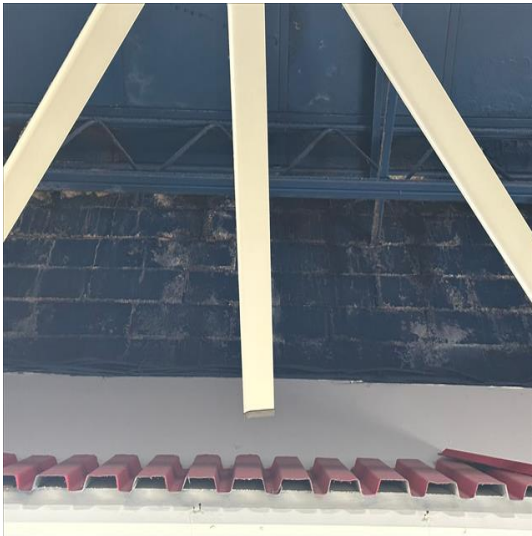
Image Number: 2

Observation: 1. Multiple moisture stains found within interior of structure. These stains were primarily found on the false ceiling tiles. Upon further investigation it was revealed that the moisture stains were consistent with roof penetrations in most areas. 2. Some areas of moisture staining that did not have roof penetrations nearby were most likely the result of condensation from HVAC tubing which was observed to be ripped in one area. 3. Efflorescence was observed on the upper part of the wall on the main entrance. This is indicative of the presence of moisture within the masonry.

Cause: 1. The moisture staining on the ceiling tiles were observed to be from the roof penetrations that were not properly sealed or flashed, and in some cases incorrectly installed on the roof. 2. The HVAC tubing in some areas was observed to be ripped or not insulated correctly, which results in condensation and can mimic roof leaks in some cases. 3. The efflorescence was observed to be consistent with the parapet wall and coping that was damaged or in need of repair, directly above the staining.

Remedy: 1. Before any remediation or restoration can commence, the repairs discussed in this report must first be performed. 2. Possible HVAC condensation staining must first be verified by a licensed HVAC tech before any replacement of damaged tiles. 3. Muriatic acid is sometimes effective with removing efflorescence staining. While the staining does not pose a structural issue, it does indicate the source of the problem on the roof.

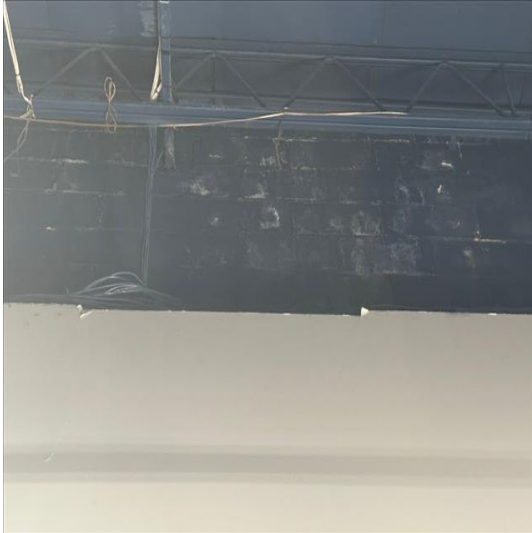
Image Number: 3

Observation: 1. Multiple moisture stains found within interior of structure. These stains were primarily found on the false ceiling tiles. Upon further investigation it was revealed that the moisture stains were consistent with roof penetrations in most areas. 2. Some areas of moisture staining that did not have roof penetrations nearby were most likely the result of condensation from HVAC tubing which was observed to be ripped in one area. 3. Efflorescence was observed on the upper part of the wall on the main entrance. This is indicative of the presence of moisture within the masonry.

Cause: 1. The moisture staining on the ceiling tiles were observed to be from the roof penetrations that were not properly sealed or flashed, and in some cases incorrectly installed on the roof. 2. The HVAC tubing in some areas was observed to be ripped or not insulated correctly, which results in condensation and can mimic roof leaks in some cases. 3. The efflorescence was observed to be consistent with the parapet wall and coping that was damaged or in need of repair, directly above the staining.

Remedy: 1. Before any remediation or restoration can commence, the repairs discussed in this report must first be performed. 2. Possible HVAC condensation staining must first be verified by a licensed HVAC tech before any replacement of damaged tiles. 3. Muriatic acid is sometimes effective with removing efflorescence staining. While the staining does not pose a structural issue, it does indicate the source of the problem on the roof.

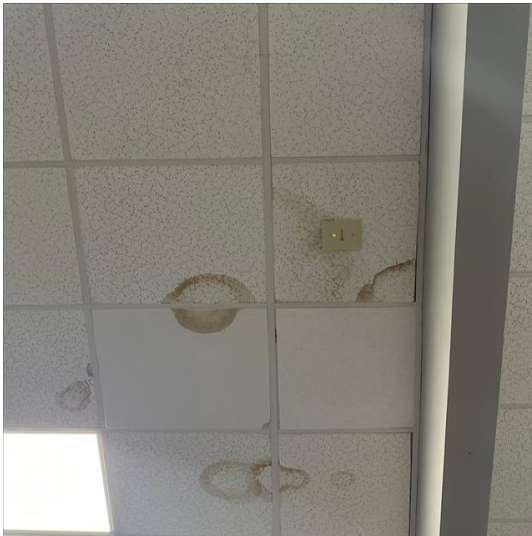
Image Number: 4

Observation: 1. Multiple moisture stains found within interior of structure. These stains were primarily found on the false ceiling tiles. Upon further investigation it was revealed that the moisture stains were consistent with roof penetrations in most areas. 2. Some areas of moisture staining that did not have roof penetrations nearby were most likely the result of condensation from HVAC tubing which was observed to be ripped in one area. 3. Efflorescence was observed on the upper part of the wall on the main entrance. This is indicative of the presence of moisture within the masonry.

Cause: 1. The moisture staining on the ceiling tiles were observed to be from the roof penetrations that were not properly sealed or flashed, and in some cases incorrectly installed on the roof. 2. The HVAC tubing in some areas was observed to be ripped or not insulated correctly, which results in condensation and can mimic roof leaks in some cases. 3. The efflorescence was observed to be consistent with the parapet wall and coping that was damaged or in need of repair, directly above the staining.

Remedy: 1. Before any remediation or restoration can commence, the repairs discussed in this report must first be performed. 2. Possible HVAC condensation staining must first be verified by a licensed HVAC tech before any replacement of damaged tiles. 3. Muriatic acid is sometimes effective with removing efflorescence staining. While the staining does not pose a structural issue, it does indicate the source of the problem on the roof.

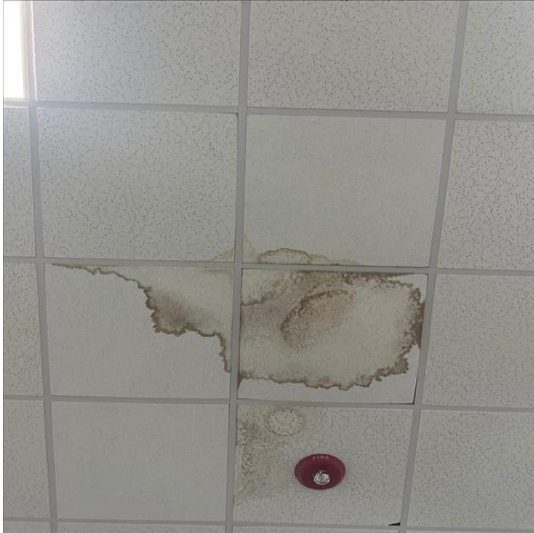
Image Number: 5

Observation: 1. Multiple moisture stains found within interior of structure. These stains were primarily found on the false ceiling tiles. Upon further investigation it was revealed that the moisture stains were consistent with roof penetrations in most areas. 2. Some areas of moisture staining that did not have roof penetrations nearby were most likely the result of condensation from HVAC tubing which was observed to be ripped in one area. 3. Efflorescence was observed on the upper part of the wall on the main entrance. This is indicative of the presence of moisture within the masonry.

Cause: 1. The moisture staining on the ceiling tiles were observed to be from the roof penetrations that were not properly sealed or flashed, and in some cases incorrectly installed on the roof. 2. The HVAC tubing in some areas was observed to be ripped or not insulated correctly, which results in condensation and can mimic roof leaks in some cases. 3. The efflorescence was observed to be consistent with the parapet wall and coping that was damaged or in need of repair, directly above the staining.

Remedy: 1. Before any remediation or restoration can commence, the repairs discussed in this report must first be performed. 2. Possible HVAC condensation staining must first be verified by a licensed HVAC tech before any replacement of damaged tiles. 3. Muriatic acid is sometimes effective with removing efflorescence staining. While the staining does not pose a structural issue, it does indicate the source of the problem on the roof.

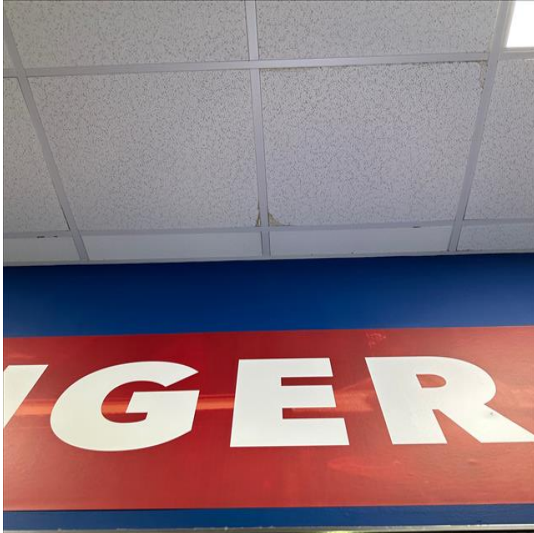
Image Number: 9

Observation: 1. Multiple moisture stains found within interior of structure. These stains were primarily found on the false ceiling tiles. Upon further investigation it was revealed that the moisture stains were consistent with roof penetrations in most areas. 2. Some areas of moisture staining that did not have roof penetrations nearby were most likely the result of condensation from HVAC tubing which was observed to be ripped in one area. 3. Efflorescence was observed on the upper part of the wall on the main entrance. This is indicative of the presence of moisture within the masonry.

Cause: 1. The moisture staining on the ceiling tiles were observed to be from the roof penetrations that were not properly sealed or flashed, and in some cases incorrectly installed on the roof. 2. The HVAC tubing in some areas was observed to be ripped or not insulated correctly, which results in condensation and can mimic roof leaks in some cases. 3. The efflorescence was observed to be consistent with the parapet wall and coping that was damaged or in need of repair, directly above the staining.

Remedy: 1. Before any remediation or restoration can commence, the repairs discussed in this report must first be performed. 2. Possible HVAC condensation staining must first be verified by a licensed HVAC tech before any replacement of damaged tiles. 3. Muriatic acid is sometimes effective with removing efflorescence staining. While the staining does not pose a structural issue, it does indicate the source of the problem on the roof.

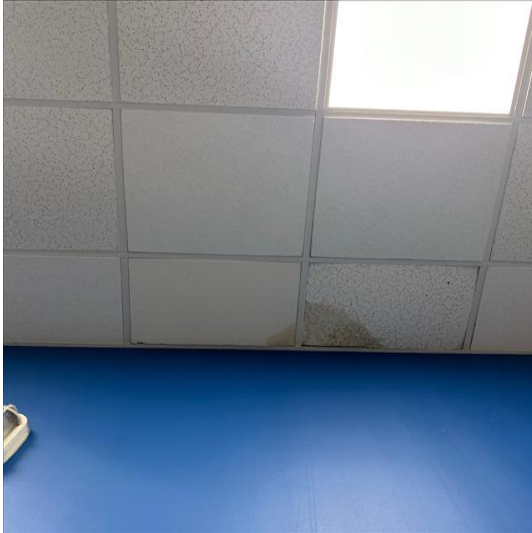
Image Number: 11

Observation: 1. Multiple moisture stains found within interior of structure. These stains were primarily found on the false ceiling tiles. Upon further investigation it was revealed that the moisture stains were consistent with roof penetrations in most areas. 2. Some areas of moisture staining that did not have roof penetrations nearby were most likely the result of condensation from HVAC tubing which was observed to be ripped in one area. 3. Efflorescence was observed on the upper part of the wall on the main entrance. This is indicative of the presence of moisture within the masonry.

Cause: 1. The moisture staining on the ceiling tiles were observed to be from the roof penetrations that were not properly sealed or flashed, and in some cases incorrectly installed on the roof. 2. The HVAC tubing in some areas was observed to be ripped or not insulated correctly, which results in condensation and can mimic roof leaks in some cases. 3. The efflorescence was observed to be consistent with the parapet wall and coping that was damaged or in need of repair, directly above the staining.

Remedy: 1. Before any remediation or restoration can commence, the repairs discussed in this report must first be performed. 2. Possible HVAC condensation staining must first be verified by a licensed HVAC tech before any replacement of damaged tiles. 3. Muriatic acid is sometimes effective with removing efflorescence staining. While the staining does not pose a structural issue, it does indicate the source of the problem on the roof.

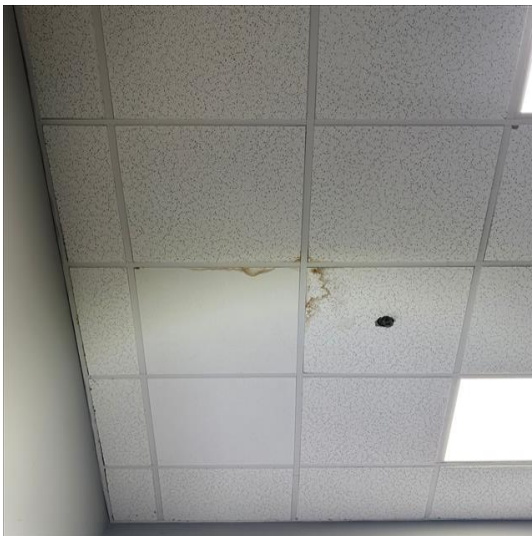
Image Number: 12

Observation: 1. Multiple moisture stains found within interior of structure. These stains were primarily found on the false ceiling tiles. Upon further investigation it was revealed that the moisture stains were consistent with roof penetrations in most areas. 2. Some areas of moisture staining that did not have roof penetrations nearby were most likely the result of condensation from HVAC tubing which was observed to be ripped in one area. 3. Efflorescence was observed on the upper part of the wall on the main entrance. This is indicative of the presence of moisture within the masonry.

Cause: 1. The moisture staining on the ceiling tiles were observed to be from the roof penetrations that were not properly sealed or flashed, and in some cases incorrectly installed on the roof. 2. The HVAC tubing in some areas was observed to be ripped or not insulated correctly, which results in condensation and can mimic roof leaks in some cases. 3. The efflorescence was observed to be consistent with the parapet wall and coping that was damaged or in need of repair, directly above the staining.

Remedy: 1. Before any remediation or restoration can commence, the repairs discussed in this report must first be performed. 2. Possible HVAC condensation staining must first be verified by a licensed HVAC tech before any replacement of damaged tiles. 3. Muriatic acid is sometimes effective with removing efflorescence staining. While the staining does not pose a structural issue, it does indicate the source of the problem on the roof.

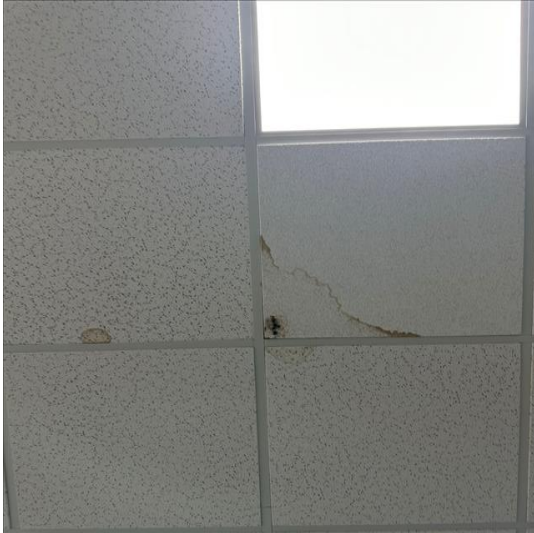
Image Number: 15

Observation: 1. Multiple moisture stains found within interior of structure. These stains were primarily found on the false ceiling tiles. Upon further investigation it was revealed that the moisture stains were consistent with roof penetrations in most areas. 2. Some areas of moisture staining that did not have roof penetrations nearby were most likely the result of condensation from HVAC tubing which was observed to be ripped in one area. 3. Efflorescence was observed on the upper part of the wall on the main entrance. This is indicative of the presence of moisture within the masonry.

Remedy: 1. Before any remediation or restoration can commence, the repairs discussed in this report must first be performed. 2. Possible HVAC condensation staining must first be verified by a licensed HVAC tech before any replacement of damaged tiles. 3. Muriatic acid is sometimes effective with removing efflorescence staining. While the staining does not pose a structural issue, it does indicate the source of the problem on the roof.

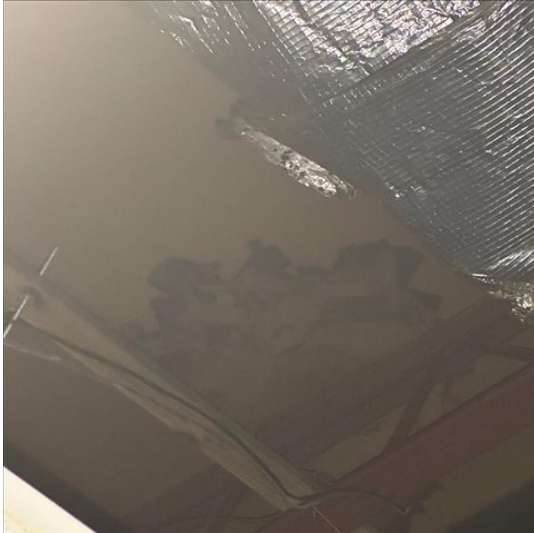
Image Number: 17

Observation: 1. Multiple moisture stains found within interior of structure. These stains were primarily found on the false ceiling tiles. Upon further investigation it was revealed that the moisture stains were consistent with roof penetrations in most areas. 2. Some areas of moisture staining that did not have roof penetrations nearby were most likely the result of condensation from HVAC tubing which was observed to be ripped in one area. 3. Efflorescence was observed on the upper part of the wall on the main entrance. This is indicative of the presence of moisture within the masonry.

Remedy: 1. Before any remediation or restoration can commence, the repairs discussed in this report must first be performed. 2. Possible HVAC condensation staining must first be verified by a licensed HVAC tech before any replacement of damaged tiles. 3. Muriatic acid is sometimes effective with removing efflorescence staining. While the staining does not pose a structural issue, it does indicate the source of the problem on the roof.

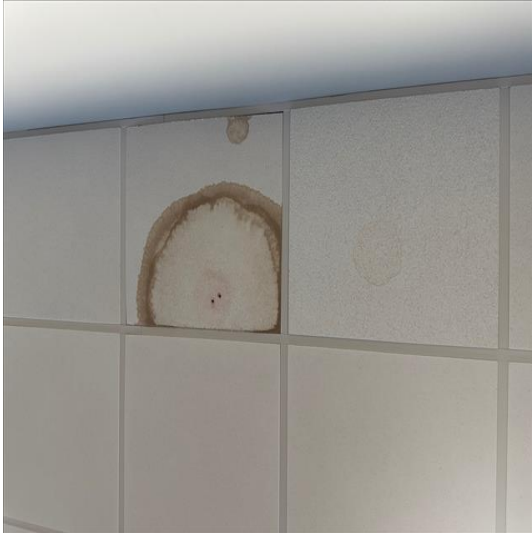
Image Number: 19

Observation: 1. Multiple moisture stains found within interior of structure. These stains were primarily found on the false ceiling tiles. Upon further investigation it was revealed that the moisture stains were consistent with roof penetrations in most areas. 2. Some areas of moisture staining that did not have roof penetrations nearby were most likely the result of condensation from HVAC tubing which was observed to be ripped in one area. 3. Efflorescence was observed on the upper part of the wall on the main entrance. This is indicative of the presence of moisture within the masonry.

Cause: 1. The moisture staining on the ceiling tiles were observed to be from the roof penetrations that were not properly sealed or flashed, and in some cases incorrectly installed on the roof. 2. The HVAC tubing in some areas was observed to be ripped or not insulated correctly, which results in condensation and can mimic roof leaks in some cases. 3. The efflorescence was observed to be consistent with the parapet wall and coping that was damaged or in need of repair, directly above the staining.

Remedy: 1. Before any remediation or restoration can commence, the repairs discussed in this report must first be performed. 2. Possible HVAC condensation staining must first be verified by a licensed HVAC tech before any replacement of damaged tiles. 3. Muriatic acid is sometimes effective with removing efflorescence staining. While the staining does not pose a structural issue, it does indicate the source of the problem on the roof.

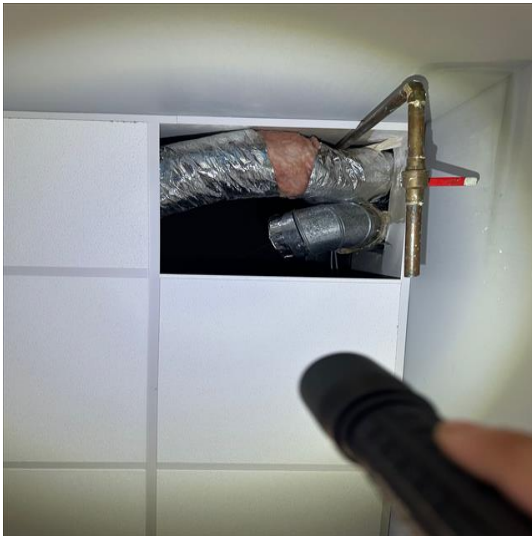
Image Number: 20

Observation: 1. Multiple moisture stains found within interior of structure. These stains were primarily found on the false ceiling tiles. Upon further investigation it was revealed that the moisture stains were consistent with roof penetrations in most areas. 2. Some areas of moisture staining that did not have roof penetrations nearby were most likely the result of condensation from HVAC tubing which was observed to be ripped in one area. 3. Efflorescence was observed on the upper part of the wall on the main entrance. This is indicative of the presence of moisture within the masonry.

Remedy: 1. Before any remediation or restoration can commence, the repairs discussed in this report must first be performed. 2. Possible HVAC condensation staining must first be verified by a licensed HVAC tech before any replacement of damaged tiles. 3. Muriatic acid is sometimes effective with removing efflorescence staining. While the staining does not pose a structural issue, it does indicate the source of the problem on the roof.

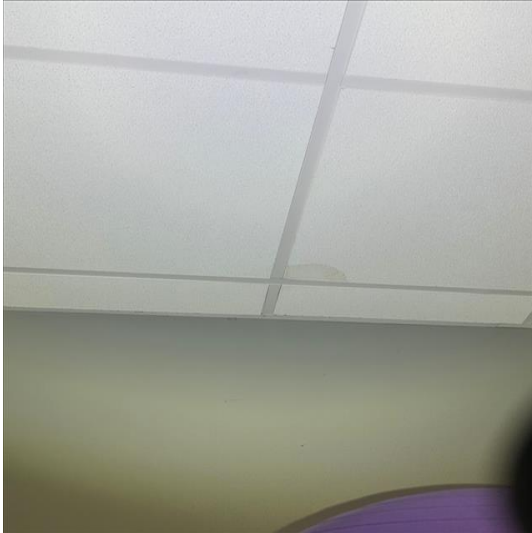
Image Number: 21

Observation: 1. Multiple moisture stains found within interior of structure. These stains were primarily found on the false ceiling tiles. Upon further investigation it was revealed that the moisture stains were consistent with roof penetrations in most areas. 2. Some areas of moisture staining that did not have roof penetrations nearby were most likely the result of condensation from HVAC tubing which was observed to be ripped in one area. 3. Efflorescence was observed on the upper part of the wall on the main entrance. This is indicative of the presence of moisture within the masonry.

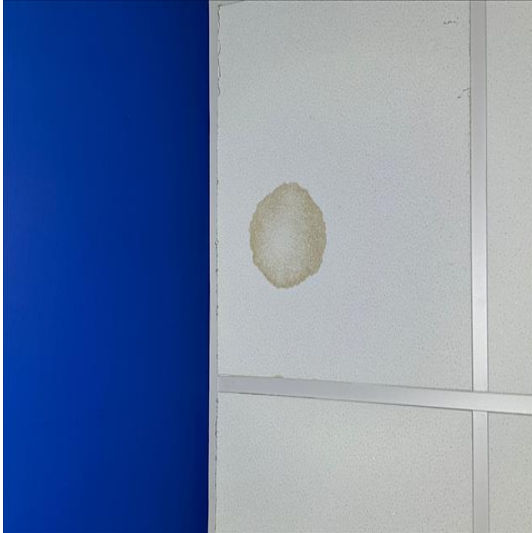
Image Number: 23

Observation: 1. Multiple moisture stains found within interior of structure. These stains were primarily found on the false ceiling tiles. Upon further investigation it was revealed that the moisture stains were consistent with roof penetrations in most areas. 2. Some areas of moisture staining that did not have roof penetrations nearby were most likely the result of condensation from HVAC tubing which was observed to be ripped in one area. 3. Efflorescence was observed on the upper part of the wall on the main entrance. This is indicative of the presence of moisture within the masonry.

Cause: 1. The moisture staining on the ceiling tiles were observed to be from the roof penetrations that were not properly sealed or flashed, and in some cases incorrectly installed on the roof. 2. The HVAC tubing in some areas was observed to be ripped or not insulated correctly, which results in condensation and can mimic roof leaks in some cases. 3. The efflorescence was observed to be consistent with the parapet wall and coping that was damaged or in need of repair, directly above the staining.

Remedy: 1. Before any remediation or restoration can commence, the repairs discussed in this report must first be performed. 2. Possible HVAC condensation staining must first be verified by a licensed HVAC tech before any replacement of damaged tiles. 3. Muriatic acid is sometimes effective with removing efflorescence staining. While the staining does not pose a structural issue, it does indicate the source of the problem on the roof.

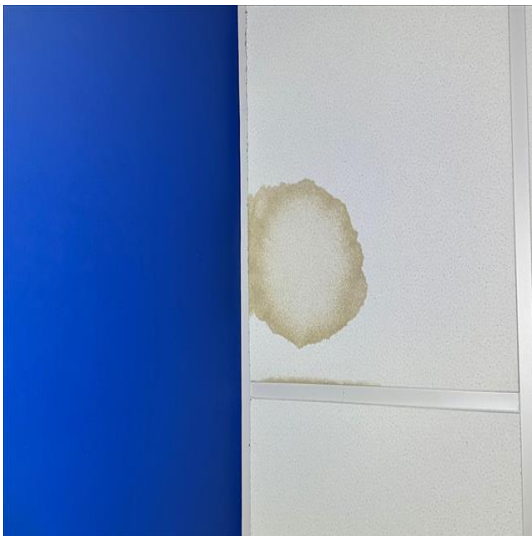
Image Number: 24

Observation: 1. Multiple moisture stains found within interior of structure. These stains were primarily found on the false ceiling tiles. Upon further investigation it was revealed that the moisture stains were consistent with roof penetrations in most areas. 2. Some areas of moisture staining that did not have roof penetrations nearby were most likely the result of condensation from HVAC tubing which was observed to be ripped in one area. 3. Efflorescence was observed on the upper part of the wall on the main entrance. This is indicative of the presence of moisture within the masonry.

Cause: 1. The moisture staining on the ceiling tiles were observed to be from the roof penetrations that were not properly sealed or flashed, and in some cases incorrectly installed on the roof. 2. The HVAC tubing in some areas was observed to be ripped or not insulated correctly, which results in condensation and can mimic roof leaks in some cases. 3. The efflorescence was observed to be consistent with the parapet wall and coping that was damaged or in need of repair, directly above the staining.

Remedy: 1. Before any remediation or restoration can commence, the repairs discussed in this report must first be performed. 2. Possible HVAC condensation staining must first be verified by a licensed HVAC tech before any replacement of damaged tiles. 3. Muriatic acid is sometimes effective with removing efflorescence staining. While the staining does not pose a structural issue, it does indicate the source of the problem on the roof.

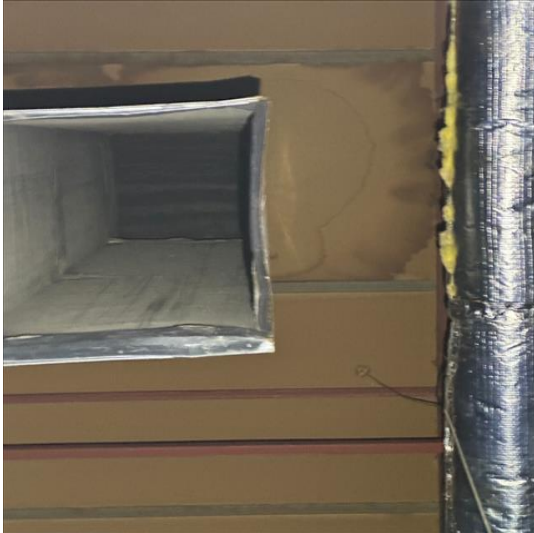
Image Number: 25

Observation: 1. Multiple moisture stains found within interior of structure. These stains were primarily found on the false ceiling tiles. Upon further investigation it was revealed that the moisture stains were consistent with roof penetrations in most areas. 2. Some areas of moisture staining that did not have roof penetrations nearby were most likely the result of condensation from HVAC tubing which was observed to be ripped in one area. 3. Efflorescence was observed on the upper part of the wall on the main entrance. This is indicative of the presence of moisture within the masonry.

Cause: 1. The moisture staining on the ceiling tiles were observed to be from the roof penetrations that were not properly sealed or flashed, and in some cases incorrectly installed on the roof. 2. The HVAC tubing in some areas was observed to be ripped or not insulated correctly, which results in condensation and can mimic roof leaks in some cases. 3. The efflorescence was observed to be consistent with the parapet wall and coping that was damaged or in need of repair, directly above the staining.

Remedy: 1. Before any remediation or restoration can commence, the repairs discussed in this report must first be performed. 2. Possible HVAC condensation staining must first be verified by a licensed HVAC tech before any replacement of damaged tiles. 3. Muriatic acid is sometimes effective with removing efflorescence staining. While the staining does not pose a structural issue, it does indicate the source of the problem on the roof.

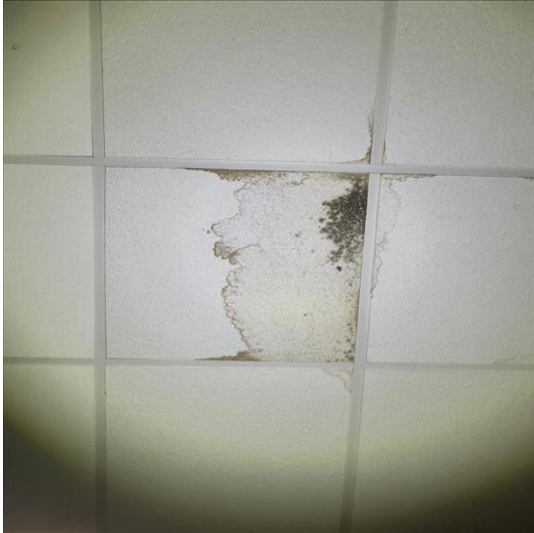
Image Number: 27

Observation: 1. Multiple moisture stains found within interior of structure. These stains were primarily found on the false ceiling tiles. Upon further investigation it was revealed that the moisture stains were consistent with roof penetrations in most areas. 2. Some areas of moisture staining that did not have roof penetrations nearby were most likely the result of condensation from HVAC tubing which was observed to be ripped in one area. 3. Efflorescence was observed on the upper part of the wall on the main entrance. This is indicative of the presence of moisture within the masonry.

Cause: 1. The moisture staining on the ceiling tiles were observed to be from the roof penetrations that were not properly sealed or flashed, and in some cases incorrectly installed on the roof. 2. The HVAC tubing in some areas was observed to be ripped or not insulated correctly, which results in condensation and can mimic roof leaks in some cases. 3. The efflorescence was observed to be consistent with the parapet wall and coping that was damaged or in need of repair, directly above the staining.

Remedy: 1. Before any remediation or restoration can commence, the repairs discussed in this report must first be performed. 2. Possible HVAC condensation staining must first be verified by a licensed HVAC tech before any replacement of damaged tiles. 3. Muriatic acid is sometimes effective with removing efflorescence staining. While the staining does not pose a structural issue, it does indicate the source of the problem on the roof.

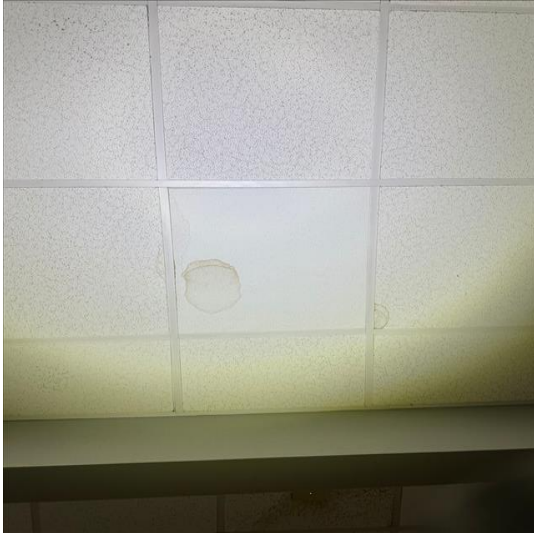
Image Number: 29

Observation: 1. Multiple moisture stains found within interior of structure. These stains were primarily found on the false ceiling tiles. Upon further investigation it was revealed that the moisture stains were consistent with roof penetrations in most areas. 2. Some areas of moisture staining that did not have roof penetrations nearby were most likely the result of condensation from HVAC tubing which was observed to be ripped in one area. 3. Efflorescence was observed on the upper part of the wall on the main entrance. This is indicative of the presence of moisture within the masonry.

Cause: 1. The moisture staining on the ceiling tiles were observed to be from the roof penetrations that were not properly sealed or flashed, and in some cases incorrectly installed on the roof. 2. The HVAC tubing in some areas was observed to be ripped or not insulated correctly, which results in condensation and can mimic roof leaks in some cases. 3. The efflorescence was observed to be consistent with the parapet wall and coping that was damaged or in need of repair, directly above the staining.

Remedy: 1. Before any remediation or restoration can commence, the repairs discussed in this report must first be performed. 2. Possible HVAC condensation staining must first be verified by a licensed HVAC tech before any replacement of damaged tiles. 3. Muriatic acid is sometimes effective with removing efflorescence staining. While the staining does not pose a structural issue, it does indicate the source of the problem on the roof.

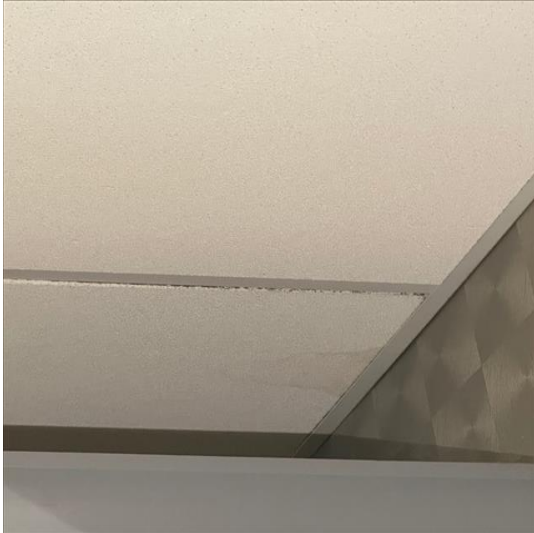
Image Number: 31

Observation: 1. Multiple moisture stains found within interior of structure. These stains were primarily found on the false ceiling tiles. Upon further investigation it was revealed that the moisture stains were consistent with roof penetrations in most areas. 2. Some areas of moisture staining that did not have roof penetrations nearby were most likely the result of condensation from HVAC tubing which was observed to be ripped in one area. 3. Efflorescence was observed on the upper part of the wall on the main entrance. This is indicative of the presence of moisture within the masonry.

Cause: 1. The moisture staining on the ceiling tiles were observed to be from the roof penetrations that were not properly sealed or flashed, and in some cases incorrectly installed on the roof. 2. The HVAC tubing in some areas was observed to be ripped or not insulated correctly, which results in condensation and can mimic roof leaks in some cases. 3. The efflorescence was observed to be consistent with the parapet wall and coping that was damaged or in need of repair, directly above the staining.

Remedy: 1. Before any remediation or restoration can commence, the repairs discussed in this report must first be performed. 2. Possible HVAC condensation staining must first be verified by a licensed HVAC tech before any replacement of damaged tiles. 3. Muriatic acid is sometimes effective with removing efflorescence staining. While the staining does not pose a structural issue, it does indicate the source of the problem on the roof.

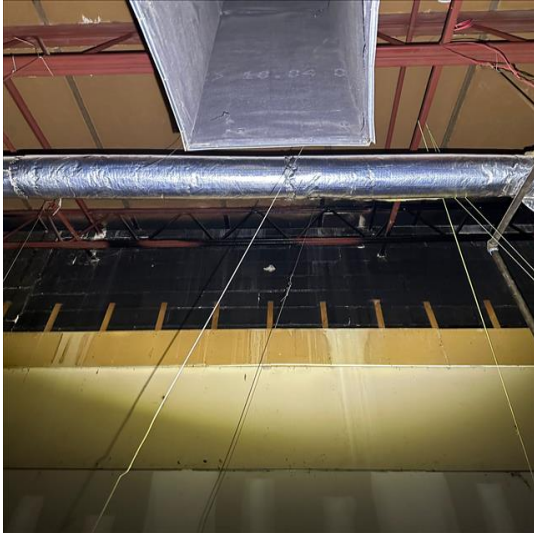
Image Number: 33

Observation: 1. Multiple moisture stains found within interior of structure. These stains were primarily found on the false ceiling tiles. Upon further investigation it was revealed that the moisture stains were consistent with roof penetrations in most areas. 2. Some areas of moisture staining that did not have roof penetrations nearby were most likely the result of condensation from HVAC tubing which was observed to be ripped in one area. 3. Efflorescence was observed on the upper part of the wall on the main entrance. This is indicative of the presence of moisture within the masonry.

Cause: 1. The moisture staining on the ceiling tiles were observed to be from the roof penetrations that were not properly sealed or flashed, and in some cases incorrectly installed on the roof. 2. The HVAC tubing in some areas was observed to be ripped or not insulated correctly, which results in condensation and can mimic roof leaks in some cases. 3. The efflorescence was observed to be consistent with the parapet wall and coping that was damaged or in need of repair, directly above the staining.

Remedy: 1. Before any remediation or restoration can commence, the repairs discussed in this report must first be performed. 2. Possible HVAC condensation staining must first be verified by a licensed HVAC tech before any replacement of damaged tiles. 3. Muriatic acid is sometimes effective with removing efflorescence staining. While the staining does not pose a structural issue, it does indicate the source of the problem on the roof.

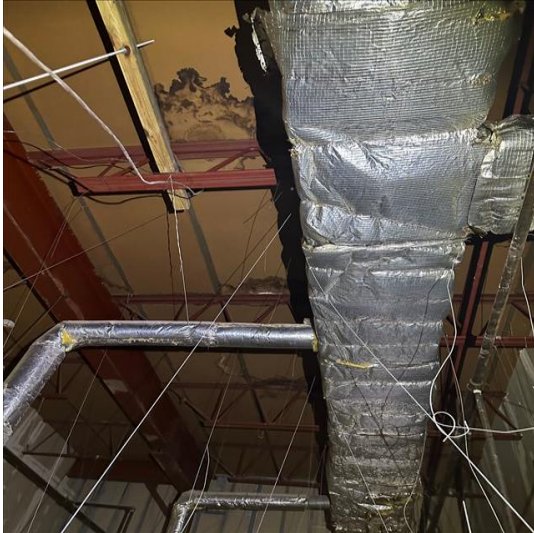
Image Number: 35

Observation: 1. Multiple moisture stains found within interior of structure. These stains were primarily found on the false ceiling tiles. Upon further investigation it was revealed that the moisture stains were consistent with roof penetrations in most areas. 2. Some areas of moisture staining that did not have roof penetrations nearby were most likely the result of condensation from HVAC tubing which was observed to be ripped in one area. 3. Efflorescence was observed on the upper part of the wall on the main entrance. This is indicative of the presence of moisture within the masonry.

Cause: 1. The moisture staining on the ceiling tiles were observed to be from the roof penetrations that were not properly sealed or flashed, and in some cases incorrectly installed on the roof. 2. The HVAC tubing in some areas was observed to be ripped or not insulated correctly, which results in condensation and can mimic roof leaks in some cases. 3. The efflorescence was observed to be consistent with the parapet wall and coping that was damaged or in need of repair, directly above the staining.

Remedy: 1. Before any remediation or restoration can commence, the repairs discussed in this report must first be performed. 2. Possible HVAC condensation staining must first be verified by a licensed HVAC tech before any replacement of damaged tiles. 3. Muriatic acid is sometimes effective with removing efflorescence staining. While the staining does not pose a structural issue, it does indicate the source of the problem on the roof.

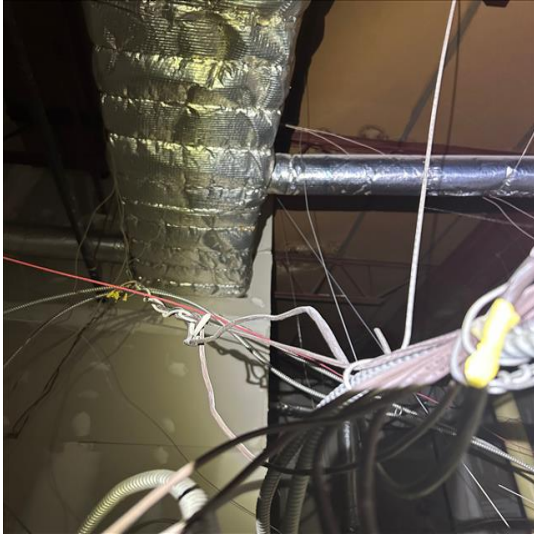
Image Number: 39

Observation: 1. Multiple moisture stains found within interior of structure. These stains were primarily found on the false ceiling tiles. Upon further investigation it was revealed that the moisture stains were consistent with roof penetrations in most areas. 2. Some areas of moisture staining that did not have roof penetrations nearby were most likely the result of condensation from HVAC tubing which was observed to be ripped in one area. 3. Efflorescence was observed on the upper part of the wall on the main entrance. This is indicative of the presence of moisture within the masonry.

Cause: 1. The moisture staining on the ceiling tiles were observed to be from the roof penetrations that were not properly sealed or flashed, and in some cases incorrectly installed on the roof. 2. The HVAC tubing in some areas was observed to be ripped or not insulated correctly, which results in condensation and can mimic roof leaks in some cases. 3. The efflorescence was observed to be consistent with the parapet wall and coping that was damaged or in need of repair, directly above the staining.

Remedy: 1. Before any remediation or restoration can commence, the repairs discussed in this report must first be performed. 2. Possible HVAC condensation staining must first be verified by a licensed HVAC tech before any replacement of damaged tiles. 3. Muriatic acid is sometimes effective with removing efflorescence staining. While the staining does not pose a structural issue, it does indicate the source of the problem on the roof.

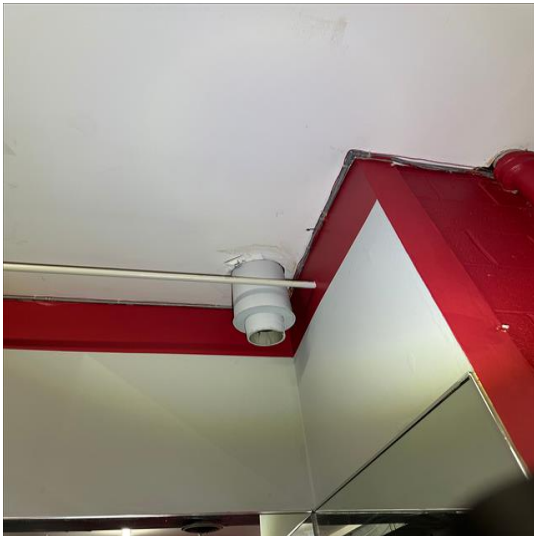
Image Number: 40

Observation: 1. Multiple moisture stains found within interior of structure. These stains were primarily found on the false ceiling tiles. Upon further investigation it was revealed that the moisture stains were consistent with roof penetrations in most areas. 2. Some areas of moisture staining that did not have roof penetrations nearby were most likely the result of condensation from HVAC tubing which was observed to be ripped in one area. 3. Efflorescence was observed on the upper part of the wall on the main entrance. This is indicative of the presence of moisture within the masonry.

Remedy: 1. Before any remediation or restoration can commence, the repairs discussed in this report must first be performed. 2. Possible HVAC condensation staining must first be verified by a licensed HVAC tech before any replacement of damaged tiles. 3. Muriatic acid is sometimes effective with removing efflorescence staining. While the staining does not pose a structural issue, it does indicate the source of the problem on the roof.

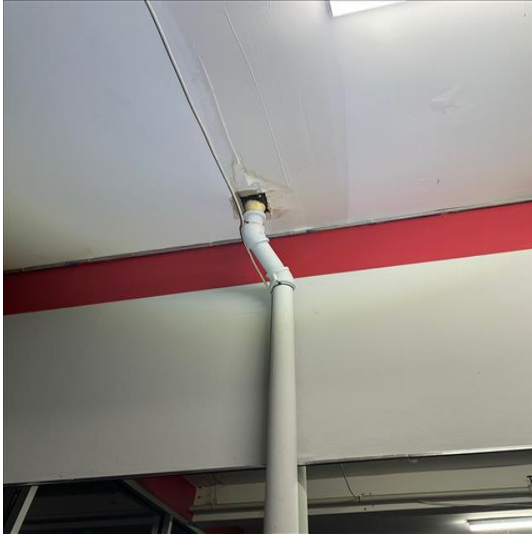
Image Number: 41

Observation: 1. Multiple moisture stains found within interior of structure. These stains were primarily found on the false ceiling tiles. Upon further investigation it was revealed that the moisture stains were consistent with roof penetrations in most areas. 2. Some areas of moisture staining that did not have roof penetrations nearby were most likely the result of condensation from HVAC tubing which was observed to be ripped in one area. 3. Efflorescence was observed on the upper part of the wall on the main entrance. This is indicative of the presence of moisture within the masonry.

Cause: 1. The moisture staining on the ceiling tiles were observed to be from the roof penetrations that were not properly sealed or flashed, and in some cases incorrectly installed on the roof. 2. The HVAC tubing in some areas was observed to be ripped or not insulated correctly, which results in condensation and can mimic roof leaks in some cases. 3. The efflorescence was observed to be consistent with the parapet wall and coping that was damaged or in need of repair, directly above the staining.

Remedy: 1. Before any remediation or restoration can commence, the repairs discussed in this report must first be performed. 2. Possible HVAC condensation staining must first be verified by a licensed HVAC tech before any replacement of damaged tiles. 3. Muriatic acid is sometimes effective with removing efflorescence staining. While the staining does not pose a structural issue, it does indicate the source of the problem on the roof.

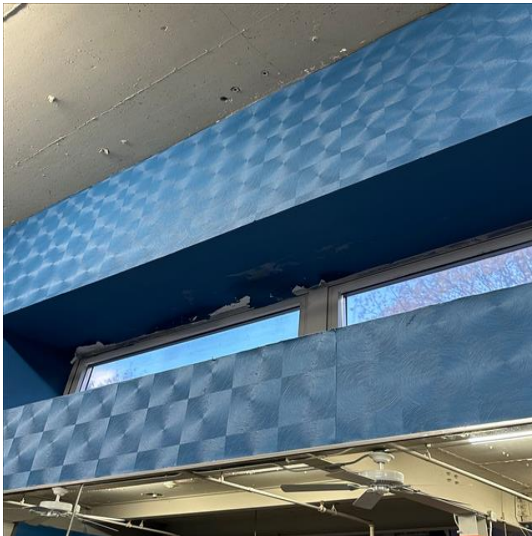
Image Number: 42

Observation: 1. Multiple moisture stains found within interior of structure. These stains were primarily found on the false ceiling tiles. Upon further investigation it was revealed that the moisture stains were consistent with roof penetrations in most areas. 2. Some areas of moisture staining that did not have roof penetrations nearby were most likely the result of condensation from HVAC tubing which was observed to be ripped in one area. 3. Efflorescence was observed on the upper part of the wall on the main entrance. This is indicative of the presence of moisture within the masonry.

Remedy: 1. Before any remediation or restoration can commence, the repairs discussed in this report must first be performed. 2. Possible HVAC condensation staining must first be verified by a licensed HVAC tech before any replacement of damaged tiles. 3. Muriatic acid is sometimes effective with removing efflorescence staining. While the staining does not pose a structural issue, it does indicate the source of the problem on the roof.

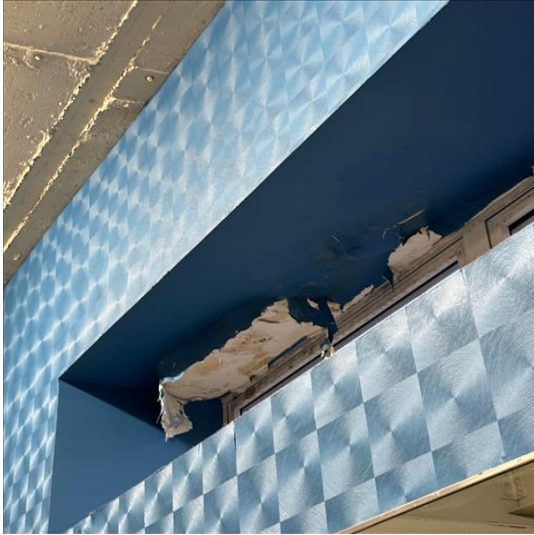
Image Number: 43

Observation: 1. Multiple moisture stains found within interior of structure. These stains were primarily found on the false ceiling tiles. Upon further investigation it was revealed that the moisture stains were consistent with roof penetrations in most areas. 2. Some areas of moisture staining that did not have roof penetrations nearby were most likely the result of condensation from HVAC tubing which was observed to be ripped in one area. 3. Efflorescence was observed on the upper part of the wall on the main entrance. This is indicative of the presence of moisture within the masonry.

Cause: 1. The moisture staining on the ceiling tiles were observed to be from the roof penetrations that were not properly sealed or flashed, and in some cases incorrectly installed on the roof. 2. The HVAC tubing in some areas was observed to be ripped or not insulated correctly, which results in condensation and can mimic roof leaks in some cases. 3. The efflorescence was observed to be consistent with the parapet wall and coping that was damaged or in need of repair, directly above the staining.

Remedy: 1. Before any remediation or restoration can commence, the repairs discussed in this report must first be performed. 2. Possible HVAC condensation staining must first be verified by a licensed HVAC tech before any replacement of damaged tiles. 3. Muriatic acid is sometimes effective with removing efflorescence staining. While the staining does not pose a structural issue, it does indicate the source of the problem on the roof.

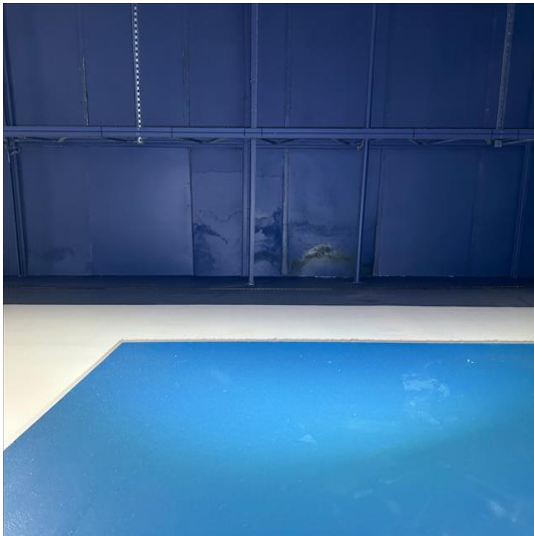
Image Number: 44

Observation: 1. Multiple moisture stains found within interior of structure. These stains were primarily found on the false ceiling tiles. Upon further investigation it was revealed that the moisture stains were consistent with roof penetrations in most areas. 2. Some areas of moisture staining that did not have roof penetrations nearby were most likely the result of condensation from HVAC tubing which was observed to be ripped in one area. 3. Efflorescence was observed on the upper part of the wall on the main entrance. This is indicative of the presence of moisture within the masonry.

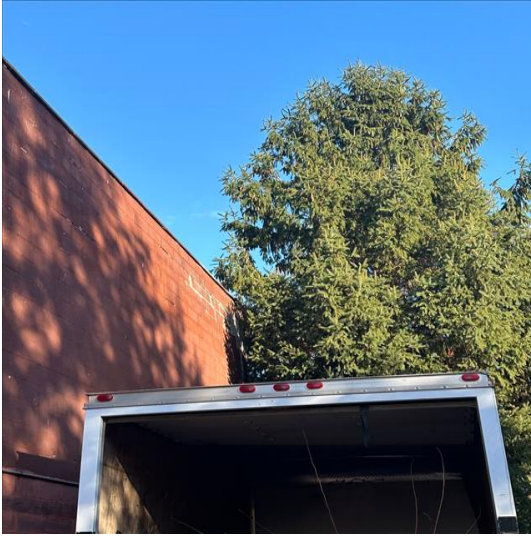
Image Number: 49

Observation: A tree was observed to be overhanging the structure at time of inspection.

Remedy: Cut back tree to prevent any damage or accelerated deterioration of roof coverings.

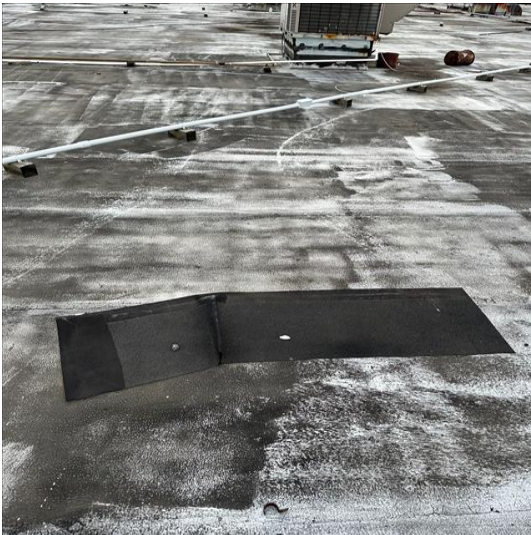
Image Number: 50

Observation: It could not be determined if this was a piece of material left behind that bonded to the roof or if this is evidence of a previous repair.

Determination: Roof Replacement required for LeakFREE Roof Certification

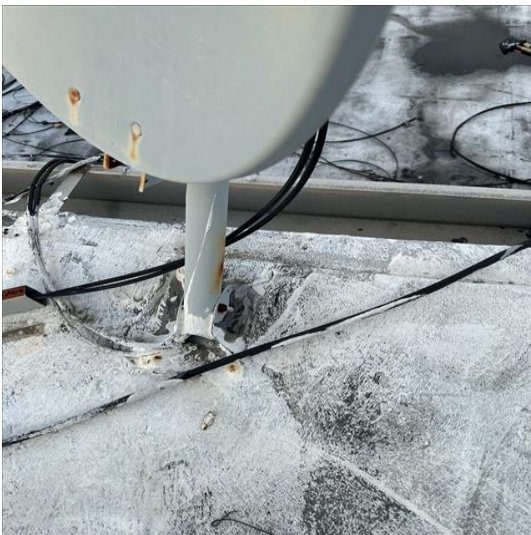
Image Number: 51

Observation: Third party damage was observed at time of inspection. Improper installation, paired with improper flashing and sealing may result in moisture intrusion.

Cause: Third party damage, poor workmanship.

Determination: Roof Replacement required for LeakFREE Roof Certification

Remedy: Replace sealant and flashings to ensure the penetrations are water tight.

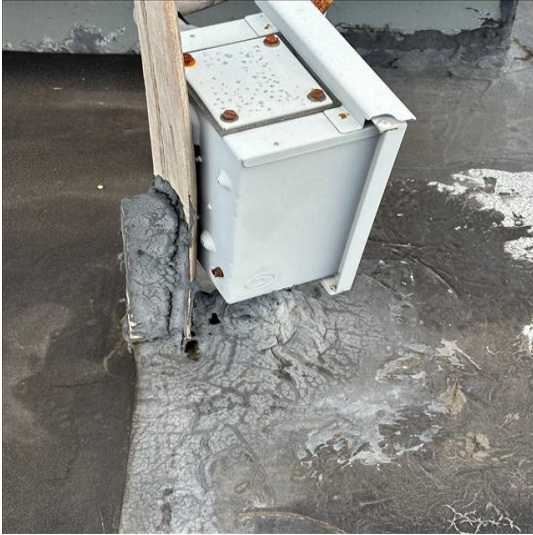
Image Number: 52

Observation: Third party damage was observed at time of inspection. Improper installation, paired with improper flashing and sealing may result in moisture intrusion.

Cause: Third party damage, poor workmanship.

Determination: Roof Replacement required for LeakFREE Roof Certification

Remedy: Replace sealant and flashings to ensure the penetrations are water tight.

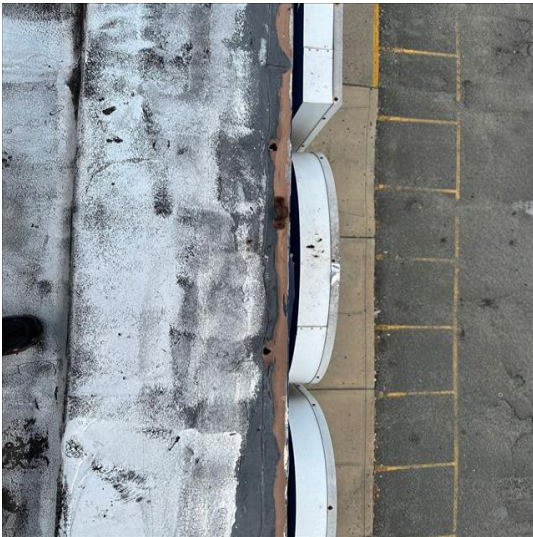
Image Number: 53

Observation: Multiple punctures were observed above sign on front of building, located directly where the coping of the parapet wall is located. This may introduce the exposure of moisture to the building as this is a place for water to go.

Cause: Deferred maintenance.

Determination: Roof Replacement required for LeakFREE Roof Certification

Remedy: Replace coping metal on this section to prevent any further moisture intrusion.

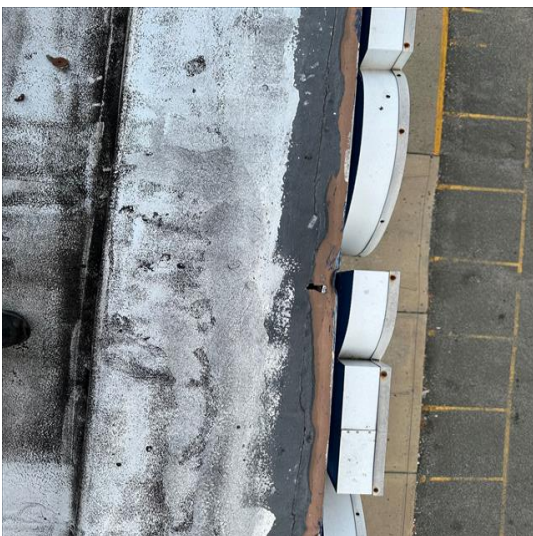
Image Number: 54

Observation: Multiple punctures were observed above sign on front of building, located directly where the coping of the parapet wall is located. This may introduce the exposure of moisture to the building as this is a place for water to go.

Cause: Deferred maintenance.

Determination: Roof Replacement required for LeakFREE Roof Certification

Remedy: Replace coping metal on this section to prevent any further moisture intrusion.

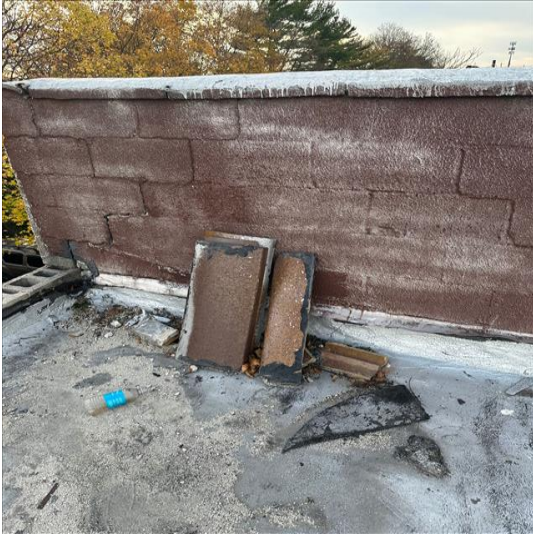
Image Number: 55

Observation: Debris that was found to be sitting on roof coverings a time of inspection.

Cause: Deferred maintenance and poor workmanship.

Determination: Roof Replacement required for LeakFREE Roof Certification

Remedy: Clear out debris.

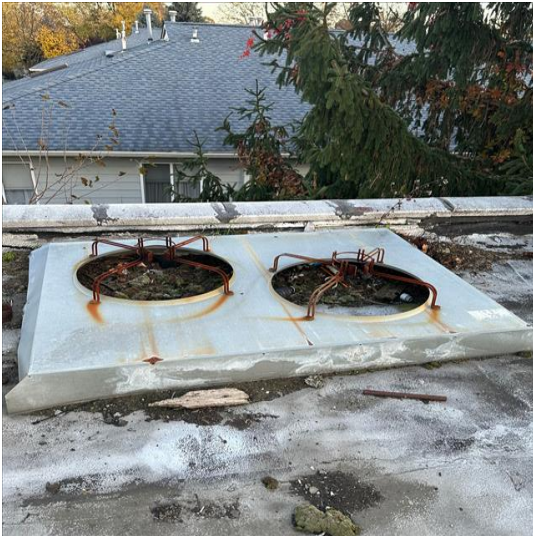
Image Number: 56

Observation: Debris that was found to be sitting on roof coverings a time of inspection.

Cause: Deferred maintenance and poor workmanship.

Determination: Roof Replacement required for LeakFREE Roof Certification

Remedy: Clear out debris.

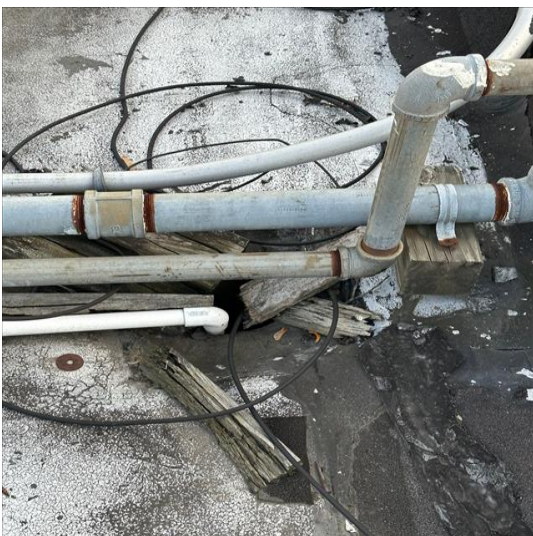
Image Number: 57

Observation: Severe debris build up and obstruction at a primary drain on the roof was observed at time of inspection. This may eventually cause damage to the surrounding roof structure due to slowing down the draining of water during a rainstorm which creates ponding and potential damage to the drain itself overtime from debris getting caught in the drain pipe.

Cause: Deferred maintenance.

Determination: Roof Replacement required for LeakFREE Roof Certification

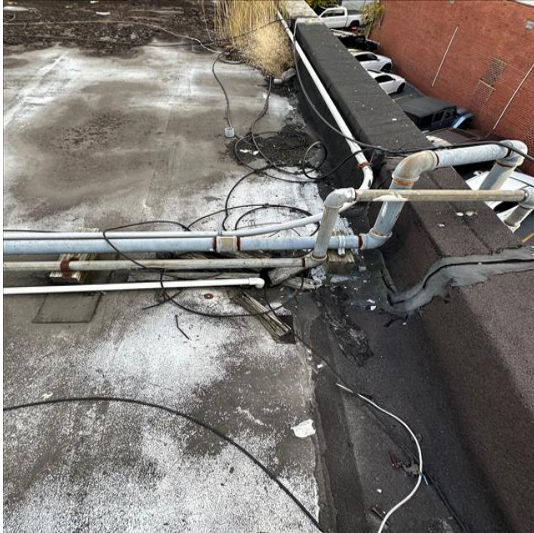
Image Number: 58

Observation: Severe debris build up and obstruction at a primary drain on the roof was observed at time of inspection. This may eventually cause damage to the surrounding roof structure due to slowing down the draining of water during a rainstorm which creates ponding and potential damage to the drain itself overtime from debris getting caught in the drain pipe.

Cause: Deferred maintenance.

Determination: Roof Replacement required for LeakFREE Roof Certification
