Inspection Date: 11/14/2023

LeakFREE® Roof Inspection

Report No :
129180

Property Inspected :
[REDACTED]
[REDACTED]

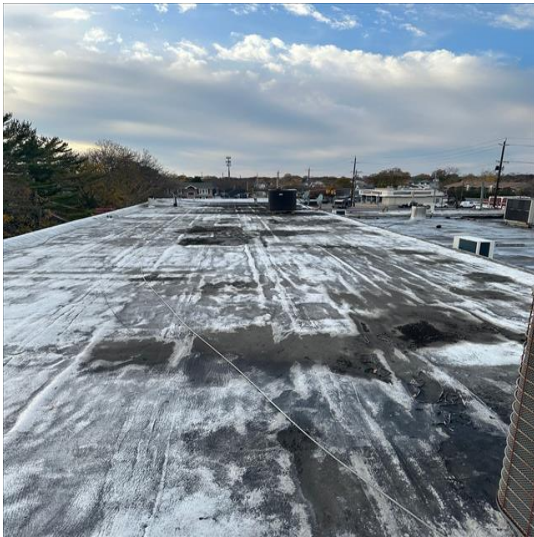
Image Number: 59

Observation: Ponding and alligatoring were observed on roof coverings at time of inspection. The ponding will cause damage to the roof structure overtime as it indicates this is where water sits for more than 72 hours at a time after it rains. The weight of the water is excessive and can cause damage. Alligatoring is the deterioration of the covering itself from UV rays, which creates excessive cracking and flaking of the covering, which accelerates deterioration.

Cause: Deferred maintenance.

Determination: Roof Replacement required for LeakFREE Roof Certification

Remedy: In areas with ponding, LWIC (light weight insulated concrete) can be used to create a minor pitch to direct water away from this area and towards a drain or scupper. This can be done during a roof replacement.

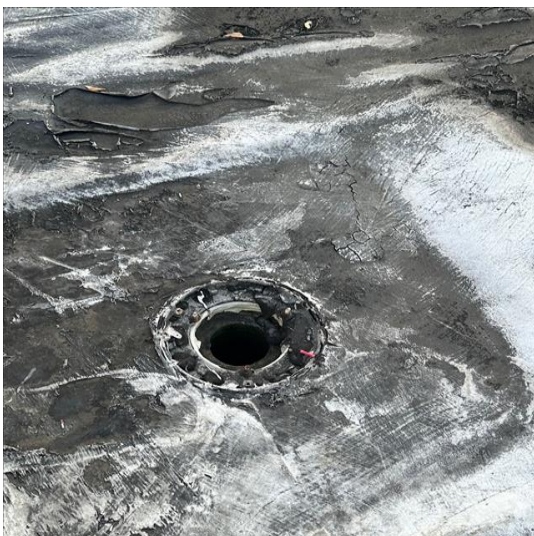
Image Number: 60

Observation: A primary drain was observed to be missing a drain screen at time of inspection. This is necessary to prevent debris and other materials from getting caught in the drain pipe and possibly causing damage or blockages.

Cause: Deferred maintenance.

Determination: Roof Replacement required for LeakFREE Roof Certification

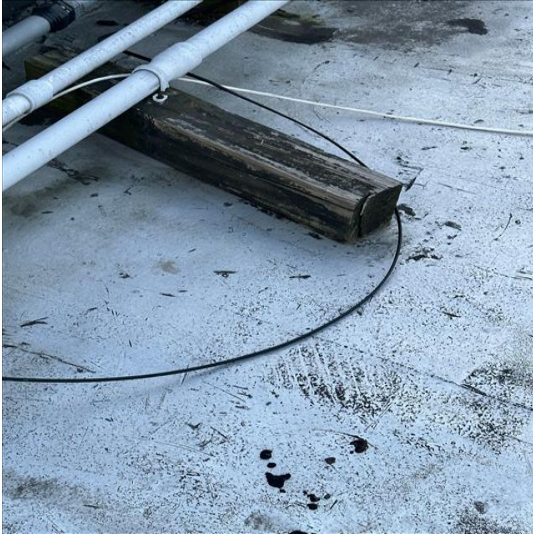
Image Number: 61

Observation: Items that were being used to chair or mount other objects on the roof were observed to not have proper padding underneath. This is important as laying the wood items or "chairs" on the roof material directly can further damage the roof coverings and accelerate deterioration.

Cause: Improper installation.

Determination: Roof Replacement required for LeakFREE Roof Certification

Remedy: Install walking mat padding under these items.

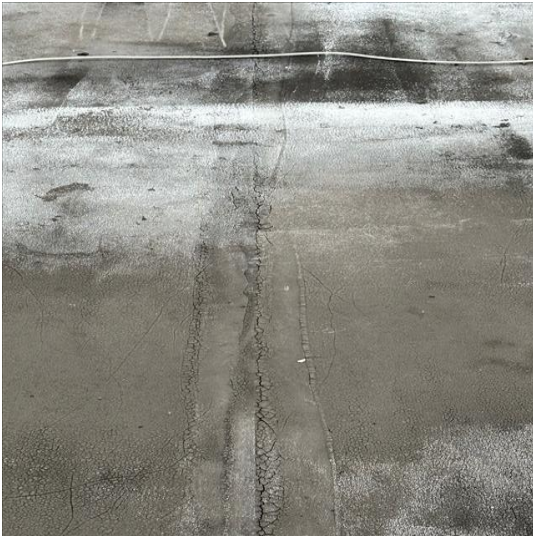
Image Number: 62

Observation: Cracking along lap seams in the roof were observed at time of inspection. This may eventually lead to moisture intrusion as the lap seam is naturally a weak spot as it is an area that is subject to exposure.

Cause: Deferred maintenance.

Determination: Roof Replacement required for LeakFREE Roof Certification

Remedy: Replacement or temporary sealant to prevent or slow down any further cracking and deterioration.

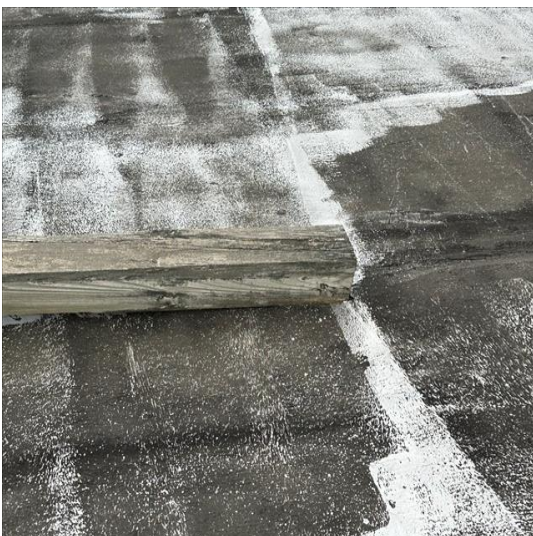
Image Number: 63

Observation: Items that were being used to chair or mount other objects on the roof were observed to not have proper padding underneath. This is important as laying the wood items or "chairs" on the roof material directly can further damage the roof coverings and accelerate deterioration.

Cause: Improper installation.

Determination: Roof Replacement required for LeakFREE Roof Certification

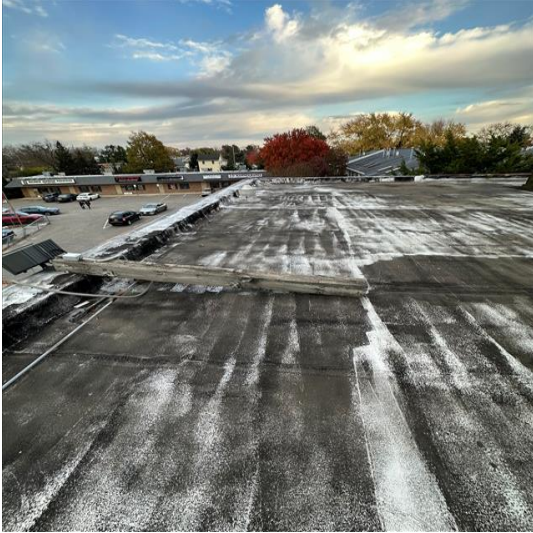
Image Number: 64

Observation: Items that were being used to chair or mount other objects on the roof were observed to not have proper padding underneath. This is important as laying the wood items or "chairs" on the roof material directly can further damage the roof coverings and accelerate deterioration.

Cause: Improper installation.

Determination: Roof Replacement required for LeakFREE Roof Certification

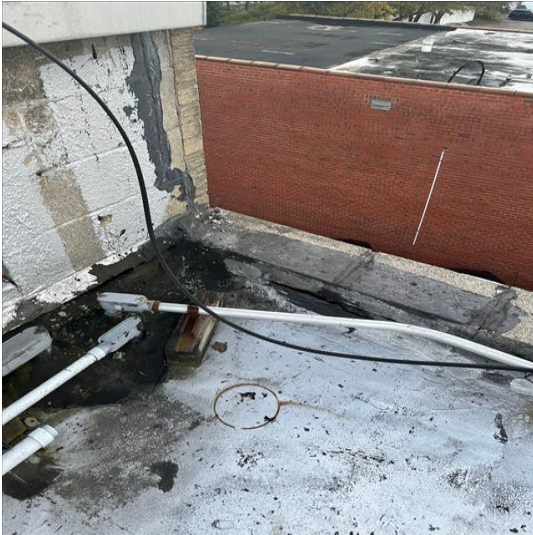
Image Number: 65

Observation: Gutter system on top roof appeared to be missing a downspout at time of inspection. Water was able to make direct contact with 2 primary points where water is able to build up. This was evident with signs of ponding and can accelerate deterioration of the roof structure and coverings over time.

Cause: Improper gutter install.

Determination: Roof Replacement required for LeakFREE Roof Certification

Remedy: Install downspouts to direct water to drains.

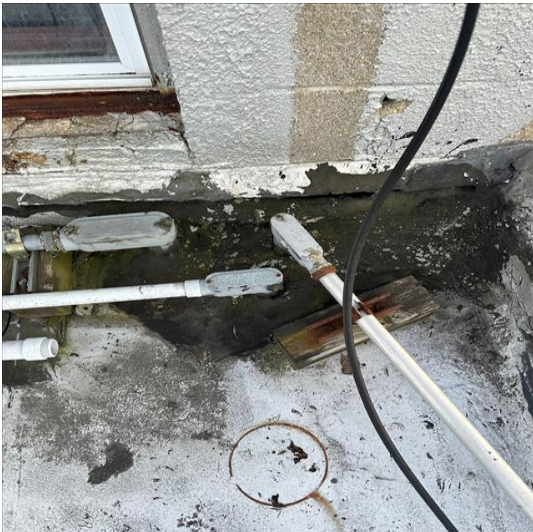
Image Number: 66

Observation: Gutter system on top roof appeared to be missing a downspout at time of inspection. Water was able to make direct contact with 2 primary points where water is able to build up. This was evident with signs of ponding and can accelerate deterioration of the roof structure and coverings over time.

Cause: Improper gutter install.

Determination: Roof Replacement required for LeakFREE Roof Certification

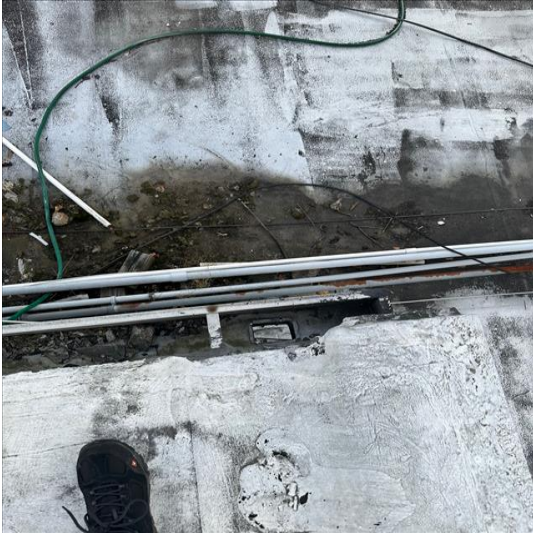
Image Number: 67

Observation: Gutter system on top roof appeared to be missing a downspout at time of inspection. Water was able to make direct contact with 2 primary points where water is able to build up. This was evident with signs of ponding and can accelerate deterioration of the roof structure and coverings over time.

Cause: Improper gutter install.

Determination: Roof Replacement required for LeakFREE Roof Certification

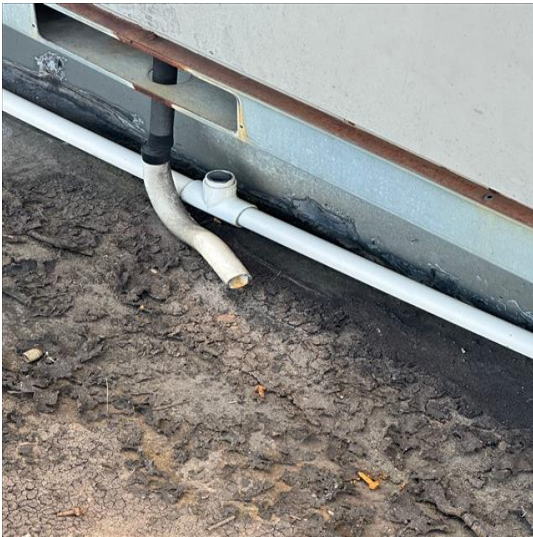
Image Number: 68

Observation: Condensate trap was observed to be incorrectly installed and can cause accelerated damage to this part of the roof coverings from constant exposure to moisture.

Cause: Poor workmanship.

Determination: Roof Replacement required for LeakFREE Roof Certification

Remedy: Replace condensate trap with correct pipe at correct height.

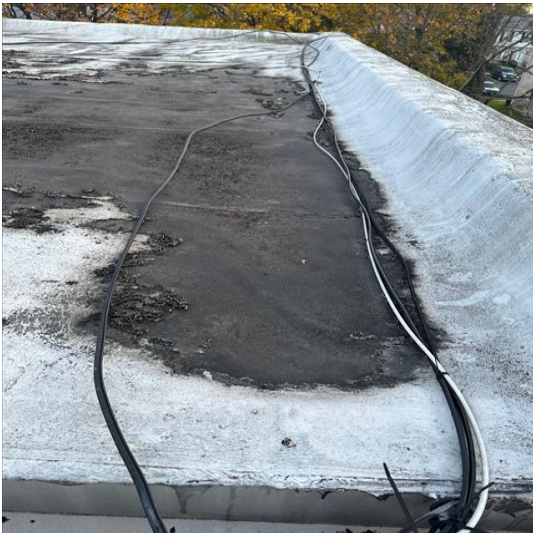
Image Number: 69

Observation: The following general deficiencies were observed on the roof covering at time of inspection; 1. Tenting of material 2. Soft spots in areas of the roof indicating weakened sheathing 3. Ponding 4. Vegetation Growth 5. Debris

Cause: Deferred maintenance.

Determination: Roof Replacement required for LeakFREE Roof Certification

Remedy: Recommend roof repair and clean up or replacement.

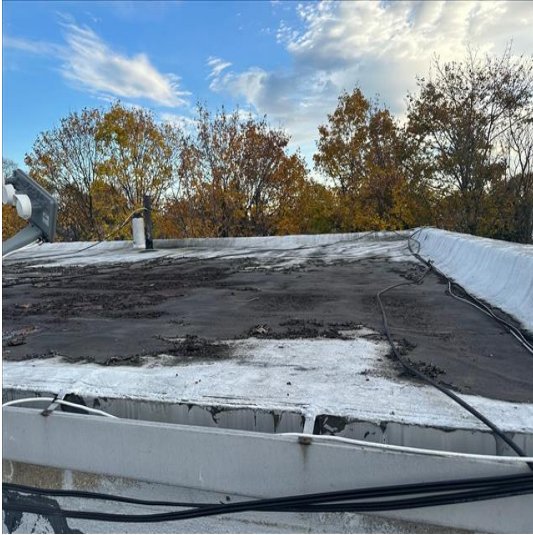
Image Number: 70

Observation: The following general deficiencies were observed on the roof covering at time of inspection; 1. Tenting of material 2. Soft spots in areas of the roof indicating weakened sheathing 3. Ponding 4. Vegetation Growth 5. Debris

Cause: Deferred maintenance.

Determination: Roof Replacement required for LeakFREE Roof Certification

Remedy: Recommend roof repair and clean up or replacement.

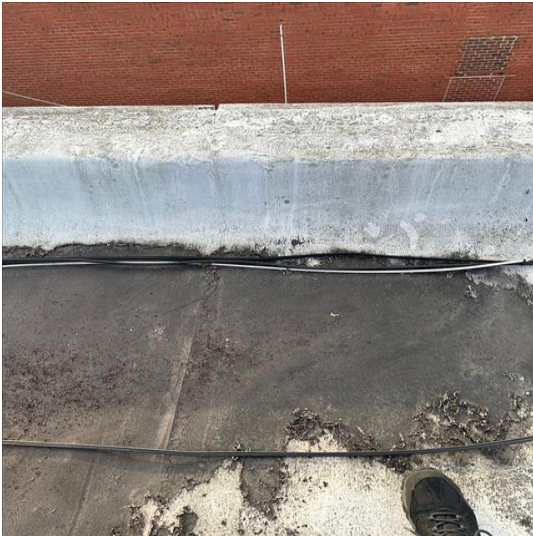
Image Number: 71

Observation: The following general deficiencies were observed on the roof covering at time of inspection; 1. Tenting of material 2. Soft spots in areas of the roof indicating weakened sheathing 3. Ponding 4. Vegetation Growth 5. Debris

Cause: Deferred maintenance.

Determination: Roof Replacement required for LeakFREE Roof Certification

Remedy: Recommend roof repair and clean up or replacement.

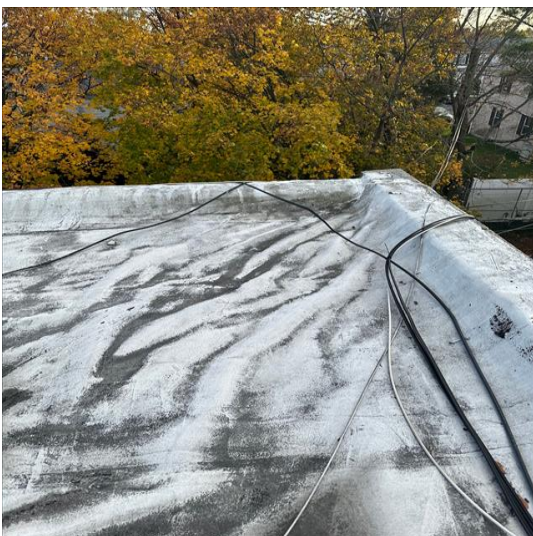
Image Number: 72

Observation: The following general deficiencies were observed on the roof covering at time of inspection; 1. Tenting of material 2. Soft spots in areas of the roof indicating weakened sheathing 3. Ponding 4. Vegetation Growth 5. Debris

Cause: Deferred maintenance.

Determination: Roof Replacement required for LeakFREE Roof Certification

Remedy: Recommend roof repair and clean up or replacement.

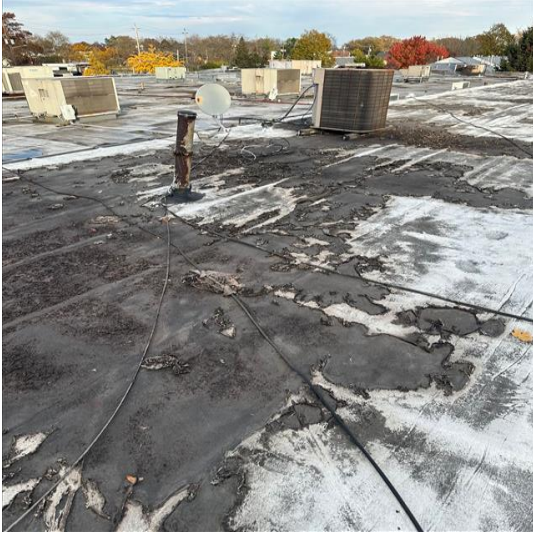
Image Number: 73

Observation: The following general deficiencies were observed on the roof covering at time of inspection; 1. Tenting of material 2. Soft spots in areas of the roof indicating weakened sheathing 3. Ponding 4. Vegetation Growth 5. Debris

Cause: Deferred maintenance.

Determination: Roof Replacement required for LeakFREE Roof Certification

Remedy: Recommend roof repair and clean up or replacement.

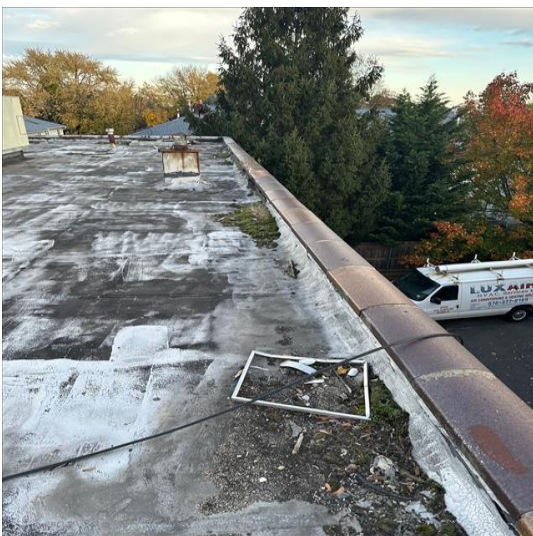
Image Number: 75

Observation: The following general deficiencies were observed on the roof covering at time of inspection; 1. Tenting of material 2. Soft spots in areas of the roof indicating weakened sheathing 3. Ponding 4. Vegetation Growth 5. Debris

Cause: Deferred maintenance.

Determination: Roof Replacement required for LeakFREE Roof Certification

Remedy: Recommend roof repair and clean up or replacement.

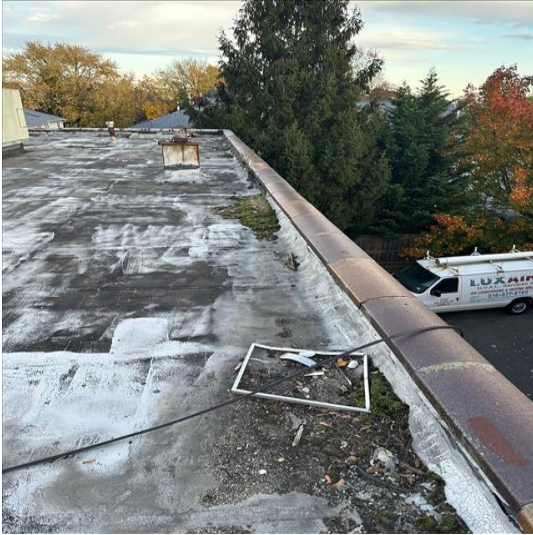
Image Number: 76

Observation: The following general deficiencies were observed on the roof covering at time of inspection; 1. Tenting of material 2. Soft spots in areas of the roof indicating weakened sheathing 3. Ponding 4. Vegetation Growth 5. Debris

Cause: Deferred maintenance.

Determination: Roof Replacement required for LeakFREE Roof Certification

Remedy: Recommend roof repair and clean up or replacement.

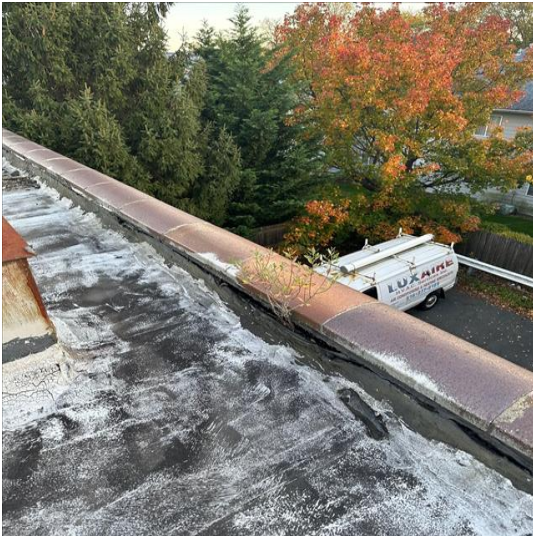
Image Number: 77

Observation: The following general deficiencies were observed on the roof covering at time of inspection; 1. Tenting of material 2. Soft spots in areas of the roof indicating weakened sheathing 3. Ponding 4. Vegetation Growth 5. Debris

Cause: Deferred maintenance.

Determination: Roof Replacement required for LeakFREE Roof Certification

Remedy: Recommend roof repair and clean up or replacement.

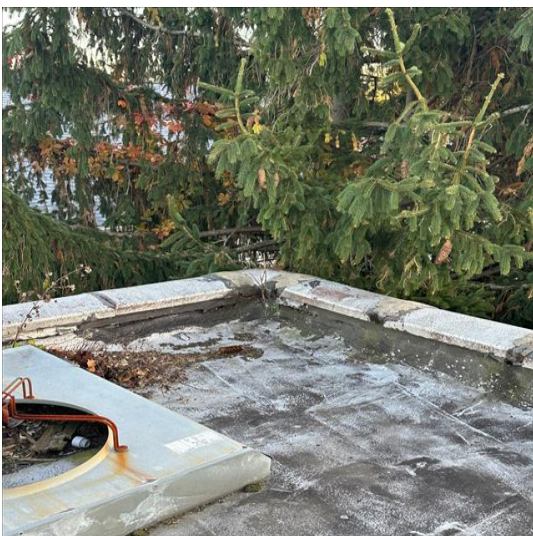
Image Number: 78

Observation: The following general deficiencies were observed on the roof covering at time of inspection; 1. Tenting of material 2. Soft spots in areas of the roof indicating weakened sheathing 3. Ponding 4. Vegetation Growth 5. Debris

Cause: Deferred maintenance.

Determination: Roof Replacement required for LeakFREE Roof Certification

Remedy: Recommend roof repair and clean up or replacement.

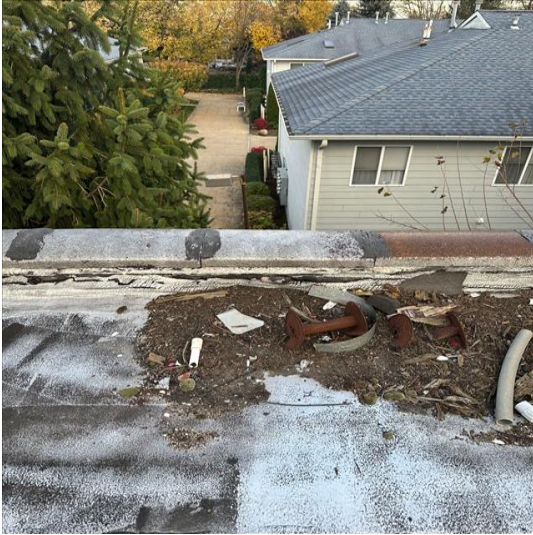
Image Number: 79

Observation: The following general deficiencies were observed on the roof covering at time of inspection; 1. Tenting of material 2. Soft spots in areas of the roof indicating weakened sheathing 3. Ponding 4. Vegetation Growth 5. Debris

Cause: Deferred maintenance.

Determination: Roof Replacement required for LeakFREE Roof Certification

Remedy: Recommend roof repair and clean up or replacement.

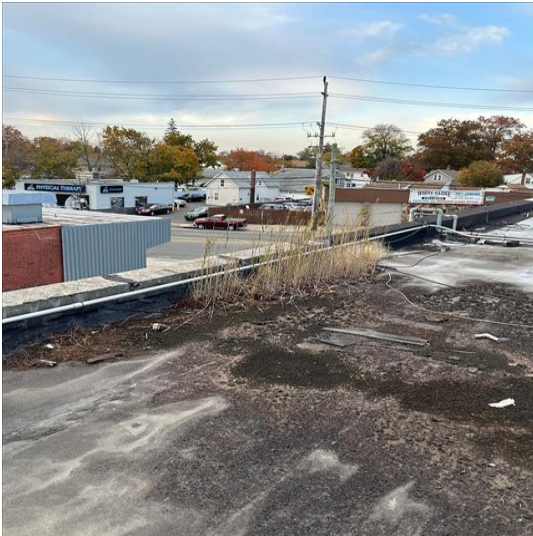
Image Number: 80

Observation: The following general deficiencies were observed on the roof covering at time of inspection; 1. Tenting of material 2. Soft spots in areas of the roof indicating weakened sheathing 3. Ponding 4. Vegetation Growth 5. Debris

Cause: Deferred maintenance.

Determination: Roof Replacement required for LeakFREE Roof Certification

Remedy: Recommend roof repair and clean up or replacement.

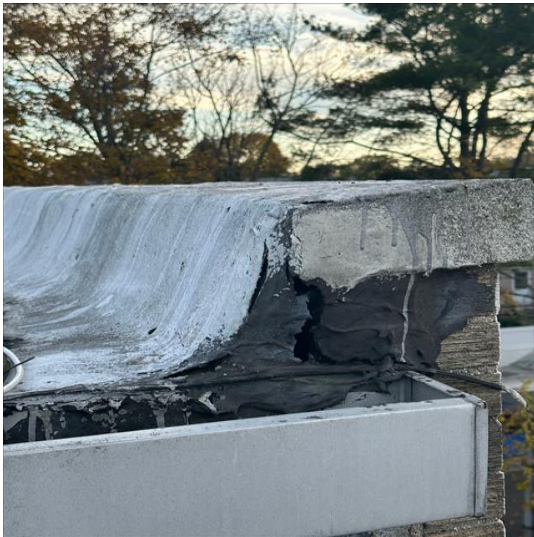
Image Number: 89

Observation: Damage to the coping metal or clay cap was noted in multiple areas at time of inspection. 1. Lap seams at the parapet wall in some places were not sealed or bonded properly and allowed for moisture intrusion. 2. In one area, coping tile caps were missing completely and allowed for the parapet CMU wall structure to be exposed. 3. Cracks and damage to sealant was observed at the coping tile and metal at multiple points, allowing for moisture intrusion.

Cause: Deferred maintenance.

Determination: Roof Replacement required for LeakFREE Roof Certification

Remedy: Repair and replace sections that were damaged at time of inspection. Failure to repair or replace will eventually lead to advanced deterioration of the parapet wall and surrounding roof structure.

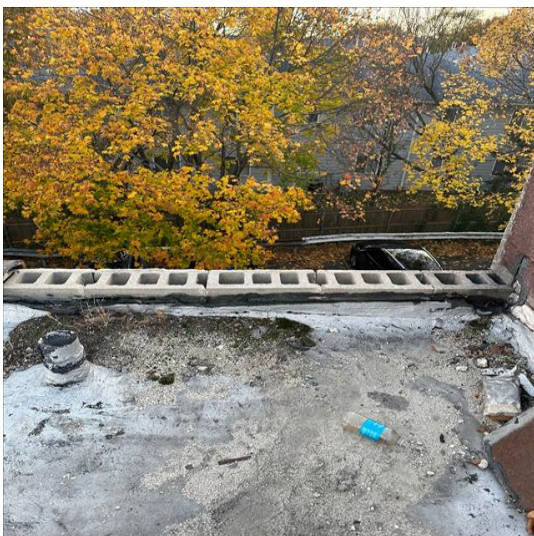
Image Number: 90

Observation: Damage to the coping metal or clay cap was noted in multiple areas at time of inspection. 1. Lap seams at the parapet wall in some places were not sealed or bonded properly and allowed for moisture intrusion. 2. In one area, coping tile caps were missing completely and allowed for the parapet CMU wall structure to be exposed. 3. Cracks and damage to sealant was observed at the coping tile and metal at multiple points, allowing for moisture intrusion.

Cause: Deferred maintenance.

Determination: Roof Replacement required for LeakFREE Roof Certification

Remedy: Repair and replace sections that were damaged at time of inspection. Failure to repair or replace will eventually lead to advanced deterioration of the parapet wall and surrounding roof structure.

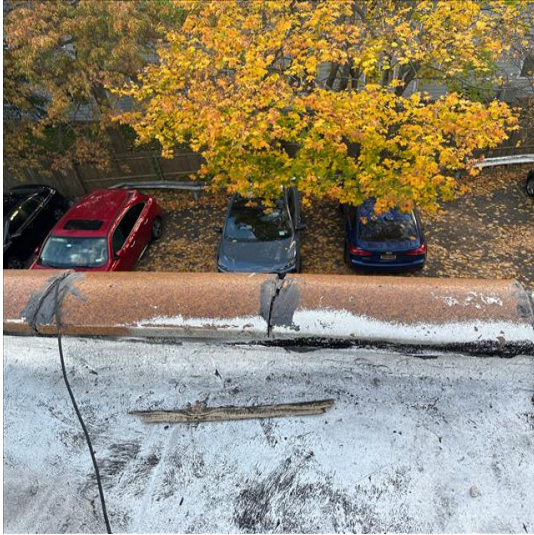
Image Number: 91

Observation: Damage to the coping metal or clay cap was noted in multiple areas at time of inspection. 1. Lap seams at the parapet wall in some places were not sealed or bonded properly and allowed for moisture intrusion. 2. In one area, coping tile caps were missing completely and allowed for the parapet CMU wall structure to be exposed. 3. Cracks and damage to sealant was observed at the coping tile and metal at multiple points, allowing for moisture intrusion.

Cause: Deferred maintenance.

Determination: Roof Replacement required for LeakFREE Roof Certification

Remedy: Repair and replace sections that were damaged at time of inspection. Failure to repair or replace will eventually lead to advanced deterioration of the parapet wall and surrounding roof structure.

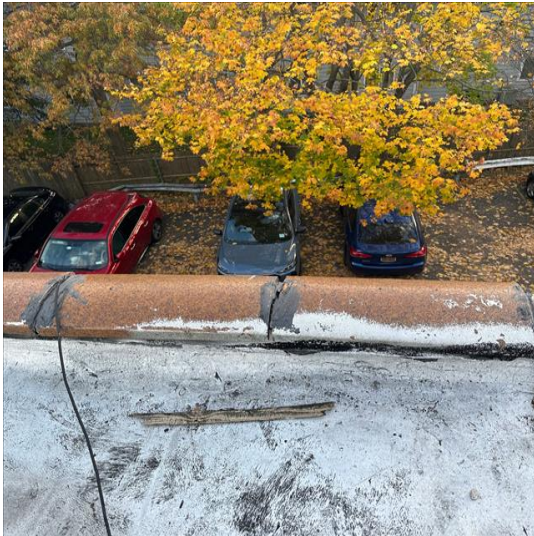
Image Number: 92

Observation: Damage to the coping metal or clay cap was noted in multiple areas at time of inspection. 1. Lap seams at the parapet wall in some places were not sealed or bonded properly and allowed for moisture intrusion. 2. In one area, coping tile caps were missing completely and allowed for the parapet CMU wall structure to be exposed. 3. Cracks and damage to sealant was observed at the coping tile and metal at multiple points, allowing for moisture intrusion.

Cause: Deferred maintenance.

Determination: Roof Replacement required for LeakFREE Roof Certification

Remedy: Repair and replace sections that were damaged at time of inspection. Failure to repair or replace will eventually lead to advanced deterioration of the parapet wall and surrounding roof structure.

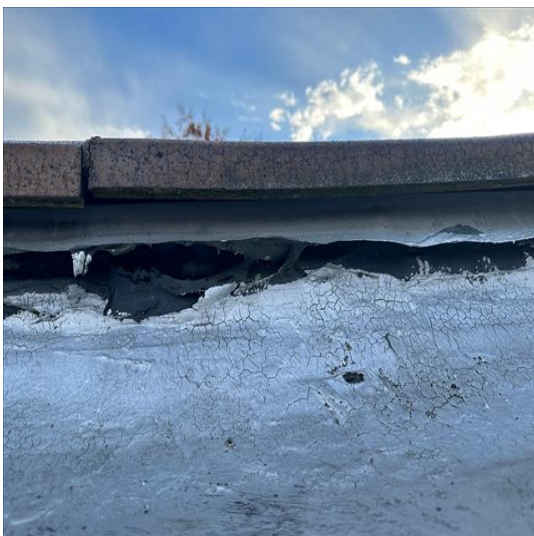
Image Number: 93

Observation: Damage to the coping metal or clay cap was noted in multiple areas at time of inspection. 1. Lap seams at the parapet wall in some places were not sealed or bonded properly and allowed for moisture intrusion. 2. In one area, coping tile caps were missing completely and allowed for the parapet CMU wall structure to be exposed. 3. Cracks and damage to sealant was observed at the coping tile and metal at multiple points, allowing for moisture intrusion.

Cause: Deferred maintenance.

Determination: Roof Replacement required for LeakFREE Roof Certification

Remedy: Repair and replace sections that were damaged at time of inspection. Failure to repair or replace will eventually lead to advanced deterioration of the parapet wall and surrounding roof structure.

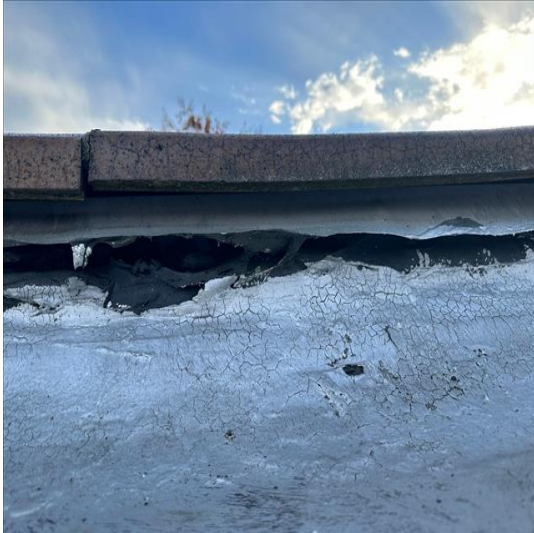
Image Number: 94

Observation: Damage to the coping metal or clay cap was noted in multiple areas at time of inspection. 1. Lap seams at the parapet wall in some places were not sealed or bonded properly and allowed for moisture intrusion. 2. In one area, coping tile caps were missing completely and allowed for the parapet CMU wall structure to be exposed. 3. Cracks and damage to sealant was observed at the coping tile and metal at multiple points, allowing for moisture intrusion.

Cause: Deferred maintenance.

Determination: Roof Replacement required for LeakFREE Roof Certification

Remedy: Repair and replace sections that were damaged at time of inspection. Failure to repair or replace will eventually lead to advanced deterioration of the parapet wall and surrounding roof structure.

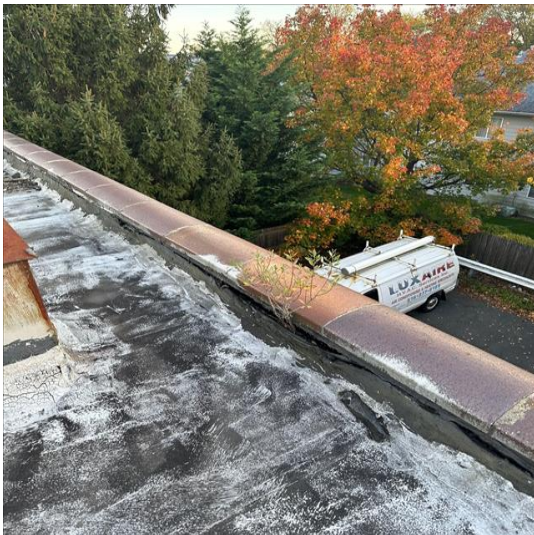
Image Number: 95

Observation: Damage to the coping metal or clay cap was noted in multiple areas at time of inspection. 1. Lap seams at the parapet wall in some places were not sealed or bonded properly and allowed for moisture intrusion. 2. In one area, coping tile caps were missing completely and allowed for the parapet CMU wall structure to be exposed. 3. Cracks and damage to sealant was observed at the coping tile and metal at multiple points, allowing for moisture intrusion.

Cause: Deferred maintenance.

Determination: Roof Replacement required for LeakFREE Roof Certification

Remedy: Repair and replace sections that were damaged at time of inspection. Failure to repair or replace will eventually lead to advanced deterioration of the parapet wall and surrounding roof structure.

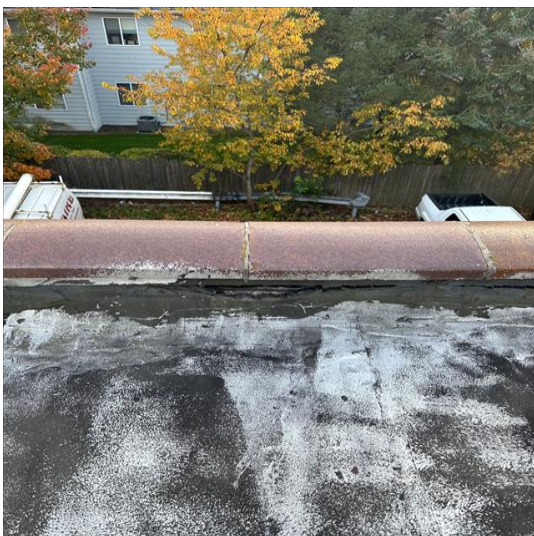
Image Number: 96

Observation: Damage to the coping metal or clay cap was noted in multiple areas at time of inspection. 1. Lap seams at the parapet wall in some places were not sealed or bonded properly and allowed for moisture intrusion. 2. In one area, coping tile caps were missing completely and allowed for the parapet CMU wall structure to be exposed. 3. Cracks and damage to sealant was observed at the coping tile and metal at multiple points, allowing for moisture intrusion.

Cause: Deferred maintenance.

Determination: Roof Replacement required for LeakFREE Roof Certification

Remedy: Repair and replace sections that were damaged at time of inspection. Failure to repair or replace will eventually lead to advanced deterioration of the parapet wall and surrounding roof structure.

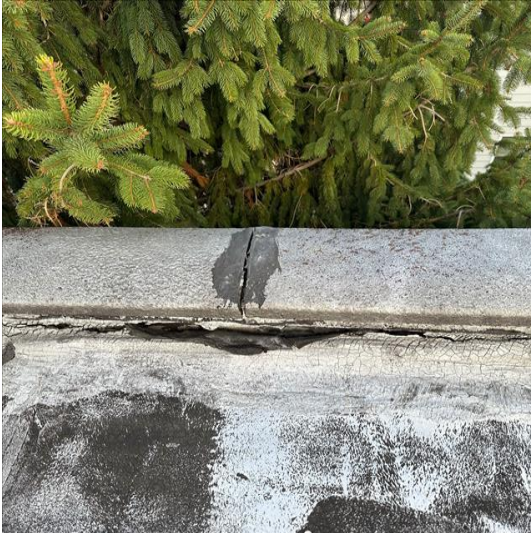
Image Number: 97

Observation: Damage to the coping metal or clay cap was noted in multiple areas at time of inspection. 1. Lap seams at the parapet wall in some places were not sealed or bonded properly and allowed for moisture intrusion. 2. In one area, coping tile caps were missing completely and allowed for the parapet CMU wall structure to be exposed. 3. Cracks and damage to sealant was observed at the coping tile and metal at multiple points, allowing for moisture intrusion.

Cause: Deferred maintenance.

Determination: Roof Replacement required for LeakFREE Roof Certification

Remedy: Repair and replace sections that were damaged at time of inspection. Failure to repair or replace will eventually lead to advanced deterioration of the parapet wall and surrounding roof structure.

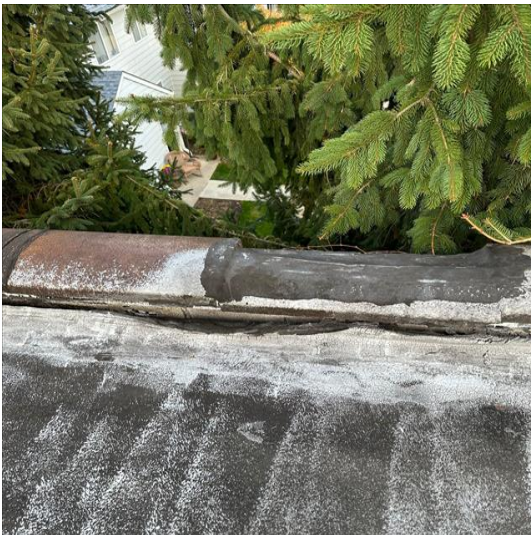
Image Number: 98

Observation: Damage to the coping metal or clay cap was noted in multiple areas at time of inspection. 1. Lap seams at the parapet wall in some places were not sealed or bonded properly and allowed for moisture intrusion. 2. In one area, coping tile caps were missing completely and allowed for the parapet CMU wall structure to be exposed. 3. Cracks and damage to sealant was observed at the coping tile and metal at multiple points, allowing for moisture intrusion.

Cause: Deferred maintenance.

Determination: Roof Replacement required for LeakFREE Roof Certification

Remedy: Repair and replace sections that were damaged at time of inspection. Failure to repair or replace will eventually lead to advanced deterioration of the parapet wall and surrounding roof structure.

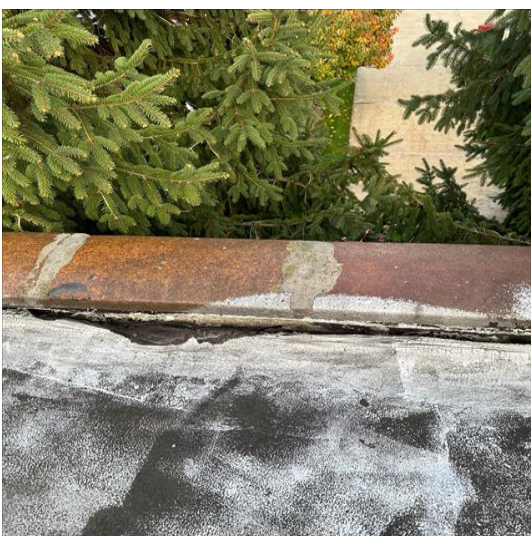
Image Number: 99

Observation: Damage to the coping metal or clay cap was noted in multiple areas at time of inspection. 1. Lap seams at the parapet wall in some places were not sealed or bonded properly and allowed for moisture intrusion. 2. In one area, coping tile caps were missing completely and allowed for the parapet CMU wall structure to be exposed. 3. Cracks and damage to sealant was observed at the coping tile and metal at multiple points, allowing for moisture intrusion.

Cause: Deferred maintenance.

Determination: Roof Replacement required for LeakFREE Roof Certification

Remedy: Repair and replace sections that were damaged at time of inspection. Failure to repair or replace will eventually lead to advanced deterioration of the parapet wall and surrounding roof structure.

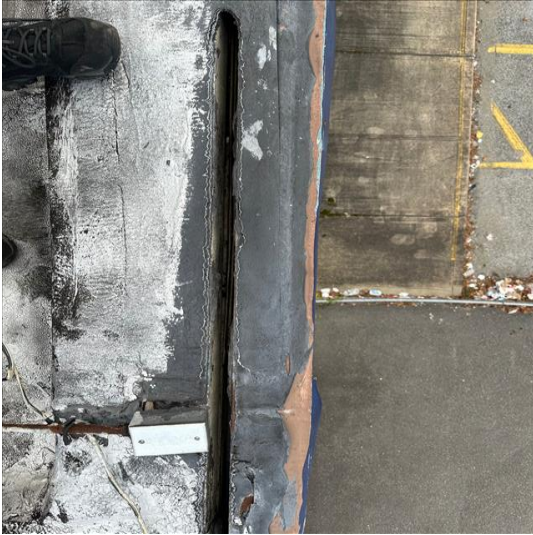
Image Number: 100

Observation: The coping of the parapet wall was not complete in some sections of the roof. The space between the brick veneer wall and the structure was exposed from the top. The space you see is how the building is designed, as it allows a space for water and dampness to dry out. However it is not meant to be exposed and should be covered with a coping metal or material to prevent exposure.

Cause: Improper installation.

Determination: Roof Replacement required for LeakFREE Roof Certification

Remedy: Install coping metal or cap.

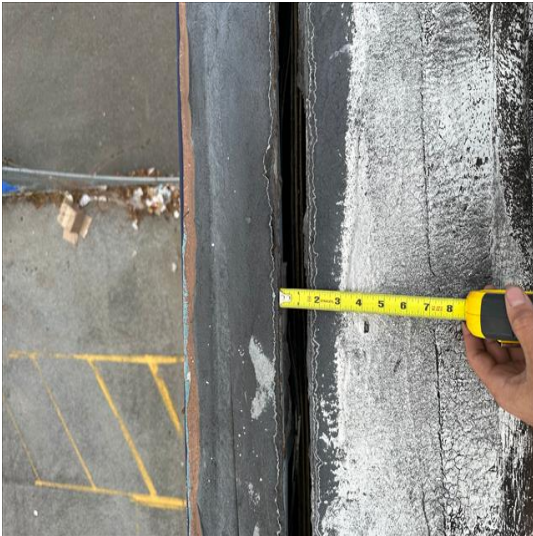
Image Number: 101

Observation: The coping of the parapet wall was not complete in some sections of the roof. The space between the brick veneer wall and the structure was exposed from the top. The space you see is how the building is designed, as it allows a space for water and dampness to dry out. However it is not meant to be exposed and should be covered with a coping metal or material to prevent exposure.

Cause: Improper installation.

Determination: Roof Replacement required for LeakFREE Roof Certification

Remedy: Install coping metal or cap.

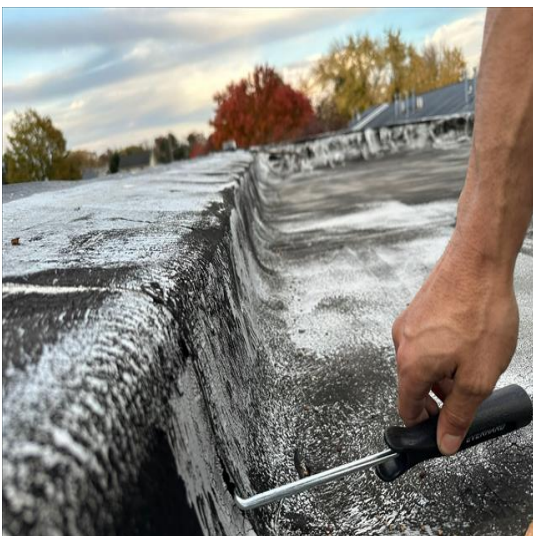
Image Number: 102

Observation: Damage to the coping metal or clay cap was noted in multiple areas at time of inspection. 1. Lap seams at the parapet wall in some places were not sealed or bonded properly and allowed for moisture intrusion. 2. In one area, coping tile caps were missing completely and allowed for the parapet CMU wall structure to be exposed. 3. Cracks and damage to sealant was observed at the coping tile and metal at multiple points, allowing for moisture intrusion.

Cause: Deferred maintenance.

Determination: Roof Replacement required for LeakFREE Roof Certification

Remedy: Repair and replace sections that were damaged at time of inspection. Failure to repair or replace will eventually lead to advanced deterioration of the parapet wall and surrounding roof structure.

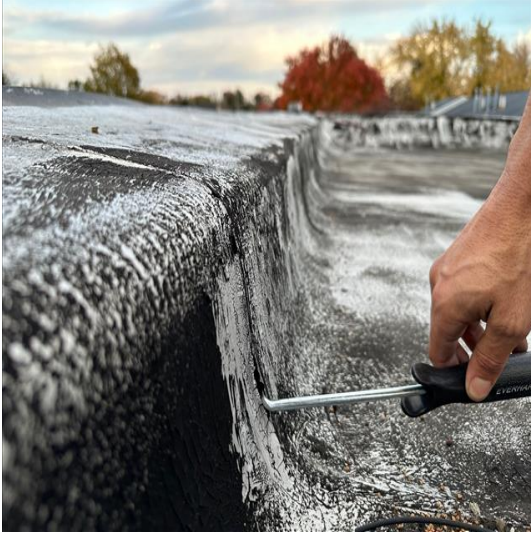
Image Number: 103

Observation: Damage to the coping metal or clay cap was noted in multiple areas at time of inspection. 1. Lap seams at the parapet wall in some places were not sealed or bonded properly and allowed for moisture intrusion. 2. In one area, coping tile caps were missing completely and allowed for the parapet CMU wall structure to be exposed. 3. Cracks and damage to sealant was observed at the coping tile and metal at multiple points, allowing for moisture intrusion.

Cause: Deferred maintenance.

Determination: Roof Replacement required for LeakFREE Roof Certification

Remedy: Repair and replace sections that were damaged at time of inspection. Failure to repair or replace will eventually lead to advanced deterioration of the parapet wall and surrounding roof structure.

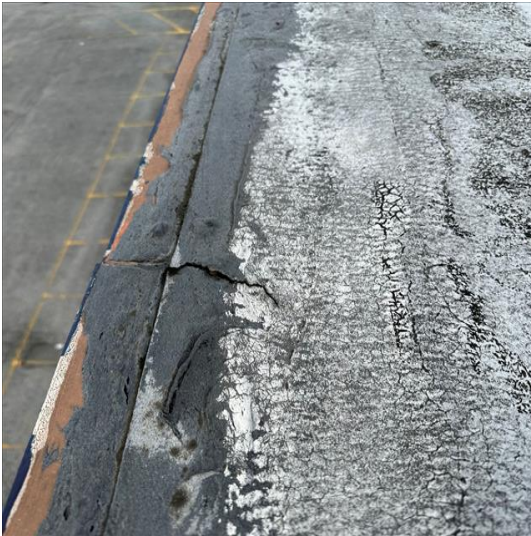
Image Number: 104

Observation: Damage to the coping metal or clay cap was noted in multiple areas at time of inspection. 1. Lap seams at the parapet wall in some places were not sealed or bonded properly and allowed for moisture intrusion. 2. In one area, coping tile caps were missing completely and allowed for the parapet CMU wall structure to be exposed. 3. Cracks and damage to sealant was observed at the coping tile and metal at multiple points, allowing for moisture intrusion.

Cause: Deferred maintenance.

Determination: Roof Replacement required for LeakFREE Roof Certification

Remedy: Repair and replace sections that were damaged at time of inspection. Failure to repair or replace will eventually lead to advanced deterioration of the parapet wall and surrounding roof structure.

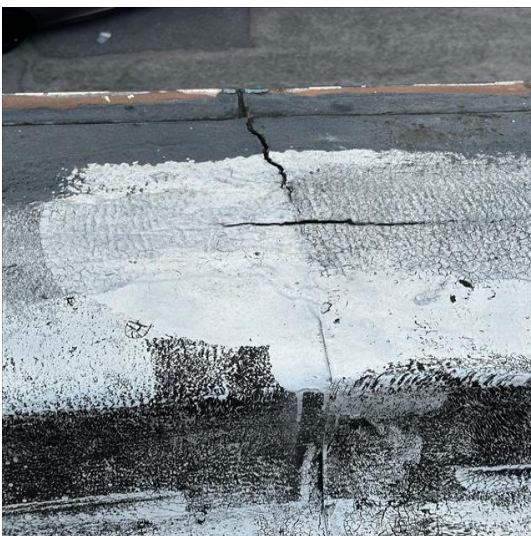
Image Number: 105

Observation: Damage to the coping metal or clay cap was noted in multiple areas at time of inspection. 1. Lap seams at the parapet wall in some places were not sealed or bonded properly and allowed for moisture intrusion. 2. In one area, coping tile caps were missing completely and allowed for the parapet CMU wall structure to be exposed. 3. Cracks and damage to sealant was observed at the coping tile and metal at multiple points, allowing for moisture intrusion.

Cause: Deferred maintenance.

Determination: Roof Replacement required for LeakFREE Roof Certification

Remedy: Repair and replace sections that were damaged at time of inspection. Failure to repair or replace will eventually lead to advanced deterioration of the parapet wall and surrounding roof structure.

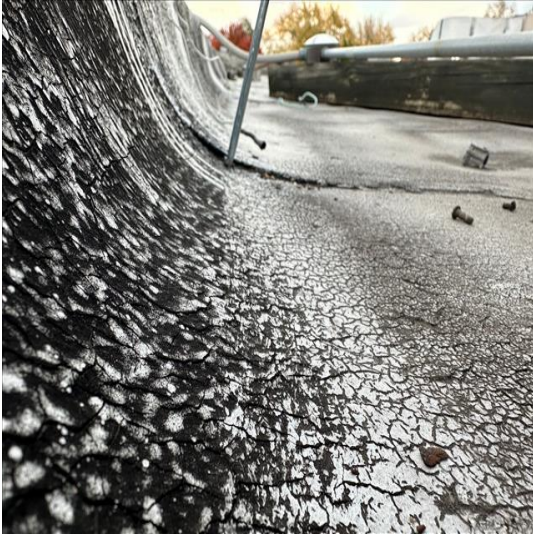
Image Number: 106

Observation: Damage to the coping metal or clay cap was noted in multiple areas at time of inspection. 1. Lap seams at the parapet wall in some places were not sealed or bonded properly and allowed for moisture intrusion. 2. In one area, coping tile caps were missing completely and allowed for the parapet CMU wall structure to be exposed. 3. Cracks and damage to sealant was observed at the coping tile and metal at multiple points, allowing for moisture intrusion.

Cause: Deferred maintenance.

Determination: Roof Replacement required for LeakFREE Roof Certification

Remedy: Repair and replace sections that were damaged at time of inspection. Failure to repair or replace will eventually lead to advanced deterioration of the parapet wall and surrounding roof structure.

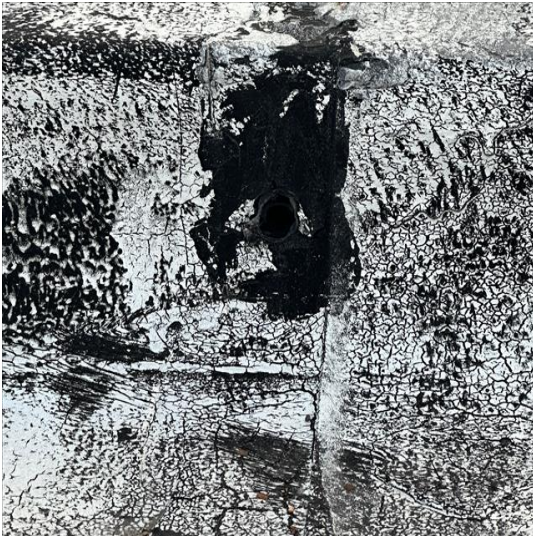
Image Number: 107

Observation: There was a hole observed on the parapet wall. This will allow for moisture intrusion and will contribute to accelerated deterioration of the area.

Cause: Cannot be determined.

Determination: Roof Replacement required for LeakFREE Roof Certification

Remedy: Seal hole.

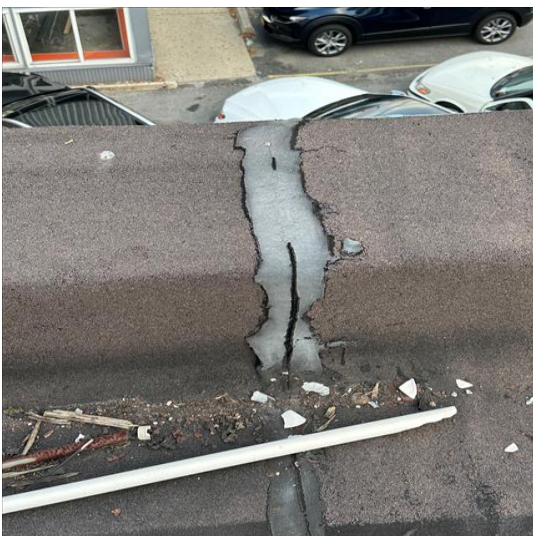
Image Number: 108

Observation: Damage to the coping metal or clay cap was noted in multiple areas at time of inspection. 1. Lap seams at the parapet wall in some places were not sealed or bonded properly and allowed for moisture intrusion. 2. In one area, coping tile caps were missing completely and allowed for the parapet CMU wall structure to be exposed. 3. Cracks and damage to sealant was observed at the coping tile and metal at multiple points, allowing for moisture intrusion.

Cause: Deferred maintenance.

Determination: Roof Replacement required for LeakFREE Roof Certification

Remedy: Repair and replace sections that were damaged at time of inspection. Failure to repair or replace will eventually lead to advanced deterioration of the parapet wall and surrounding roof structure.

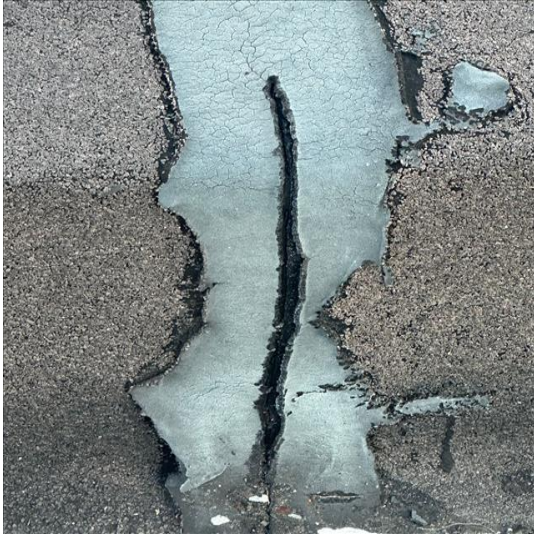
Image Number: 109

Observation: Damage to the coping metal or clay cap was noted in multiple areas at time of inspection. 1. Lap seams at the parapet wall in some places were not sealed or bonded properly and allowed for moisture intrusion. 2. In one area, coping tile caps were missing completely and allowed for the parapet CMU wall structure to be exposed. 3. Cracks and damage to sealant was observed at the coping tile and metal at multiple points, allowing for moisture intrusion.

Cause: Deferred maintenance.

Determination: Roof Replacement required for LeakFREE Roof Certification

Remedy: Repair and replace sections that were damaged at time of inspection. Failure to repair or replace will eventually lead to advanced deterioration of the parapet wall and surrounding roof structure.

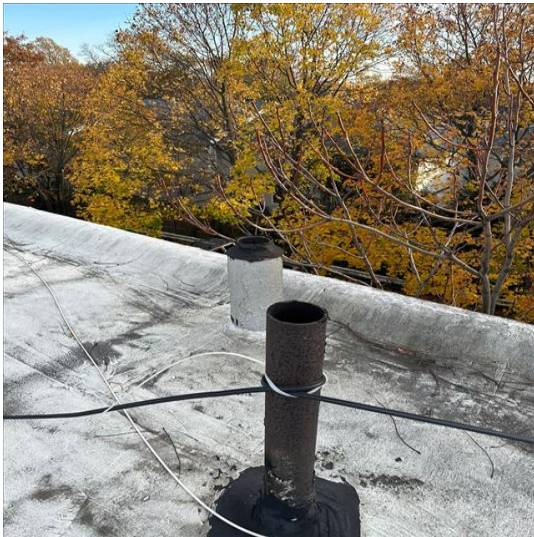
Image Number: 110

Observation: Most vent pipes on roof were observed to be missing a rain cap for the vent pipe and/or needed flashing and sealant to be replaced as it was aging. In some cases, a bucket was used as a rain cap. This can be an issue down the road as the bucket will deteriorate and break down, causing pieces to break off and get stuck in the vent pipes.

Cause: Deferred maintenance.

Determination: Roof Replacement required for LeakFREE Roof Certification

Remedy: Replace outdated rain caps, flashing and sealant. Remove buckets and replace with appropriate rain cap to prevent damage.

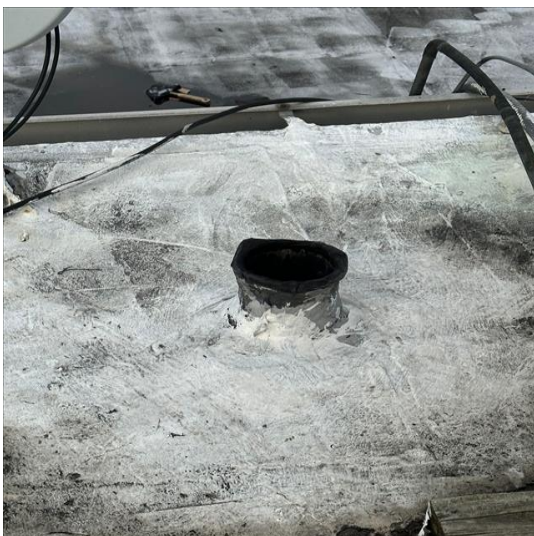
Image Number: 111

Observation: Most vent pipes on roof were observed to be missing a rain cap for the vent pipe and/or needed flashing and sealant to be replaced as it was aging. In some cases, a bucket was used as a rain cap. This can be an issue down the road as the bucket will deteriorate and break down, causing pieces to break off and get stuck in the vent pipes.

Cause: Deferred maintenance.

Determination: Roof Replacement required for LeakFREE Roof Certification

Remedy: Replace outdated rain caps, flashing and sealant. Remove buckets and replace with appropriate rain cap to prevent damage.

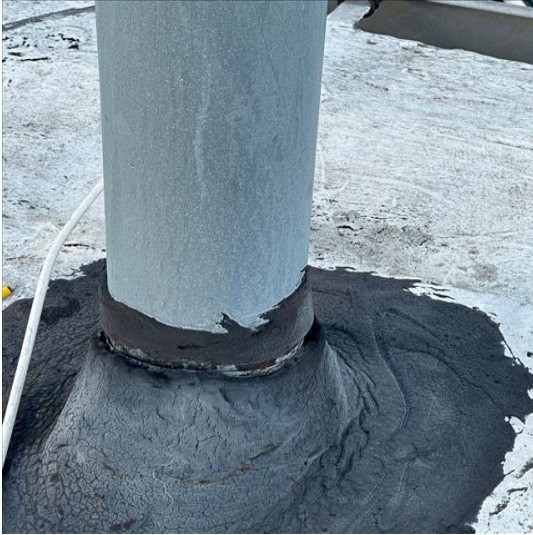
Image Number: 112

Observation: Most vent pipes on roof were observed to be missing a rain cap for the vent pipe and/or needed flashing and sealant to be replaced as it was aging. In some cases, a bucket was used as a rain cap. This can be an issue down the road as the bucket will deteriorate and break down, causing pieces to break off and get stuck in the vent pipes.

Cause: Deferred maintenance.

Determination: Roof Replacement required for LeakFREE Roof Certification

Remedy: Replace outdated rain caps, flashing and sealant. Remove buckets and replace with appropriate rain cap to prevent damage.

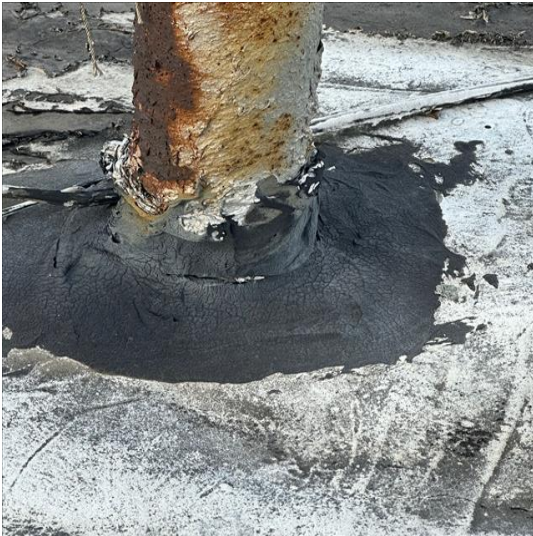
Image Number: 113

Observation: Most vent pipes on roof were observed to be missing a rain cap for the vent pipe and/or needed flashing and sealant to be replaced as it was aging. In some cases, a bucket was used as a rain cap. This can be an issue down the road as the bucket will deteriorate and break down, causing pieces to break off and get stuck in the vent pipes.

Cause: Deferred maintenance.

Determination: Roof Replacement required for LeakFREE Roof Certification

Remedy: Replace outdated rain caps, flashing and sealant. Remove buckets and replace with appropriate rain cap to prevent damage.

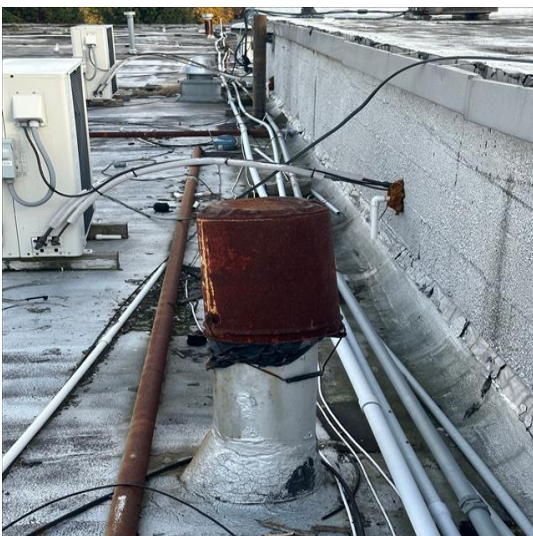
Image Number: 114

Observation: Most vent pipes on roof were observed to be missing a rain cap for the vent pipe and/or needed flashing and sealant to be replaced as it was aging. In some cases, a bucket was used as a rain cap. This can be an issue down the road as the bucket will deteriorate and break down, causing pieces to break off and get stuck in the vent pipes.

Cause: Deferred maintenance.

Determination: Roof Replacement required for LeakFREE Roof Certification

Remedy: Replace outdated rain caps, flashing and sealant. Remove buckets and replace with appropriate rain cap to prevent damage.

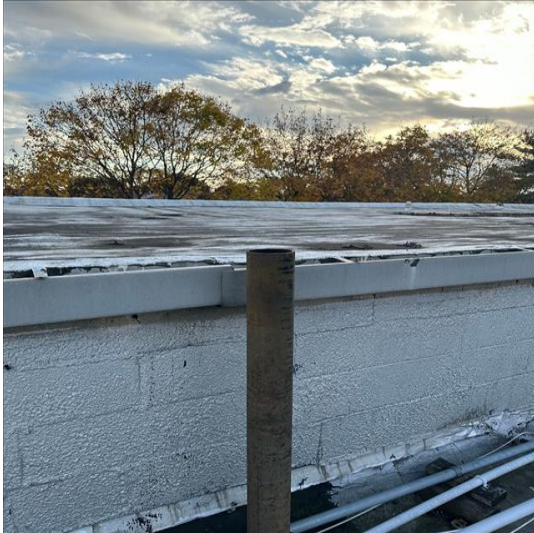
Image Number: 115

Observation: Most vent pipes on roof were observed to be missing a rain cap for the vent pipe and/or needed flashing and sealant to be replaced as it was aging. In some cases, a bucket was used as a rain cap. This can be an issue down the road as the bucket will deteriorate and break down, causing pieces to break off and get stuck in the vent pipes.

Cause: Deferred maintenance.

Determination: Roof Replacement required for LeakFREE Roof Certification

Remedy: Replace outdated rain caps, flashing and sealant. Remove buckets and replace with appropriate rain cap to prevent damage.

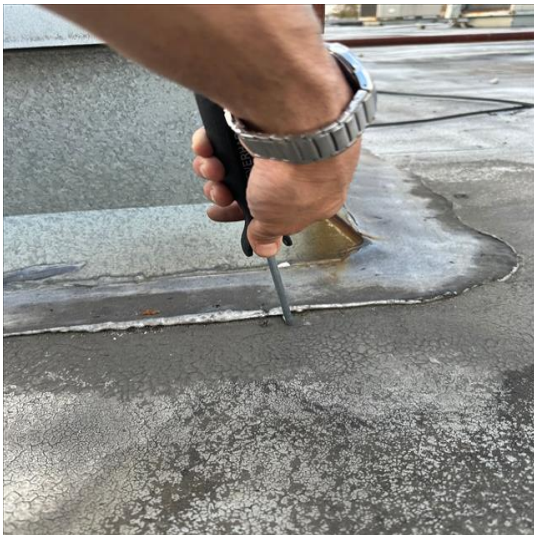
Image Number: 116

Observation: The following observations were made regarding the roof penetrations and rooftop units at the time of inspection. It should also be noted that 90% of the leaks found within the interior of the building can be traced to these units and the installation methods that took place. The following was noted; 1. Improper, failing or missing flashing at the rooftop penetrations and rooftop units. 2. Missing curbs (these are necessary for any rooftop unit, as it prevents moisture intrusion). 3. Units were not chaired on rooftop and are laying directly on roof coverings. 4. Sealant at almost all penetrations was damaged and in need of replacement. * NOTE * The interior photos within the ceiling area that show moisture stains on the ducts and the wall are consistent with the rooftop units location and observations made in this report.

Cause: 1. Deferred maintenance and improper installation. 2 & 3. Improper installation, poor workmanship. 4. Deferred maintenance.

Determination: Roof Replacement required for LeakFREE Roof Certification

Remedy: Recommend a licensed HVAC technician evaluate units and issue remedy for mounting units correctly to prevent any further damage. When roof replacement is to commence, these units will need to be chaired, installed and flashed properly.
