Inspection Date: 11/14/2023

LeakFREE® Roof Inspection

Report No :
129180

Property Inspected :
[REDACTED]
[REDACTED]

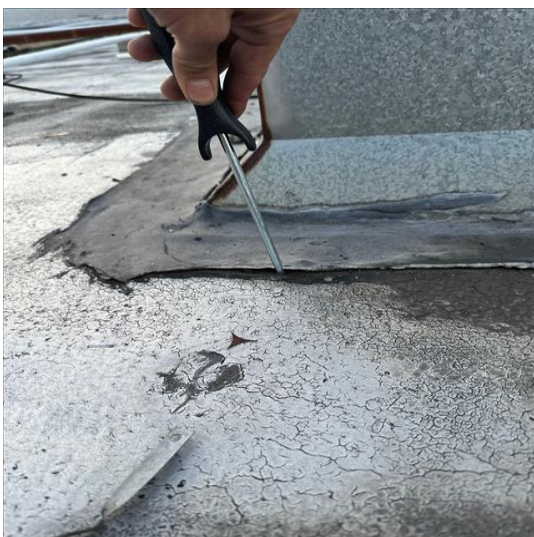
Image Number: 117

Observation: The following observations were made regarding the roof penetrations and rooftop units at the time of inspection. It should also be noted that 90% of the leaks found within the interior of the building can be traced to these units and the installation methods that took place. The following was noted; 1. Improper, failing or missing flashing at the rooftop penetrations and rooftop units. 2. Missing curbs (these are necessary for any rooftop unit, as it prevents moisture intrusion). 3. Units were not chaired on rooftop and are laying directly on roof coverings. 4. Sealant at almost all penetrations was damaged and in need of replacement. * NOTE * The interior photos within the ceiling area that show moisture stains on the ducts and the wall are consistent with the rooftop units location and observations made in this report.

Cause: 1. Deferred maintenance and improper installation. 2 & 3. Improper installation, poor workmanship. 4. Deferred maintenance.

Determination: Roof Replacement required for LeakFREE Roof Certification

Remedy: Recommend a licensed HVAC technician evaluate units and issue remedy for mounting units correctly to prevent any further damage. When roof replacement is to commence, these units will need to be chaired, installed and flashed properly.

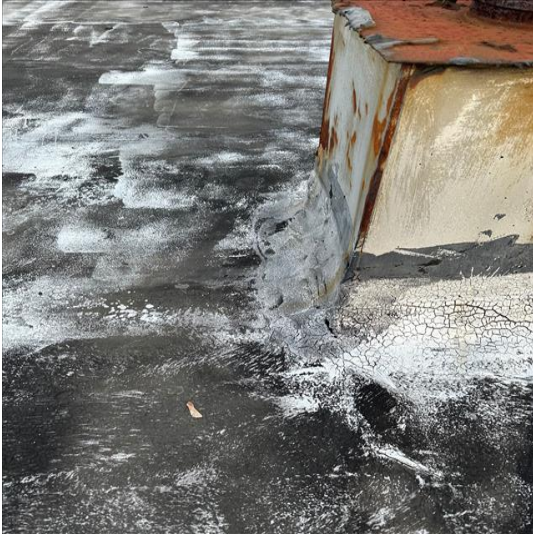
Image Number: 118

Observation: The following observations were made regarding the roof penetrations and rooftop units at the time of inspection. It should also be noted that 90% of the leaks found within the interior of the building can be traced to these units and the installation methods that took place. The following was noted; 1. Improper, failing or missing flashing at the rooftop penetrations and rooftop units. 2. Missing curbs (these are necessary for any rooftop unit, as it prevents moisture intrusion). 3. Units were not chaired on rooftop and are laying directly on roof coverings. 4. Sealant at almost all penetrations was damaged and in need of replacement. * NOTE * The interior photos within the ceiling area that show moisture stains on the ducts and the wall are consistent with the rooftop units location and observations made in this report.

Cause: 1. Deferred maintenance and improper installation. 2 & 3. Improper installation, poor workmanship. 4. Deferred maintenance.

Determination: Roof Replacement required for LeakFREE Roof Certification

Remedy: Recommend a licensed HVAC technician evaluate units and issue remedy for mounting units correctly to prevent any further damage. When roof replacement is to commence, these units will need to be chaired, installed and flashed properly.

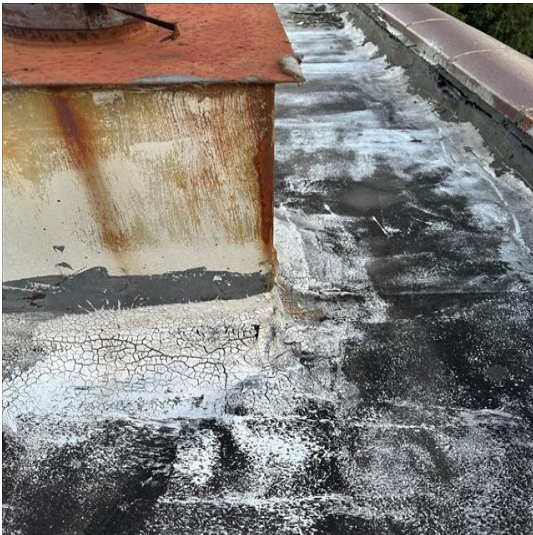
Image Number: 119

Observation: The following observations were made regarding the roof penetrations and rooftop units at the time of inspection. It should also be noted that 90% of the leaks found within the interior of the building can be traced to these units and the installation methods that took place. The following was noted; 1. Improper, failing or missing flashing at the rooftop penetrations and rooftop units. 2. Missing curbs (these are necessary for any rooftop unit, as it prevents moisture intrusion). 3. Units were not chaired on rooftop and are laying directly on roof coverings. 4. Sealant at almost all penetrations was damaged and in need of replacement. * NOTE * The interior photos within the ceiling area that show moisture stains on the ducts and the wall are consistent with the rooftop units location and observations made in this report.

Cause: 1. Deferred maintenance and improper installation. 2 & 3. Improper installation, poor workmanship. 4. Deferred maintenance.

Determination: Roof Replacement required for LeakFREE Roof Certification

Remedy: Recommend a licensed HVAC technician evaluate units and issue remedy for mounting units correctly to prevent any further damage. When roof replacement is to commence, these units will need to be chaired, installed and flashed properly.

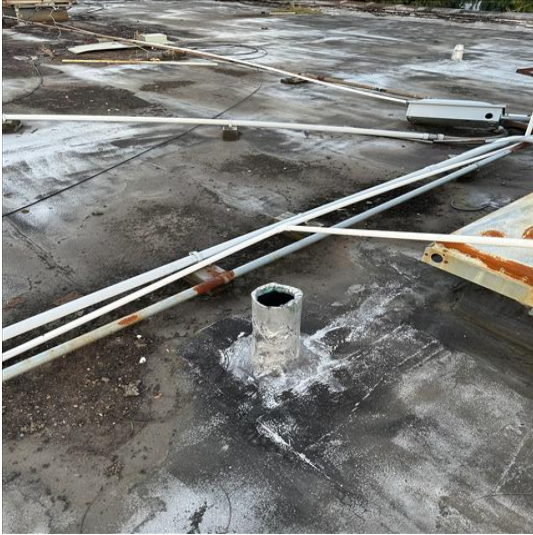
Image Number: 120

Observation: Most vent pipes on roof were observed to be missing a rain cap for the vent pipe and/or needed flashing and sealant to be replaced as it was aging. In some cases, a bucket was used as a rain cap. This can be an issue down the road as the bucket will deteriorate and break down, causing pieces to break off and get stuck in the vent pipes.

Cause: Deferred maintenance.

Determination: Roof Replacement required for LeakFREE Roof Certification

Remedy: Replace outdated rain caps, flashing and sealant. Remove buckets and replace with appropriate rain cap to prevent damage.

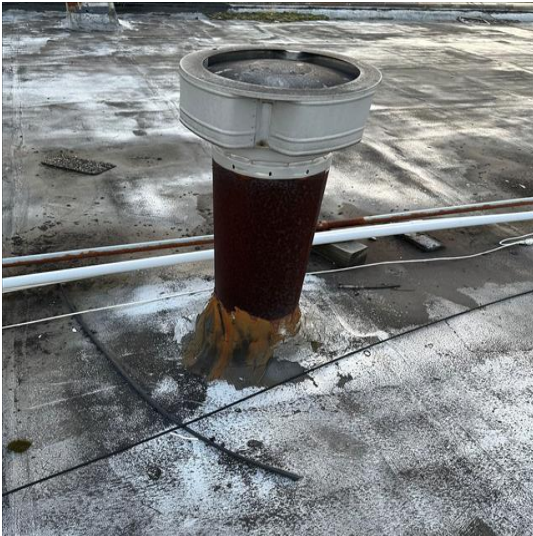
Image Number: 121

Observation: Most vent pipes on roof were observed to be missing a rain cap for the vent pipe and/or needed flashing and sealant to be replaced as it was aging. In some cases, a bucket was used as a rain cap. This can be an issue down the road as the bucket will deteriorate and break down, causing pieces to break off and get stuck in the vent pipes.

Cause: Deferred maintenance.

Determination: Roof Replacement required for LeakFREE Roof Certification

Remedy: Replace outdated rain caps, flashing and sealant. Remove buckets and replace with appropriate rain cap to prevent damage.

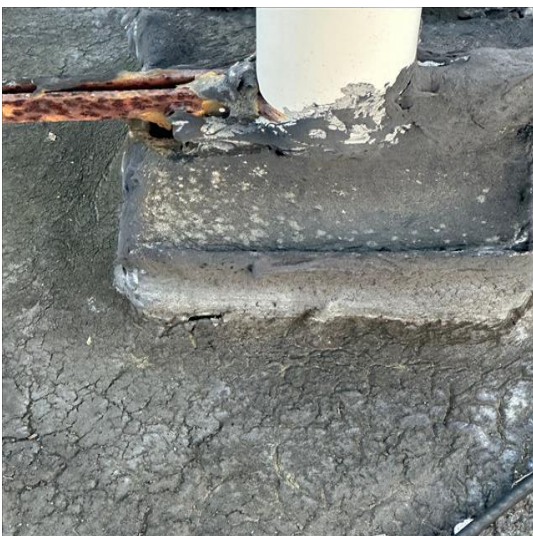
Image Number: 122

Observation: Most vent pipes on roof were observed to be missing a rain cap for the vent pipe and/or needed flashing and sealant to be replaced as it was aging. In some cases, a bucket was used as a rain cap. This can be an issue down the road as the bucket will deteriorate and break down, causing pieces to break off and get stuck in the vent pipes.

Cause: Deferred maintenance.

Determination: Roof Replacement required for LeakFREE Roof Certification

Remedy: Replace outdated rain caps, flashing and sealant. Remove buckets and replace with appropriate rain cap to prevent damage.

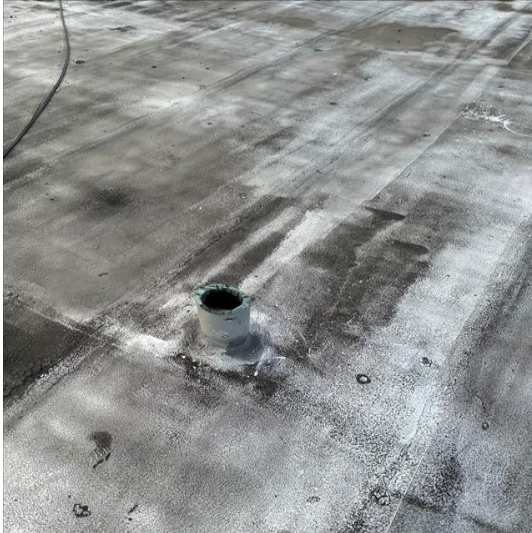
Image Number: 123

Observation: Most vent pipes on roof were observed to be missing a rain cap for the vent pipe and/or needed flashing and sealant to be replaced as it was aging. In some cases, a bucket was used as a rain cap. This can be an issue down the road as the bucket will deteriorate and break down, causing pieces to break off and get stuck in the vent pipes.

Cause: Deferred maintenance.

Determination: Roof Replacement required for LeakFREE Roof Certification

Remedy: Replace outdated rain caps, flashing and sealant. Remove buckets and replace with appropriate rain cap to prevent damage.

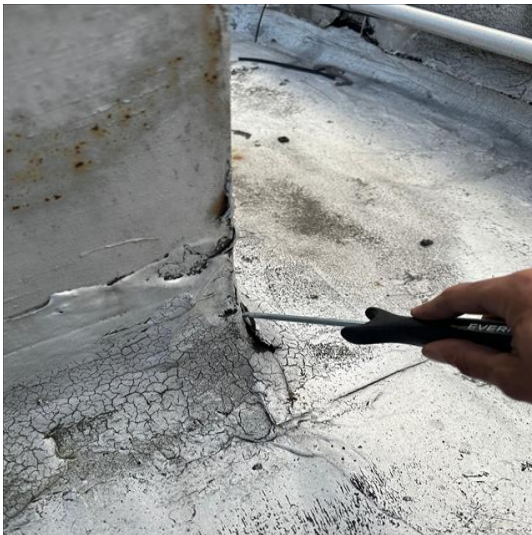
Image Number: 124

Observation: The following observations were made regarding the roof penetrations and rooftop units at the time of inspection. It should also be noted that 90% of the leaks found within the interior of the building can be traced to these units and the installation methods that took place. The following was noted; 1. Improper, failing or missing flashing at the rooftop penetrations and rooftop units. 2. Missing curbs (these are necessary for any rooftop unit, as it prevents moisture intrusion). 3. Units were not chaired on rooftop and are laying directly on roof coverings. 4. Sealant at almost all penetrations was damaged and in need of replacement. * NOTE * The interior photos within the ceiling area that show moisture stains on the ducts and the wall are consistent with the rooftop units location and observations made in this report.

Cause: 1. Deferred maintenance and improper installation. 2 & 3. Improper installation, poor workmanship. 4. Deferred maintenance.

Determination: Roof Replacement required for LeakFREE Roof Certification

Remedy: Recommend a licensed HVAC technician evaluate units and issue remedy for mounting units correctly to prevent any further damage. When roof replacement is to commence, these units will need to be chaired, installed and flashed properly.

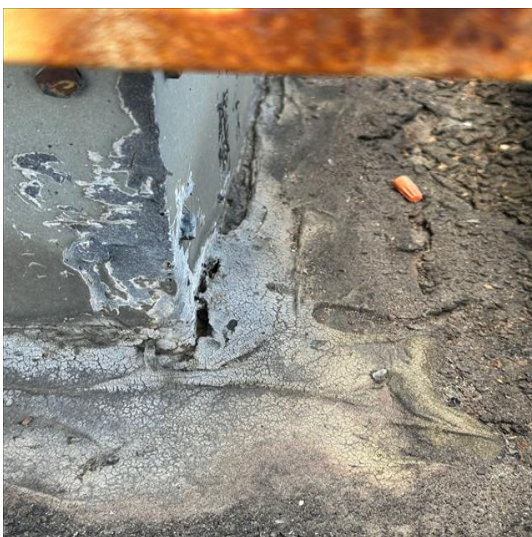
Image Number: 125

Observation: The following observations were made regarding the roof penetrations and rooftop units at the time of inspection. It should also be noted that 90% of the leaks found within the interior of the building can be traced to these units and the installation methods that took place. The following was noted; 1. Improper, failing or missing flashing at the rooftop penetrations and rooftop units. 2. Missing curbs (these are necessary for any rooftop unit, as it prevents moisture intrusion). 3. Units were not chaired on rooftop and are laying directly on roof coverings. 4. Sealant at almost all penetrations was damaged and in need of replacement. * NOTE * The interior photos within the ceiling area that show moisture stains on the ducts and the wall are consistent with the rooftop units location and observations made in this report.

Cause: 1. Deferred maintenance and improper installation. 2 & 3. Improper installation, poor workmanship. 4. Deferred maintenance.

Determination: Roof Replacement required for LeakFREE Roof Certification

Remedy: Recommend a licensed HVAC technician evaluate units and issue remedy for mounting units correctly to prevent any further damage. When roof replacement is to commence, these units will need to be chaired, installed and flashed properly.

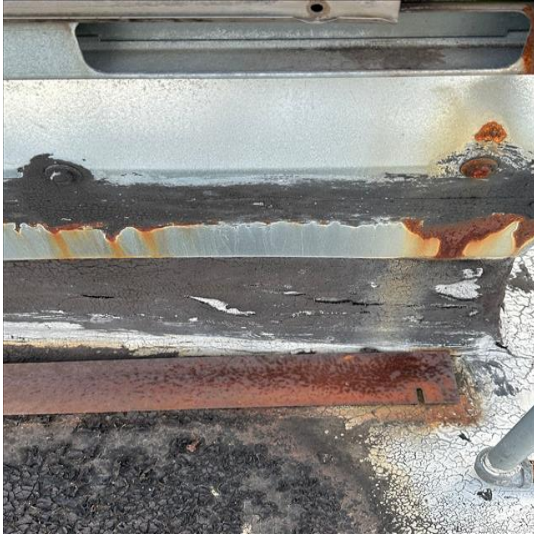
Image Number: 126

Observation: The following observations were made regarding the roof penetrations and rooftop units at the time of inspection. It should also be noted that 90% of the leaks found within the interior of the building can be traced to these units and the installation methods that took place. The following was noted; 1. Improper, failing or missing flashing at the rooftop penetrations and rooftop units. 2. Missing curbs (these are necessary for any rooftop unit, as it prevents moisture intrusion). 3. Units were not chaired on rooftop and are laying directly on roof coverings. 4. Sealant at almost all penetrations was damaged and in need of replacement. * NOTE * The interior photos within the ceiling area that show moisture stains on the ducts and the wall are consistent with the rooftop units location and observations made in this report.

Cause: 1. Deferred maintenance and improper installation. 2 & 3. Improper installation, poor workmanship. 4. Deferred maintenance.

Determination: Roof Replacement required for LeakFREE Roof Certification

Remedy: Recommend a licensed HVAC technician evaluate units and issue remedy for mounting units correctly to prevent any further damage. When roof replacement is to commence, these units will need to be chaired, installed and flashed properly.

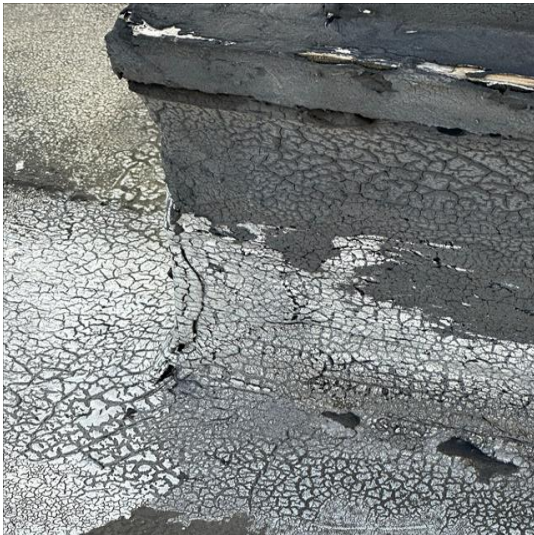
Image Number: 127

Observation: The following observations were made regarding the roof penetrations and rooftop units at the time of inspection. It should also be noted that 90% of the leaks found within the interior of the building can be traced to these units and the installation methods that took place. The following was noted; 1. Improper, failing or missing flashing at the rooftop penetrations and rooftop units. 2. Missing curbs (these are necessary for any rooftop unit, as it prevents moisture intrusion). 3. Units were not chaired on rooftop and are laying directly on roof coverings. 4. Sealant at almost all penetrations was damaged and in need of replacement. * NOTE * The interior photos within the ceiling area that show moisture stains on the ducts and the wall are consistent with the rooftop units location and observations made in this report.

Cause: 1. Deferred maintenance and improper installation. 2 & 3. Improper installation, poor workmanship. 4. Deferred maintenance.

Determination: Roof Replacement required for LeakFREE Roof Certification

Remedy: Recommend a licensed HVAC technician evaluate units and issue remedy for mounting units correctly to prevent any further damage. When roof replacement is to commence, these units will need to be chaired, installed and flashed properly.

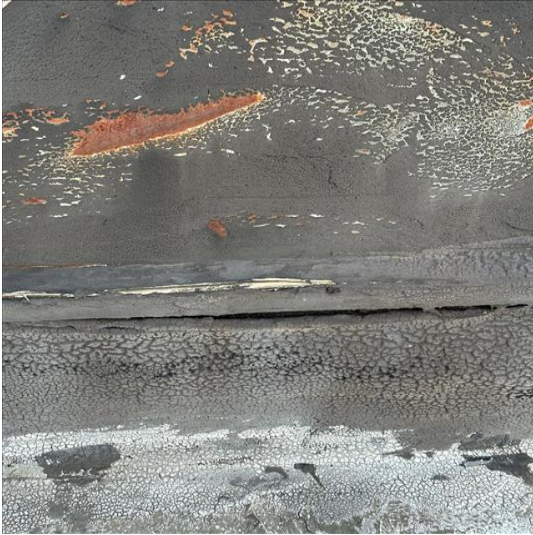
Image Number: 128

Observation: The following observations were made regarding the roof penetrations and rooftop units at the time of inspection. It should also be noted that 90% of the leaks found within the interior of the building can be traced to these units and the installation methods that took place. The following was noted; 1. Improper, failing or missing flashing at the rooftop penetrations and rooftop units. 2. Missing curbs (these are necessary for any rooftop unit, as it prevents moisture intrusion). 3. Units were not chaired on rooftop and are laying directly on roof coverings. 4. Sealant at almost all penetrations was damaged and in need of replacement. * NOTE * The interior photos within the ceiling area that show moisture stains on the ducts and the wall are consistent with the rooftop units location and observations made in this report.

Cause: 1. Deferred maintenance and improper installation. 2 & 3. Improper installation, poor workmanship. 4. Deferred maintenance.

Determination: Roof Replacement required for LeakFREE Roof Certification

Remedy: Recommend a licensed HVAC technician evaluate units and issue remedy for mounting units correctly to prevent any further damage. When roof replacement is to commence, these units will need to be chaired, installed and flashed properly.

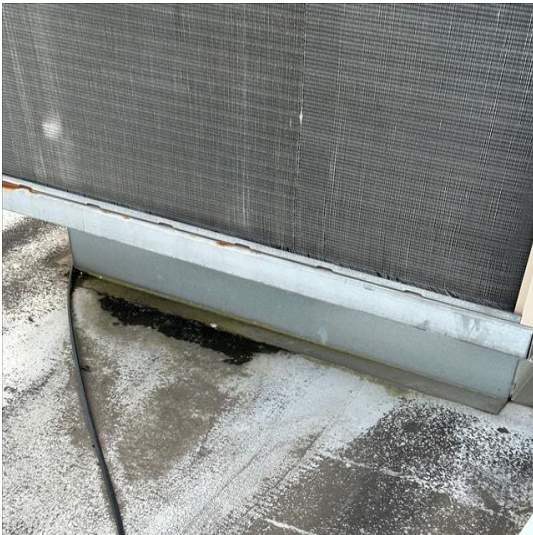
Image Number: 129

Observation: The following observations were made regarding the roof penetrations and rooftop units at the time of inspection. It should also be noted that 90% of the leaks found within the interior of the building can be traced to these units and the installation methods that took place. The following was noted; 1. Improper, failing or missing flashing at the rooftop penetrations and rooftop units. 2. Missing curbs (these are necessary for any rooftop unit, as it prevents moisture intrusion). 3. Units were not chaired on rooftop and are laying directly on roof coverings. 4. Sealant at almost all penetrations was damaged and in need of replacement. * NOTE * The interior photos within the ceiling area that show moisture stains on the ducts and the wall are consistent with the rooftop units location and observations made in this report.

Cause: 1. Deferred maintenance and improper installation. 2 & 3. Improper installation, poor workmanship. 4. Deferred maintenance.

Determination: Roof Replacement required for LeakFREE Roof Certification

Remedy: Recommend a licensed HVAC technician evaluate units and issue remedy for mounting units correctly to prevent any further damage. When roof replacement is to commence, these units will need to be chaired, installed and flashed properly.

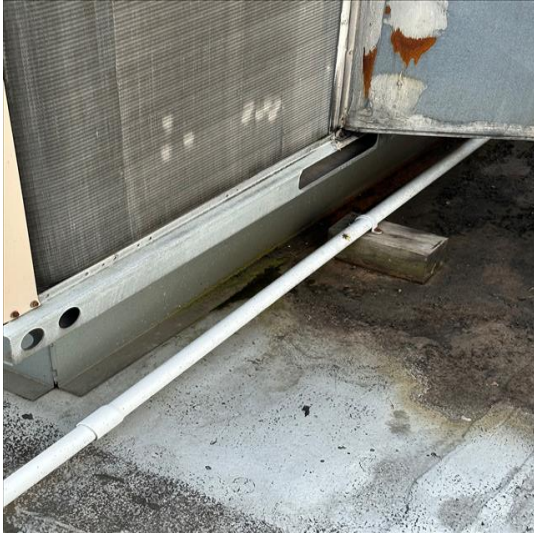
Image Number: 130

Observation: The following observations were made regarding the roof penetrations and rooftop units at the time of inspection. It should also be noted that 90% of the leaks found within the interior of the building can be traced to these units and the installation methods that took place. The following was noted; 1. Improper, failing or missing flashing at the rooftop penetrations and rooftop units. 2. Missing curbs (these are necessary for any rooftop unit, as it prevents moisture intrusion). 3. Units were not chaired on rooftop and are laying directly on roof coverings. 4. Sealant at almost all penetrations was damaged and in need of replacement. * NOTE * The interior photos within the ceiling area that show moisture stains on the ducts and the wall are consistent with the rooftop units location and observations made in this report.

Cause: 1. Deferred maintenance and improper installation. 2 & 3. Improper installation, poor workmanship. 4. Deferred maintenance.

Determination: Roof Replacement required for LeakFREE Roof Certification

Remedy: Recommend a licensed HVAC technician evaluate units and issue remedy for mounting units correctly to prevent any further damage. When roof replacement is to commence, these units will need to be chaired, installed and flashed properly.

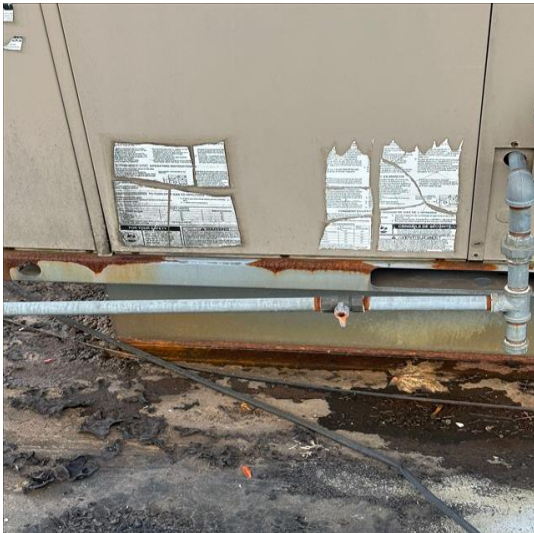
Image Number: 131

Observation: The following observations were made regarding the roof penetrations and rooftop units at the time of inspection. It should also be noted that 90% of the leaks found within the interior of the building can be traced to these units and the installation methods that took place. The following was noted; 1. Improper, failing or missing flashing at the rooftop penetrations and rooftop units. 2. Missing curbs (these are necessary for any rooftop unit, as it prevents moisture intrusion). 3. Units were not chaired on rooftop and are laying directly on roof coverings. 4. Sealant at almost all penetrations was damaged and in need of replacement. * NOTE * The interior photos within the ceiling area that show moisture stains on the ducts and the wall are consistent with the rooftop units location and observations made in this report.

Cause: 1. Deferred maintenance and improper installation. 2 & 3. Improper installation, poor workmanship. 4. Deferred maintenance.

Determination: Roof Replacement required for LeakFREE Roof Certification

Remedy: Recommend a licensed HVAC technician evaluate units and issue remedy for mounting units correctly to prevent any further damage. When roof replacement is to commence, these units will need to be chaired, installed and flashed properly.

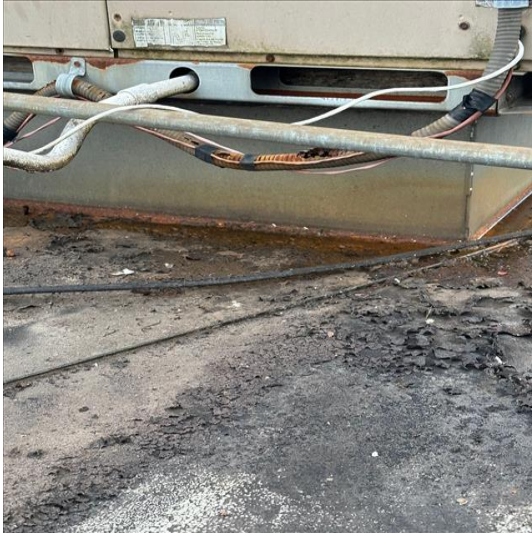
Image Number: 132

Observation: The following observations were made regarding the roof penetrations and rooftop units at the time of inspection. It should also be noted that 90% of the leaks found within the interior of the building can be traced to these units and the installation methods that took place. The following was noted; 1. Improper, failing or missing flashing at the rooftop penetrations and rooftop units. 2. Missing curbs (these are necessary for any rooftop unit, as it prevents moisture intrusion). 3. Units were not chaired on rooftop and are laying directly on roof coverings. 4. Sealant at almost all penetrations was damaged and in need of replacement. * NOTE * The interior photos within the ceiling area that show moisture stains on the ducts and the wall are consistent with the rooftop units location and observations made in this report.

Cause: 1. Deferred maintenance and improper installation. 2 & 3. Improper installation, poor workmanship. 4. Deferred maintenance.

Determination: Roof Replacement required for LeakFREE Roof Certification

Remedy: Recommend a licensed HVAC technician evaluate units and issue remedy for mounting units correctly to prevent any further damage. When roof replacement is to commence, these units will need to be chaired, installed and flashed properly.

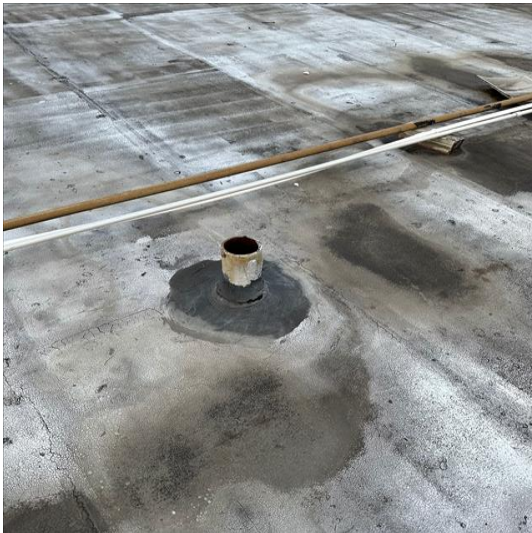
Image Number: 133

Observation: Most vent pipes on roof were observed to be missing a rain cap for the vent pipe and/or needed flashing and sealant to be replaced as it was aging. In some cases, a bucket was used as a rain cap. This can be an issue down the road as the bucket will deteriorate and break down, causing pieces to break off and get stuck in the vent pipes.

Cause: Deferred maintenance.

Determination: Roof Replacement required for LeakFREE Roof Certification

Remedy: Replace outdated rain caps, flashing and sealant. Remove buckets and replace with appropriate rain cap to prevent damage.

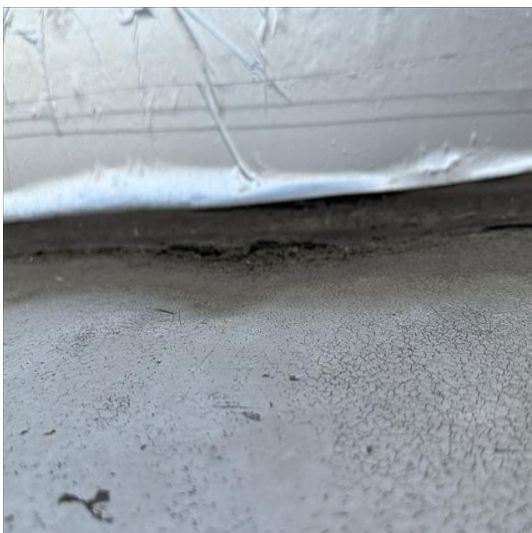
Image Number: 134

Observation: The following observations were made regarding the roof penetrations and rooftop units at the time of inspection. It should also be noted that 90% of the leaks found within the interior of the building can be traced to these units and the installation methods that took place. The following was noted; 1. Improper, failing or missing flashing at the rooftop penetrations and rooftop units. 2. Missing curbs (these are necessary for any rooftop unit, as it prevents moisture intrusion). 3. Units were not chaired on rooftop and are laying directly on roof coverings. 4. Sealant at almost all penetrations was damaged and in need of replacement. * NOTE * The interior photos within the ceiling area that show moisture stains on the ducts and the wall are consistent with the rooftop units location and observations made in this report.

Cause: 1. Deferred maintenance and improper installation. 2 & 3. Improper installation, poor workmanship. 4. Deferred maintenance.

Determination: Roof Replacement required for LeakFREE Roof Certification

Remedy: Recommend a licensed HVAC technician evaluate units and issue remedy for mounting units correctly to prevent any further damage. When roof replacement is to commence, these units will need to be chaired, installed and flashed properly.

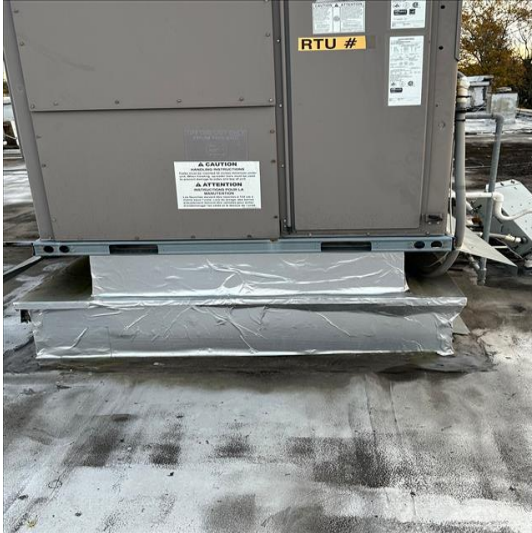
Image Number: 135

Observation: The following observations were made regarding the roof penetrations and rooftop units at the time of inspection. It should also be noted that 90% of the leaks found within the interior of the building can be traced to these units and the installation methods that took place. The following was noted; 1. Improper, failing or missing flashing at the rooftop penetrations and rooftop units. 2. Missing curbs (these are necessary for any rooftop unit, as it prevents moisture intrusion). 3. Units were not chaired on rooftop and are laying directly on roof coverings. 4. Sealant at almost all penetrations was damaged and in need of replacement. * NOTE * The interior photos within the ceiling area that show moisture stains on the ducts and the wall are consistent with the rooftop units location and observations made in this report.

Cause: 1. Deferred maintenance and improper installation. 2 & 3. Improper installation, poor workmanship. 4. Deferred maintenance.

Determination: Roof Replacement required for LeakFREE Roof Certification

Remedy: Recommend a licensed HVAC technician evaluate units and issue remedy for mounting units correctly to prevent any further damage. When roof replacement is to commence, these units will need to be chaired, installed and flashed properly.

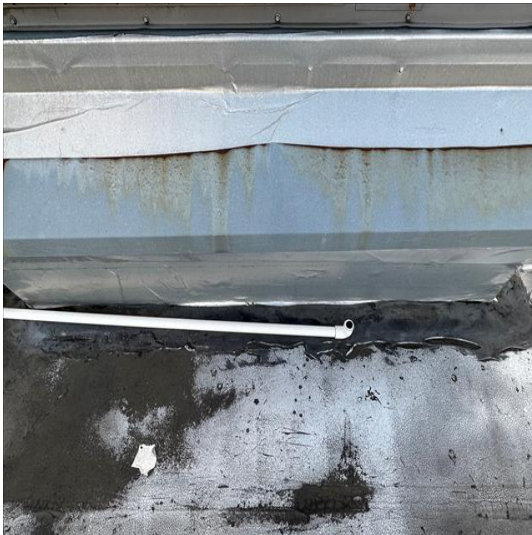
Image Number: 136

Observation: The following observations were made regarding the roof penetrations and rooftop units at the time of inspection. It should also be noted that 90% of the leaks found within the interior of the building can be traced to these units and the installation methods that took place. The following was noted; 1. Improper, failing or missing flashing at the rooftop penetrations and rooftop units. 2. Missing curbs (these are necessary for any rooftop unit, as it prevents moisture intrusion). 3. Units were not chaired on rooftop and are laying directly on roof coverings. 4. Sealant at almost all penetrations was damaged and in need of replacement. * NOTE * The interior photos within the ceiling area that show moisture stains on the ducts and the wall are consistent with the rooftop units location and observations made in this report.

Cause: 1. Deferred maintenance and improper installation. 2 & 3. Improper installation, poor workmanship. 4. Deferred maintenance.

Determination: Roof Replacement required for LeakFREE Roof Certification

Remedy: Recommend a licensed HVAC technician evaluate units and issue remedy for mounting units correctly to prevent any further damage. When roof replacement is to commence, these units will need to be chaired, installed and flashed properly.

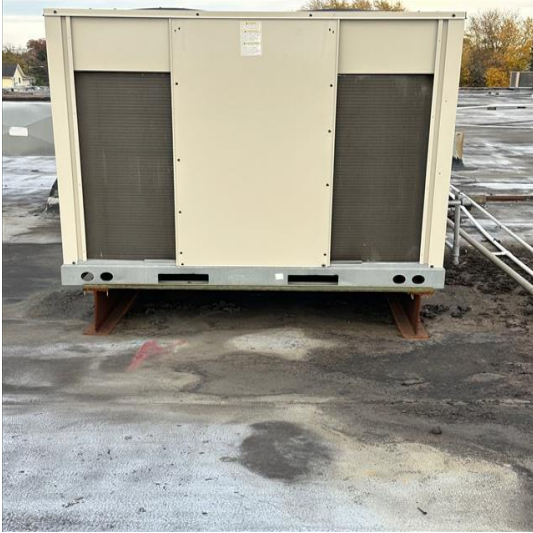
Image Number: 137

Observation: The following observations were made regarding the roof penetrations and rooftop units at the time of inspection. It should also be noted that 90% of the leaks found within the interior of the building can be traced to these units and the installation methods that took place. The following was noted; 1. Improper, failing or missing flashing at the rooftop penetrations and rooftop units. 2. Missing curbs (these are necessary for any rooftop unit, as it prevents moisture intrusion). 3. Units were not chaired on rooftop and are laying directly on roof coverings. 4. Sealant at almost all penetrations was damaged and in need of replacement. * NOTE * The interior photos within the ceiling area that show moisture stains on the ducts and the wall are consistent with the rooftop units location and observations made in this report.

Cause: 1. Deferred maintenance and improper installation. 2 & 3. Improper installation, poor workmanship. 4. Deferred maintenance.

Determination: Roof Replacement required for LeakFREE Roof Certification

Remedy: Recommend a licensed HVAC technician evaluate units and issue remedy for mounting units correctly to prevent any further damage. When roof replacement is to commence, these units will need to be chaired, installed and flashed properly.

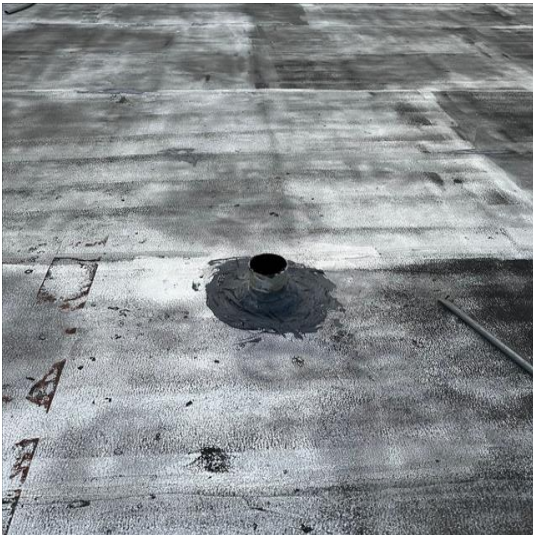
Image Number: 138

Observation: Most vent pipes on roof were observed to be missing a rain cap for the vent pipe and/or needed flashing and sealant to be replaced as it was aging. In some cases, a bucket was used as a rain cap. This can be an issue down the road as the bucket will deteriorate and break down, causing pieces to break off and get stuck in the vent pipes.

Cause: Deferred maintenance.

Determination: Roof Replacement required for LeakFREE Roof Certification

Remedy: Replace outdated rain caps, flashing and sealant. Remove buckets and replace with appropriate rain cap to prevent damage.

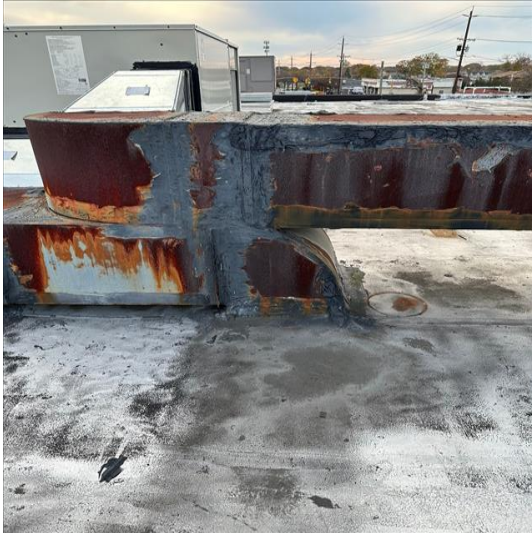
Image Number: 139

Observation: The following observations were made regarding the roof penetrations and rooftop units at the time of inspection. It should also be noted that 90% of the leaks found within the interior of the building can be traced to these units and the installation methods that took place. The following was noted; 1. Improper, failing or missing flashing at the rooftop penetrations and rooftop units. 2. Missing curbs (these are necessary for any rooftop unit, as it prevents moisture intrusion). 3. Units were not chaired on rooftop and are laying directly on roof coverings. 4. Sealant at almost all penetrations was damaged and in need of replacement. * NOTE * The interior photos within the ceiling area that show moisture stains on the ducts and the wall are consistent with the rooftop units location and observations made in this report.

Cause: 1. Deferred maintenance and improper installation. 2 & 3. Improper installation, poor workmanship. 4. Deferred maintenance.

Determination: Roof Replacement required for LeakFREE Roof Certification

Remedy: Recommend a licensed HVAC technician evaluate units and issue remedy for mounting units correctly to prevent any further damage. When roof replacement is to commence, these units will need to be chaired, installed and flashed properly.

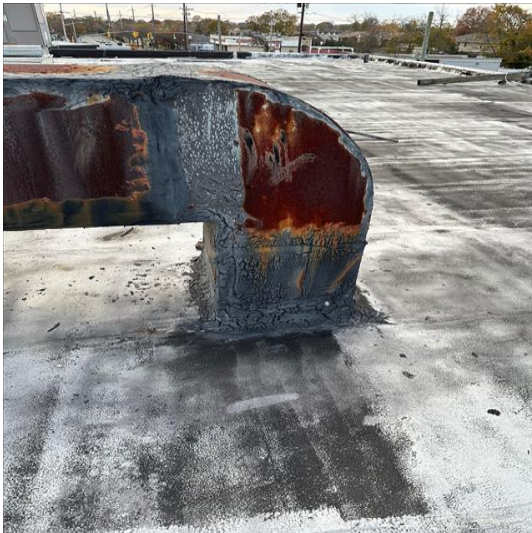
Image Number: 140

Observation: The following observations were made regarding the roof penetrations and rooftop units at the time of inspection. It should also be noted that 90% of the leaks found within the interior of the building can be traced to these units and the installation methods that took place. The following was noted; 1. Improper, failing or missing flashing at the rooftop penetrations and rooftop units. 2. Missing curbs (these are necessary for any rooftop unit, as it prevents moisture intrusion). 3. Units were not chaired on rooftop and are laying directly on roof coverings. 4. Sealant at almost all penetrations was damaged and in need of replacement. * NOTE * The interior photos within the ceiling area that show moisture stains on the ducts and the wall are consistent with the rooftop units location and observations made in this report.

Cause: 1. Deferred maintenance and improper installation. 2 & 3. Improper installation, poor workmanship. 4. Deferred maintenance.

Determination: Roof Replacement required for LeakFREE Roof Certification

Remedy: Recommend a licensed HVAC technician evaluate units and issue remedy for mounting units correctly to prevent any further damage. When roof replacement is to commence, these units will need to be chaired, installed and flashed properly.

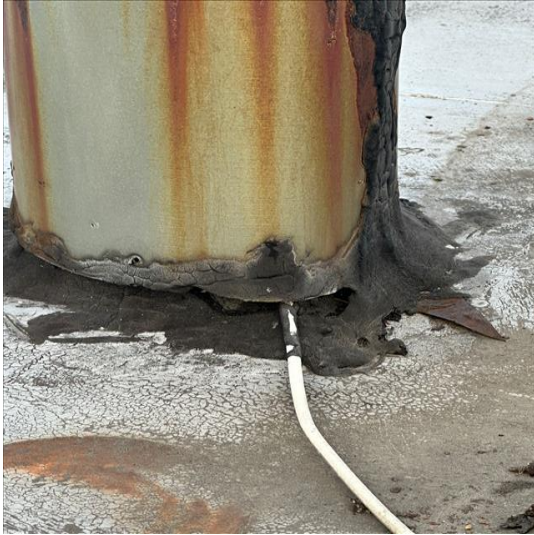
Image Number: 141

Observation: The following observations were made regarding the roof penetrations and rooftop units at the time of inspection. It should also be noted that 90% of the leaks found within the interior of the building can be traced to these units and the installation methods that took place. The following was noted; 1. Improper, failing or missing flashing at the rooftop penetrations and rooftop units. 2. Missing curbs (these are necessary for any rooftop unit, as it prevents moisture intrusion). 3. Units were not chaired on rooftop and are laying directly on roof coverings. 4. Sealant at almost all penetrations was damaged and in need of replacement. * NOTE * The interior photos within the ceiling area that show moisture stains on the ducts and the wall are consistent with the rooftop units location and observations made in this report.

Cause: 1. Deferred maintenance and improper installation. 2 & 3. Improper installation, poor workmanship. 4. Deferred maintenance.

Determination: Roof Replacement required for LeakFREE Roof Certification

Remedy: Recommend a licensed HVAC technician evaluate units and issue remedy for mounting units correctly to prevent any further damage. When roof replacement is to commence, these units will need to be chaired, installed and flashed properly.

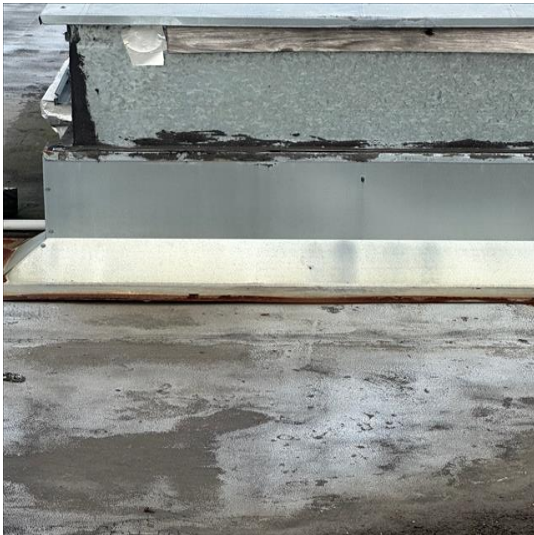
Image Number: 142

Observation: The following observations were made regarding the roof penetrations and rooftop units at the time of inspection. It should also be noted that 90% of the leaks found within the interior of the building can be traced to these units and the installation methods that took place. The following was noted; 1. Improper, failing or missing flashing at the rooftop penetrations and rooftop units. 2. Missing curbs (these are necessary for any rooftop unit, as it prevents moisture intrusion). 3. Units were not chaired on rooftop and are laying directly on roof coverings. 4. Sealant at almost all penetrations was damaged and in need of replacement. * NOTE * The interior photos within the ceiling area that show moisture stains on the ducts and the wall are consistent with the rooftop units location and observations made in this report.

Cause: 1. Deferred maintenance and improper installation. 2 & 3. Improper installation, poor workmanship. 4. Deferred maintenance.

Determination: Roof Replacement required for LeakFREE Roof Certification

Remedy: Recommend a licensed HVAC technician evaluate units and issue remedy for mounting units correctly to prevent any further damage. When roof replacement is to commence, these units will need to be chaired, installed and flashed properly.

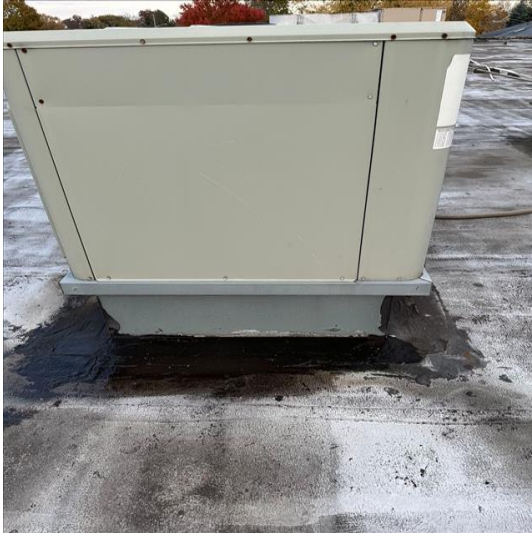
Image Number: 143

Observation: The following observations were made regarding the roof penetrations and rooftop units at the time of inspection. It should also be noted that 90% of the leaks found within the interior of the building can be traced to these units and the installation methods that took place. The following was noted; 1. Improper, failing or missing flashing at the rooftop penetrations and rooftop units. 2. Missing curbs (these are necessary for any rooftop unit, as it prevents moisture intrusion). 3. Units were not chaired on rooftop and are laying directly on roof coverings. 4. Sealant at almost all penetrations was damaged and in need of replacement. * NOTE * The interior photos within the ceiling area that show moisture stains on the ducts and the wall are consistent with the rooftop units location and observations made in this report.

Cause: 1. Deferred maintenance and improper installation. 2 & 3. Improper installation, poor workmanship. 4. Deferred maintenance.

Determination: Roof Replacement required for LeakFREE Roof Certification

Remedy: Recommend a licensed HVAC technician evaluate units and issue remedy for mounting units correctly to prevent any further damage. When roof replacement is to commence, these units will need to be chaired, installed and flashed properly.

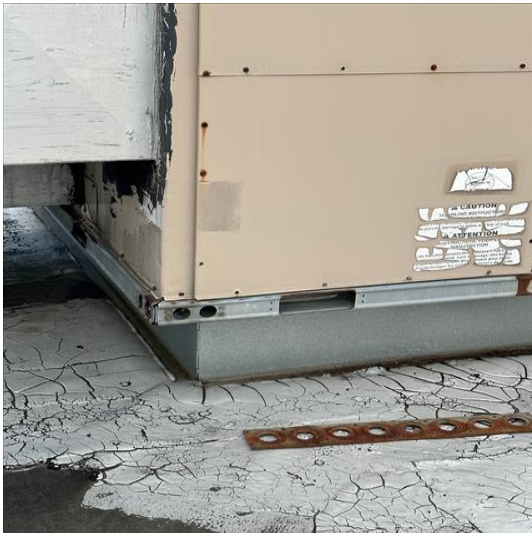
Image Number: 144

Observation: The following observations were made regarding the roof penetrations and rooftop units at the time of inspection. It should also be noted that 90% of the leaks found within the interior of the building can be traced to these units and the installation methods that took place. The following was noted; 1. Improper, failing or missing flashing at the rooftop penetrations and rooftop units. 2. Missing curbs (these are necessary for any rooftop unit, as it prevents moisture intrusion). 3. Units were not chaired on rooftop and are laying directly on roof coverings. 4. Sealant at almost all penetrations was damaged and in need of replacement. * NOTE * The interior photos within the ceiling area that show moisture stains on the ducts and the wall are consistent with the rooftop units location and observations made in this report.

Cause: 1. Deferred maintenance and improper installation. 2 & 3. Improper installation, poor workmanship. 4. Deferred maintenance.

Determination: Roof Replacement required for LeakFREE Roof Certification

Remedy: Recommend a licensed HVAC technician evaluate units and issue remedy for mounting units correctly to prevent any further damage. When roof replacement is to commence, these units will need to be chaired, installed and flashed properly.

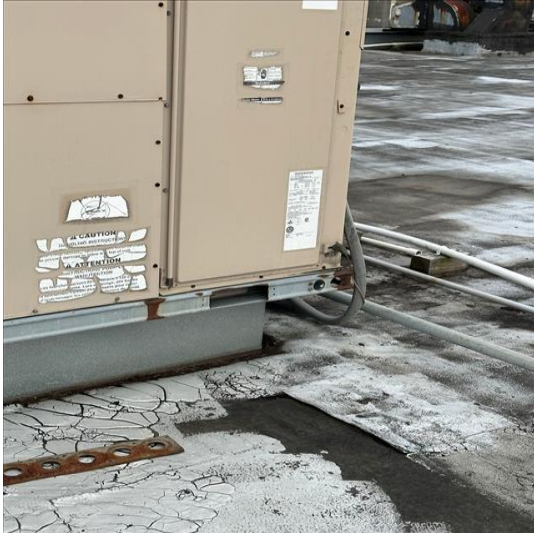
Image Number: 145

Observation: The following observations were made regarding the roof penetrations and rooftop units at the time of inspection. It should also be noted that 90% of the leaks found within the interior of the building can be traced to these units and the installation methods that took place. The following was noted; 1. Improper, failing or missing flashing at the rooftop penetrations and rooftop units. 2. Missing curbs (these are necessary for any rooftop unit, as it prevents moisture intrusion). 3. Units were not chaired on rooftop and are laying directly on roof coverings. 4. Sealant at almost all penetrations was damaged and in need of replacement. * NOTE * The interior photos within the ceiling area that show moisture stains on the ducts and the wall are consistent with the rooftop units location and observations made in this report.

Cause: 1. Deferred maintenance and improper installation. 2 & 3. Improper installation, poor workmanship. 4. Deferred maintenance.

Determination: Roof Replacement required for LeakFREE Roof Certification

Remedy: Recommend a licensed HVAC technician evaluate units and issue remedy for mounting units correctly to prevent any further damage. When roof replacement is to commence, these units will need to be chaired, installed and flashed properly.

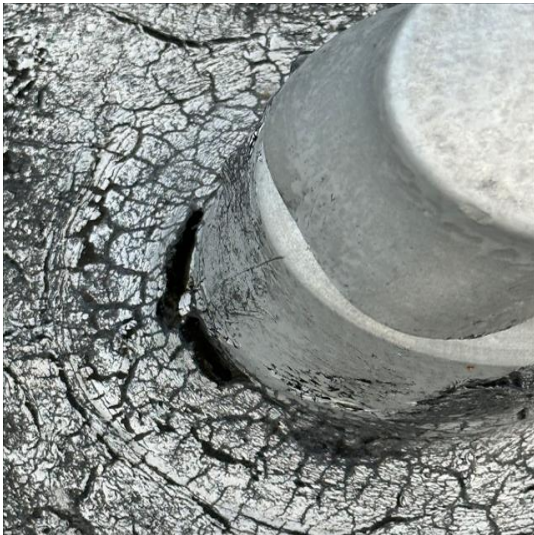
Image Number: 146

Observation: Most vent pipes on roof were observed to be missing a rain cap for the vent pipe and/or needed flashing and sealant to be replaced as it was aging. In some cases, a bucket was used as a rain cap. This can be an issue down the road as the bucket will deteriorate and break down, causing pieces to break off and get stuck in the vent pipes.

Cause: Deferred maintenance.

Determination: Roof Replacement required for LeakFREE Roof Certification

Remedy: Replace outdated rain caps, flashing and sealant. Remove buckets and replace with appropriate rain cap to prevent damage.

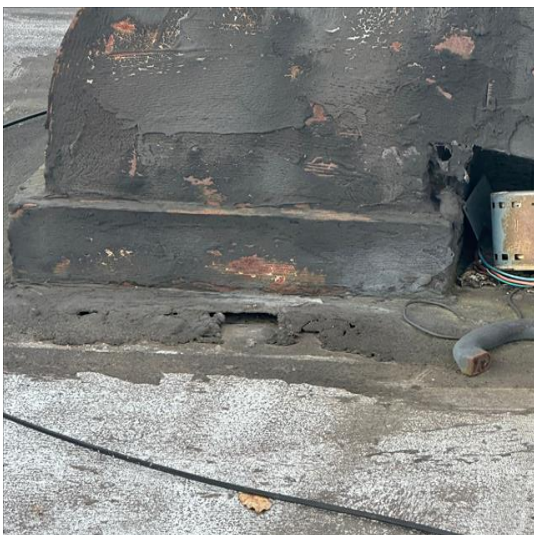
Image Number: 147

Observation: The following observations were made regarding the roof penetrations and rooftop units at the time of inspection. It should also be noted that 90% of the leaks found within the interior of the building can be traced to these units and the installation methods that took place. The following was noted; 1. Improper, failing or missing flashing at the rooftop penetrations and rooftop units. 2. Missing curbs (these are necessary for any rooftop unit, as it prevents moisture intrusion). 3. Units were not chaired on rooftop and are laying directly on roof coverings. 4. Sealant at almost all penetrations was damaged and in need of replacement. * NOTE * The interior photos within the ceiling area that show moisture stains on the ducts and the wall are consistent with the rooftop units location and observations made in this report.

Cause: 1. Deferred maintenance and improper installation. 2 & 3. Improper installation, poor workmanship. 4. Deferred maintenance.

Determination: Roof Replacement required for LeakFREE Roof Certification

Remedy: Recommend a licensed HVAC technician evaluate units and issue remedy for mounting units correctly to prevent any further damage. When roof replacement is to commence, these units will need to be chaired, installed and flashed properly.

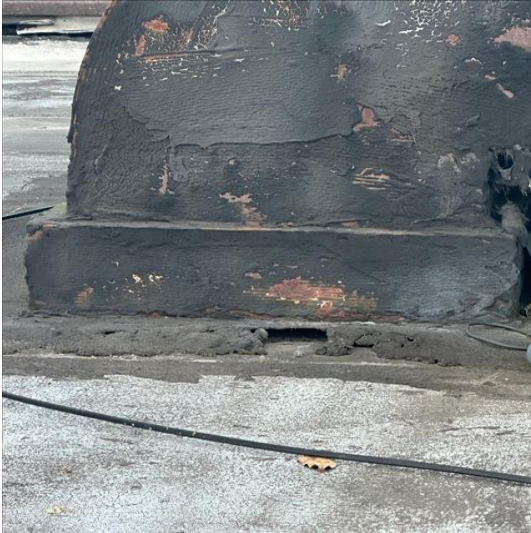
Image Number: 148

Observation: The following observations were made regarding the roof penetrations and rooftop units at the time of inspection. It should also be noted that 90% of the leaks found within the interior of the building can be traced to these units and the installation methods that took place. The following was noted; 1. Improper, failing or missing flashing at the rooftop penetrations and rooftop units. 2. Missing curbs (these are necessary for any rooftop unit, as it prevents moisture intrusion). 3. Units were not chaired on rooftop and are laying directly on roof coverings. 4. Sealant at almost all penetrations was damaged and in need of replacement. * NOTE * The interior photos within the ceiling area that show moisture stains on the ducts and the wall are consistent with the rooftop units location and observations made in this report.

Cause: 1. Deferred maintenance and improper installation. 2 & 3. Improper installation, poor workmanship. 4. Deferred maintenance.

Determination: Roof Replacement required for LeakFREE Roof Certification

Remedy: Recommend a licensed HVAC technician evaluate units and issue remedy for mounting units correctly to prevent any further damage. When roof replacement is to commence, these units will need to be chaired, installed and flashed properly.

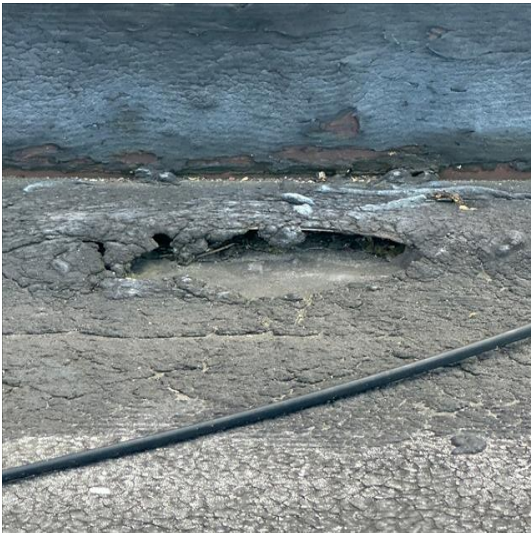
Image Number: 149

Observation: The following observations were made regarding the roof penetrations and rooftop units at the time of inspection. It should also be noted that 90% of the leaks found within the interior of the building can be traced to these units and the installation methods that took place. The following was noted; 1. Improper, failing or missing flashing at the rooftop penetrations and rooftop units. 2. Missing curbs (these are necessary for any rooftop unit, as it prevents moisture intrusion). 3. Units were not chaired on rooftop and are laying directly on roof coverings. 4. Sealant at almost all penetrations was damaged and in need of replacement. * NOTE * The interior photos within the ceiling area that show moisture stains on the ducts and the wall are consistent with the rooftop units location and observations made in this report.

Cause: 1. Deferred maintenance and improper installation. 2 & 3. Improper installation, poor workmanship. 4. Deferred maintenance.

Determination: Roof Replacement required for LeakFREE Roof Certification

Remedy: Recommend a licensed HVAC technician evaluate units and issue remedy for mounting units correctly to prevent any further damage. When roof replacement is to commence, these units will need to be chaired, installed and flashed properly.

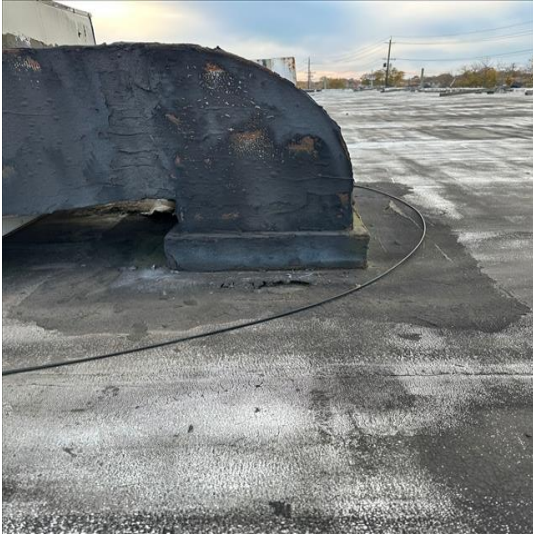
Image Number: 150

Observation: The following observations were made regarding the roof penetrations and rooftop units at the time of inspection. It should also be noted that 90% of the leaks found within the interior of the building can be traced to these units and the installation methods that took place. The following was noted; 1. Improper, failing or missing flashing at the rooftop penetrations and rooftop units. 2. Missing curbs (these are necessary for any rooftop unit, as it prevents moisture intrusion). 3. Units were not chaired on rooftop and are laying directly on roof coverings. 4. Sealant at almost all penetrations was damaged and in need of replacement. * NOTE * The interior photos within the ceiling area that show moisture stains on the ducts and the wall are consistent with the rooftop units location and observations made in this report.

Cause: 1. Deferred maintenance and improper installation. 2 & 3. Improper installation, poor workmanship. 4. Deferred maintenance.

Determination: Roof Replacement required for LeakFREE Roof Certification

Remedy: Recommend a licensed HVAC technician evaluate units and issue remedy for mounting units correctly to prevent any further damage. When roof replacement is to commence, these units will need to be chaired, installed and flashed properly.

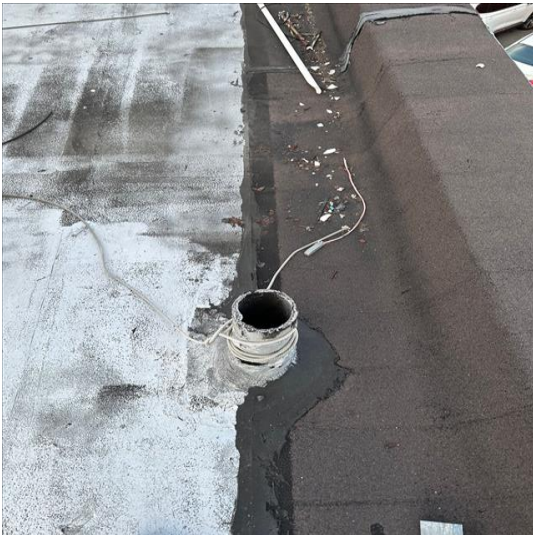
Image Number: 151

Observation: Most vent pipes on roof were observed to be missing a rain cap for the vent pipe and/or needed flashing and sealant to be replaced as it was aging. In some cases, a bucket was used as a rain cap. This can be an issue down the road as the bucket will deteriorate and break down, causing pieces to break off and get stuck in the vent pipes.

Cause: Deferred maintenance.

Determination: Roof Replacement required for LeakFREE Roof Certification

Remedy: Replace outdated rain caps, flashing and sealant. Remove buckets and replace with appropriate rain cap to prevent damage.

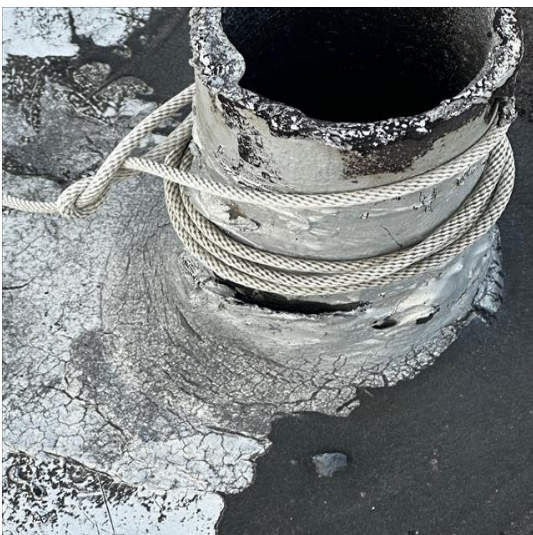
Image Number: 152

Observation: Most vent pipes on roof were observed to be missing a rain cap for the vent pipe and/or needed flashing and sealant to be replaced as it was aging. In some cases, a bucket was used as a rain cap. This can be an issue down the road as the bucket will deteriorate and break down, causing pieces to break off and get stuck in the vent pipes.

Cause: Deferred maintenance.

Determination: Roof Replacement required for LeakFREE Roof Certification

Remedy: Replace outdated rain caps, flashing and sealant. Remove buckets and replace with appropriate rain cap to prevent damage.

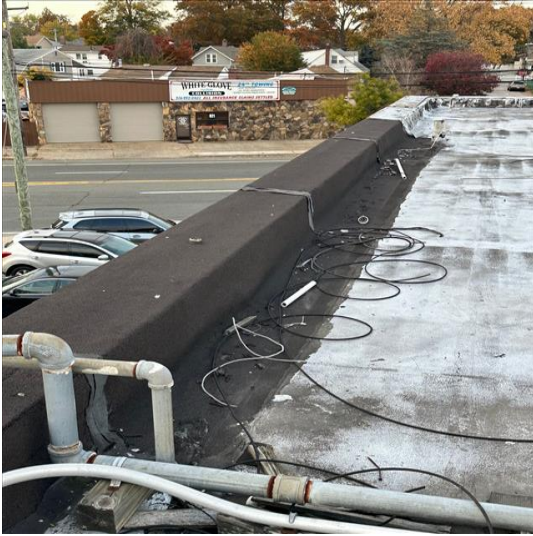
Image Number: 153

Observation: Evidence of previous repairs were observed at time of inspection.

Determination: Roof Replacement required for LeakFREE Roof Certification
