LeakFREE® Roof Inspection

Report No :
130075

Property Inspected :
[REDACTED]
[REDACTED]

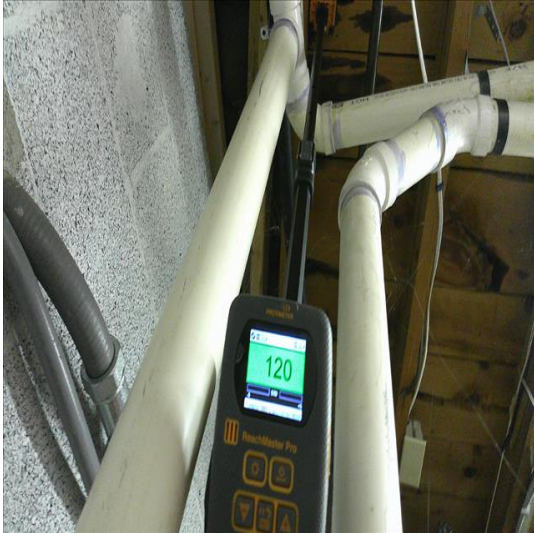
Image Number: 11

Observation: Moisture staining was observed and consistent among the following areas; (1) the windows in the upstairs office (2) the area directly below the transition of the roof from the headwall to the flat roof (3) areas below plumbing (4) areas with cut outs in drop ceilings for equipment

Remedy: (1) Replace windows and flashing that require attention (2) Roof needs to be properly integrated into the headwalls and requires replacement (3) Licensed plumber needs to evaluate the plumbing system and determine if leaks are present or if the material of the pipe is creating condensation with thermal elements (4) Monitor these cut outs for any changes.

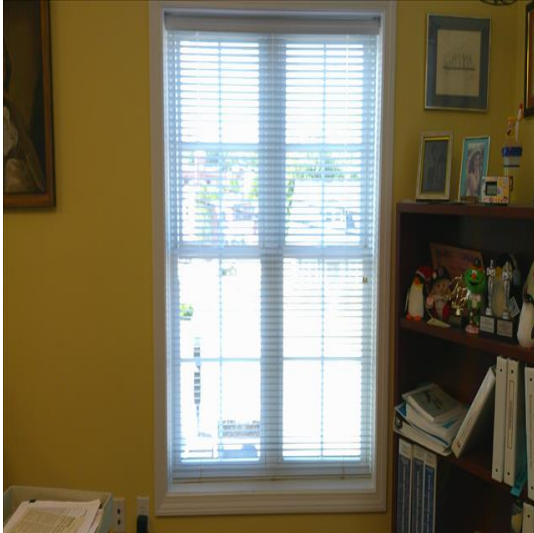
Image Number: 13

Observation: Moisture staining was observed and consistent among the following areas; (1) the windows in the upstairs office (2) the area directly below the transition of the roof from the headwall to the flat roof (3) areas below plumbing (4) areas with cut outs in drop ceilings for equipment

Remedy: (1) Replace windows and flashing that require attention (2) Roof needs to be properly integrated into the headwalls and requires replacement (3) Licensed plumber needs to evaluate the plumbing system and determine if leaks are present or if the material of the pipe is creating condensation with thermal elements (4) Monitor these cut outs for any changes.

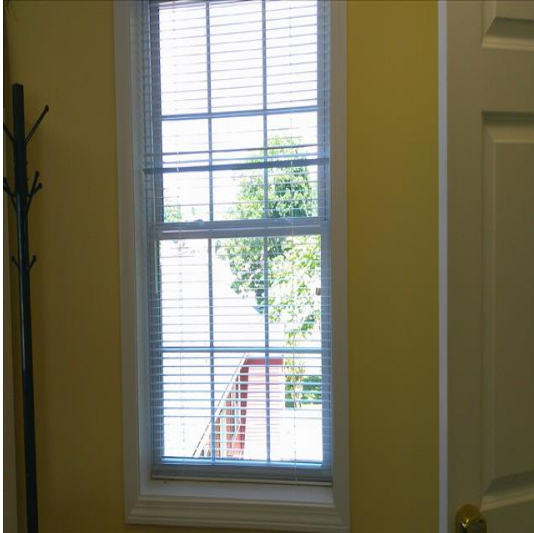
Image Number: 15

Observation: Moisture staining was observed and consistent among the following areas; (1) the windows in the upstairs office (2) the area directly below the transition of the roof from the headwall to the flat roof (3) areas below plumbing (4) areas with cut outs in drop ceilings for equipment

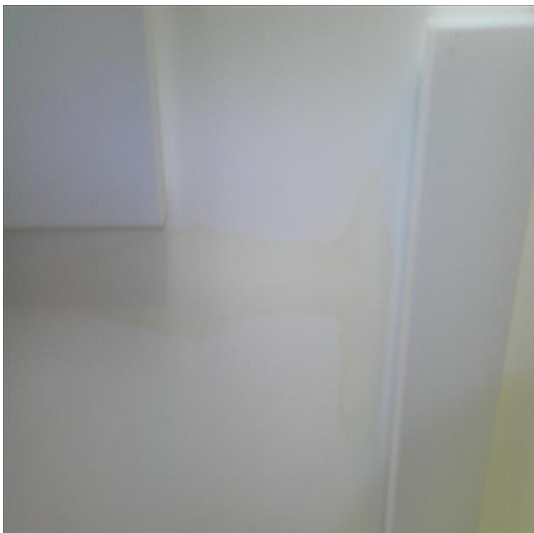
Image Number: 17

Observation: The interior was inspected and determined to have multiple locations with previous and current leaks. The meeting room downstairs was observed to have moisture staining indicating that water is gaining entry above. It was determined that (2) locations are creating moisture intrusion issues. (1) location is the toilet directly above (2) location is the floor and wall intersection where there were small spaces that were not sealed. Building owner stated that water gets in by the door and puddles.

Cause: Wax ring at the toilet is defective and needs to be replaced. The doorway is allowing water to puddle.

Remedy: Contact a licensed plumber to analyze and replace the defective wax ring. Install a weather strip for the door bottom.

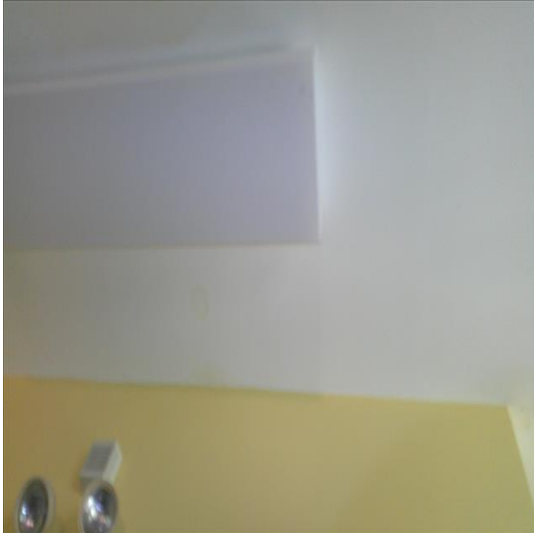
Image Number: 18

Observation: The interior was inspected and determined to have multiple locations with previous and current leaks. The meeting room downstairs was observed to have moisture staining indicating that water is gaining entry above. It was determined that (2) locations are creating moisture intrusion issues. (1) location is the toilet directly above (2) location is the floor and wall intersection where there were small spaces that were not sealed. Building owner stated that water gets in by the door and puddles.

Cause: Wax ring at the toilet is defective and needs to be replaced. The doorway is allowing water to puddle.

Remedy: Contact a licensed plumber to analyze and replace the defective wax ring. Install a weather strip for the door bottom.

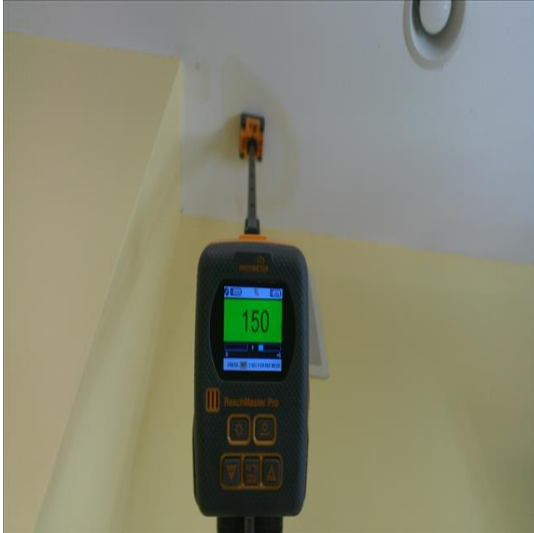
Image Number: 21

Observation: The interior was inspected and determined to have multiple locations with previous and current leaks. The meeting room downstairs was observed to have moisture staining indicating that water is gaining entry above. It was determined that (2) locations are creating moisture intrusion issues. (1) location is the toilet directly above (2) location is the floor and wall intersection where there were small spaces that were not sealed. Building owner stated that water gets in by the door and puddles.

Cause: Wax ring at the toilet is defective and needs to be replaced. The doorway is allowing water to puddle.

Remedy: Contact a licensed plumber to analyze and replace the defective wax wring. Install a weather strip for the door bottom.

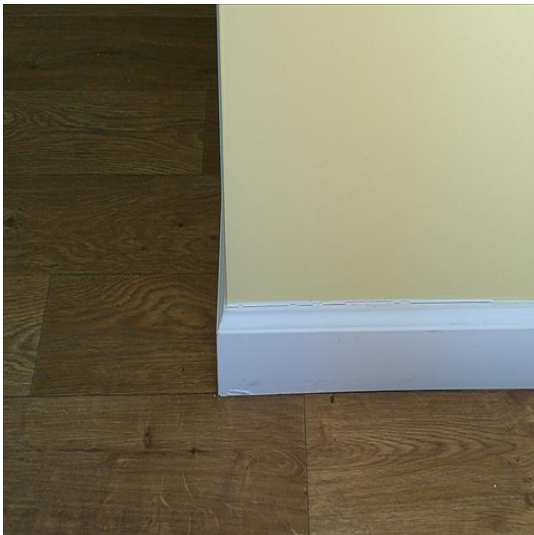
Image Number: 22

Observation: The interior was inspected and determined to have multiple locations with previous and current leaks. The meeting room downstairs was observed to have moisture staining indicating that water is gaining entry above. It was determined that (2) locations are creating moisture intrusion issues. (1) location is the toilet directly above (2) location is the floor and wall intersection where there were small spaces that were not sealed. Building owner stated that water gets in by the door and puddles.

Cause: Wax ring at the toilet is defective and needs to be replaced. The doorway is allowing water to puddle.

Remedy: Contact a licensed plumber to analyze and replace the defective wax wring. Install a weather strip for the door bottom.

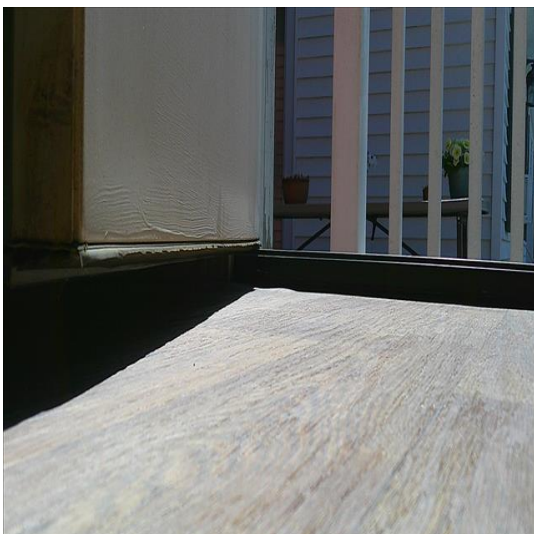
Image Number: 23

Observation: The interior was inspected and determined to have multiple locations with previous and current leaks. The meeting room downstairs was observed to have moisture staining indicating that water is gaining entry above. It was determined that (2) locations are creating moisture intrusion issues. (1) location is the toilet directly above (2) location is the floor and wall intersection where there were small spaces that were not sealed. Building owner stated that water gets in by the door and puddles.

Remedy: Contact a licensed plumber to analyze and replace the defective wax wring. Install a weather strip for the door bottom.

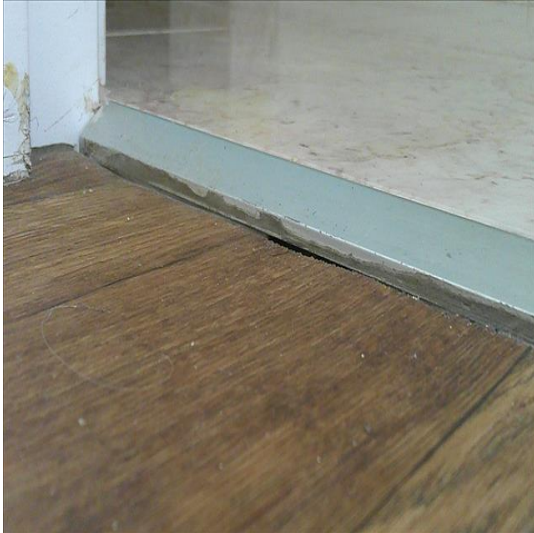
Image Number: 24

Observation: The interior was inspected and determined to have multiple locations with previous and current leaks. The meeting room downstairs was observed to have moisture staining indicating that water is gaining entry above. It was determined that (2) locations are creating moisture intrusion issues. (1) location is the toilet directly above (2) location is the floor and wall intersection where there were small spaces that were not sealed. Building owner stated that water gets in by the door and puddles.

Cause: Wax ring at the toilet is defective and needs to be replaced. The doorway is allowing water to puddle.

Remedy: Contact a licensed plumber to analyze and replace the defective wax ring. Install a weather strip for the door bottom.

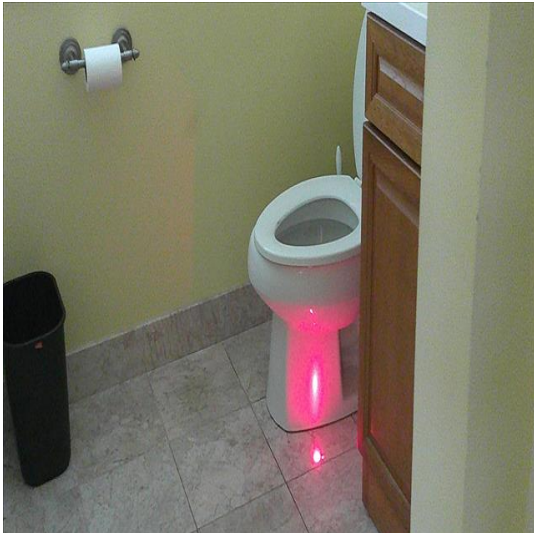
Image Number: 25

Observation: The interior was inspected and determined to have multiple locations with previous and current leaks. The meeting room downstairs was observed to have moisture staining indicating that water is gaining entry above. It was determined that (2) locations are creating moisture intrusion issues. (1) location is the toilet directly above (2) location is the floor and wall intersection where there were small spaces that were not sealed. Building owner stated that water gets in by the door and puddles.

Cause: Wax ring at the toilet is defective and needs to be replaced. The doorway is allowing water to puddle.

Remedy: Contact a licensed plumber to analyze and replace the defective wax ring. Install a weather strip for the door bottom.

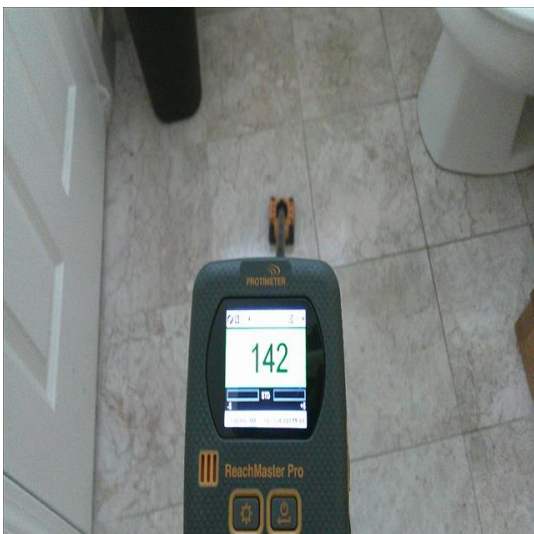
Image Number: 26

Observation: The interior was inspected and determined to have multiple locations with previous and current leaks. The meeting room downstairs was observed to have moisture staining indicating that water is gaining entry above. It was determined that (2) locations are creating moisture intrusion issues. (1) location is the toilet directly above (2) location is the floor and wall intersection where there were small spaces that were not sealed. Building owner stated that water gets in by the door and puddles.

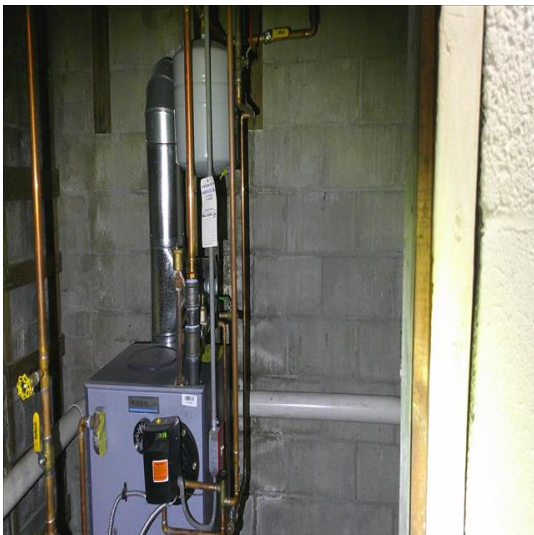
Image Number: 39

Observation: The utility room which is under the pitched roof at the rear of the building was observed to have active moisture intrusion at time of inspection. This was also indicated by the presence of efflorescence (the mineral deposits of water as it leaves masonry).

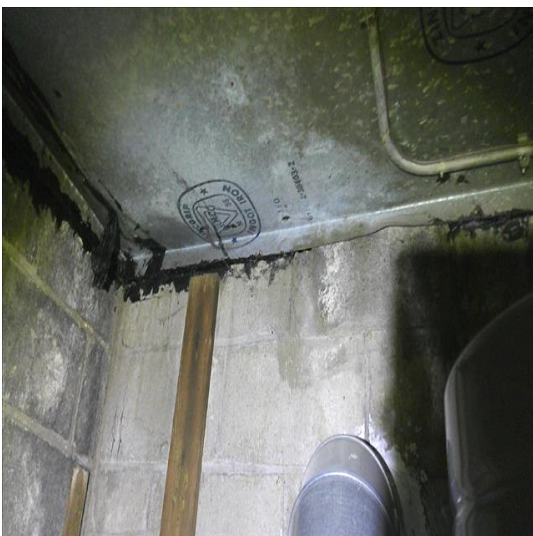
Image Number: 42

Observation: The utility room which is under the pitched roof at the rear of the building was observed to have active moisture intrusion at time of inspection. This was also indicated by the presence of efflorescence (the mineral deposits of water as it leaves masonry).

Remedy: Replace flashing, drip edge and further evaluate gutter system at this location.

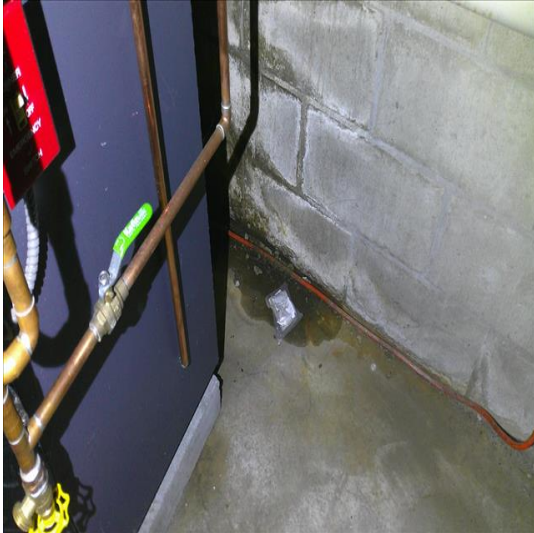
Image Number: 43

Observation: The utility room which is under the pitched roof at the rear of the building was observed to have active moisture intrusion at time of inspection. This was also indicated by the presence of efflorescence (the mineral deposits of water as it leaves masonry).

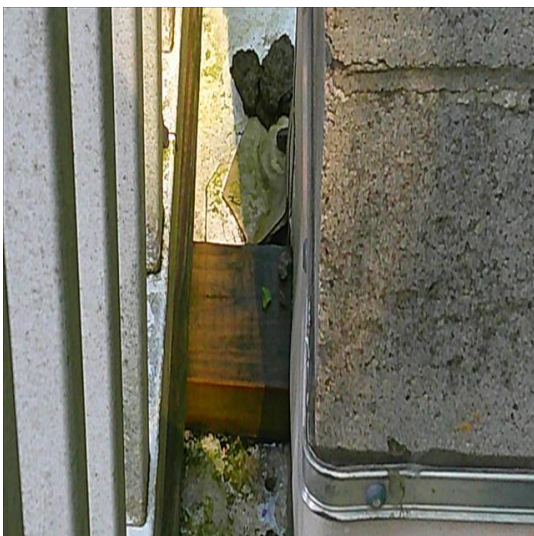
Image Number: 47

Observation: The masonry chimney was observed to have incorrect integration from the roof to the chimney at time of inspection. The corners/curbs were not weathertight and had openings at the transition base and the material did not overlap the roof correctly.

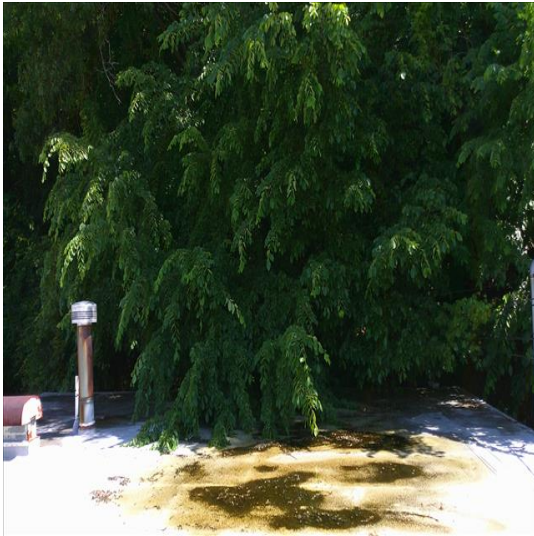
Image Number: 51

Observation: An overhanging tree was observed to be making direct contact with the roof coverings at time of inspection. This may cause damage from falling branches, accelerated deterioration of the roof surface and difficulty for water to properly drain or dry.

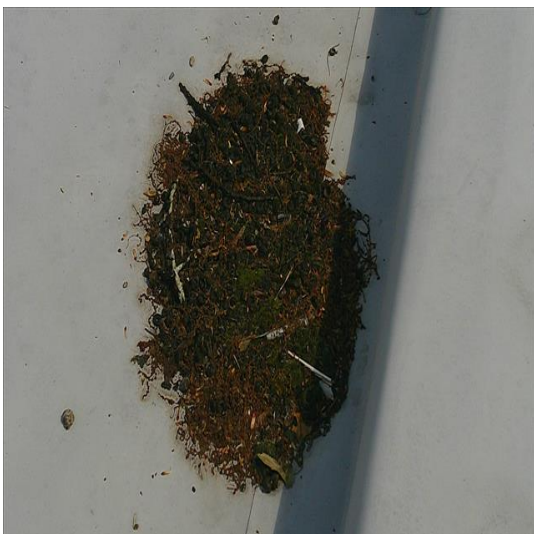
Image Number: 54

Observation: Debris was observed to be present on the roof at time of inspection. This is an issue as if these items are stepped on or compressed into the roof surface, the potential for damage that causes leaking is high. TPO roofs are known for having pin size penetrations that create major leaks and water intrusion.

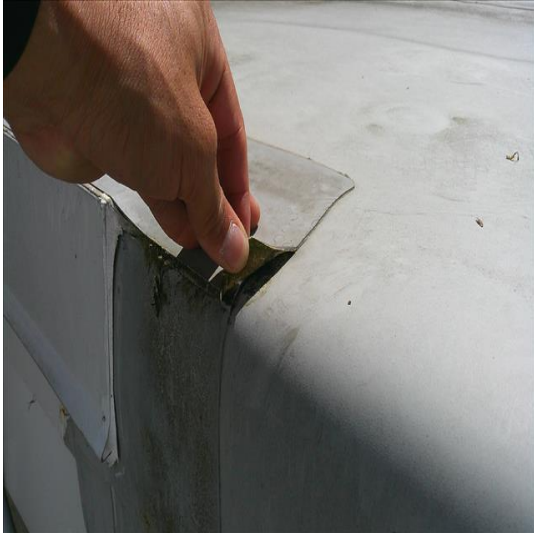
Image Number: 58

Observation: Joining flashings at some locations were observed to have adhesion failure or be improperly installed with incorrect materials. One joint flashing was observed to have adhesion failure, and another was observed to have incorrect sealant (caulk) used instead of recommended adhesive for this roof material. Caulk is not a valid form of flashing and has a general serviceable expectancy of 5 years.

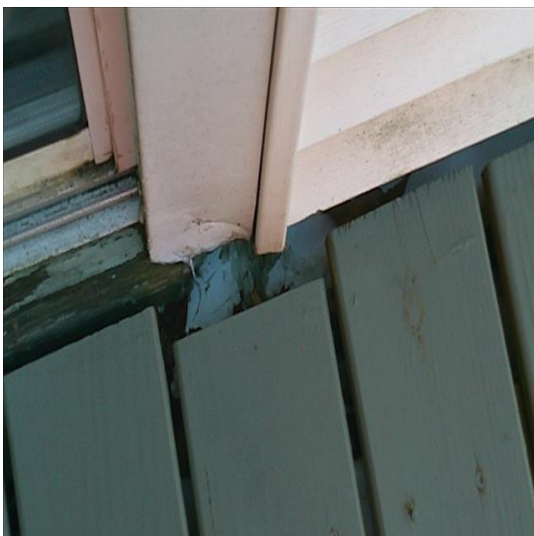
Image Number: 60

Observation: The TPO roof was observed to be incorrectly installed at time of inspection and a seam probe was initiated to determine sources of leaks and stability of roof. The roof was essentially "loose laid" in many areas. The roof was not ballasted. These locations were also directly above the leak locations within the interior. 1) adhesion failure was observed 2) improper curbing was observed 3) incorrect termination of roof material at headwall was observed 4) overlap of roofing material was incorrectly installed

Cause: Improper installation.

Determination: Replacement required

Remedy: Roof replacement is required. The roof has no watertight seal and is allowing moisture to gain entry.

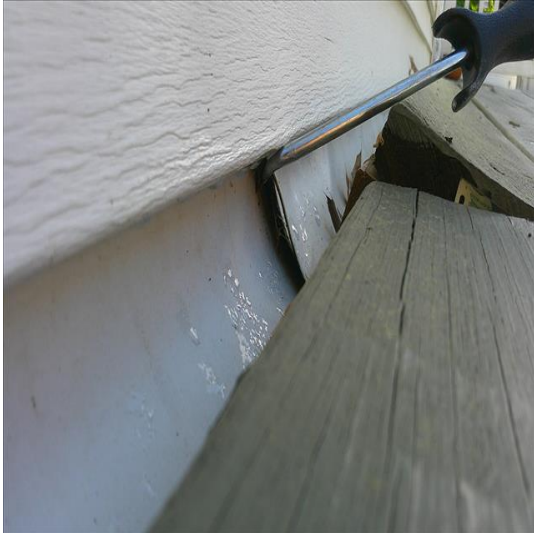
Image Number: 61

Observation: The TPO roof was observed to be incorrectly installed at time of inspection and a seam probe was initiated to determine sources of leaks and stability of roof. The roof was essentially "loose laid" in many areas. The roof was not ballasted. These locations were also directly above the leak locations within the interior. 1) adhesion failure was observed 2) improper curbing was observed 3) incorrect termination of roof material at headwall was observed 4) overlap of roofing material was incorrectly installed

Cause: Improper installation.

Determination: Replacement required

Remedy: Roof replacement is required. The roof has no watertight seal and is allowing moisture to gain entry.

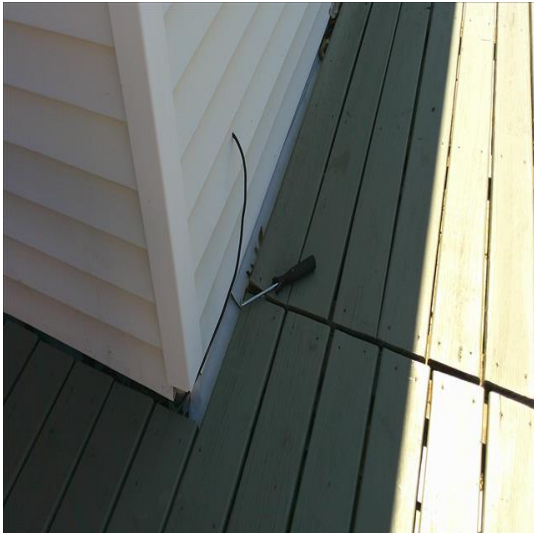
Image Number: 62

Observation: The TPO roof was observed to be incorrectly installed at time of inspection and a seam probe was initiated to determine sources of leaks and stability of roof. The roof was essentially "loose laid" in many areas. The roof was not ballasted. These locations were also directly above the leak locations within the interior. 1) adhesion failure was observed 2) improper curbing was observed 3) incorrect termination of roof material at headwall was observed 4) overlap of roofing material was incorrectly installed

Cause: Improper installation.

Determination: Replacement required

Remedy: Roof replacement is required. The roof has no watertight seal and is allowing moisture to gain entry.

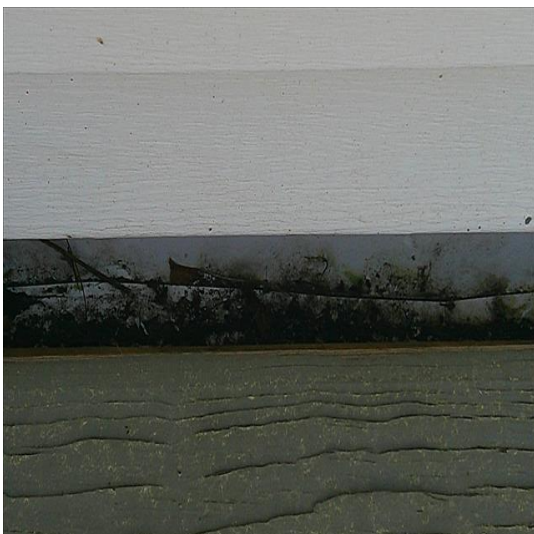
Image Number: 63

Observation: The TPO roof was observed to be incorrectly installed at time of inspection and a seam probe was initiated to determine sources of leaks and stability of roof. The roof was essentially "loose laid" in many areas. The roof was not ballasted. These locations were also directly above the leak locations within the interior. 1) adhesion failure was observed 2) improper curbing was observed 3) incorrect termination of roof material at headwall was observed 4) overlap of roofing material was incorrectly installed

Cause: Improper installation.

Determination: Replacement required

Remedy: Roof replacement is required. The roof has no watertight seal and is allowing moisture to gain entry.

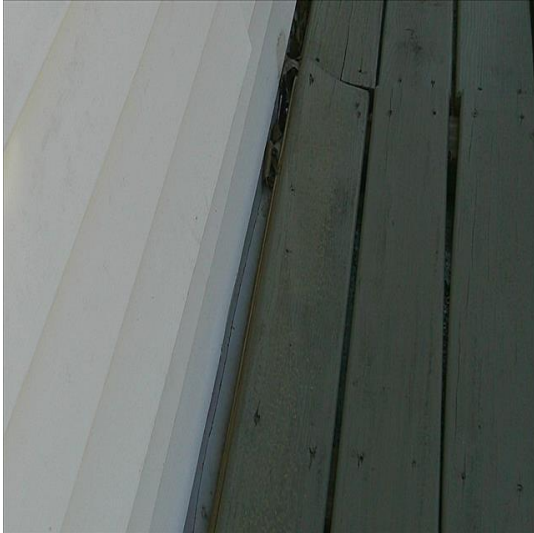
Image Number: 64

Observation: The TPO roof was observed to be incorrectly installed at time of inspection and a seam probe was initiated to determine sources of leaks and stability of roof. The roof was essentially "loose laid" in many areas. The roof was not ballasted. These locations were also directly above the leak locations within the interior. 1) adhesion failure was observed 2) improper curbing was observed 3) incorrect termination of roof material at headwall was observed 4) overlap of roofing material was incorrectly installed

Cause: Improper installation.

Determination: Replacement required

Remedy: Roof replacement is required. The roof has no watertight seal and is allowing moisture to gain entry.

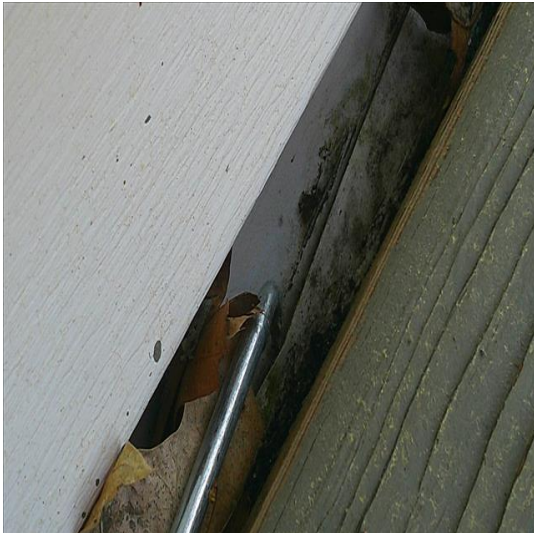
Image Number: 65

Observation: The TPO roof was observed to be incorrectly installed at time of inspection and a seam probe was initiated to determine sources of leaks and stability of roof. The roof was essentially "loose laid" in many areas. The roof was not ballasted. These locations were also directly above the leak locations within the interior. 1) adhesion failure was observed 2) improper curbing was observed 3) incorrect termination of roof material at headwall was observed 4) overlap of roofing material was incorrectly installed

Cause: Improper installation.

Determination: Replacement required

Remedy: Roof replacement is required. The roof has no watertight seal and is allowing moisture to gain entry.

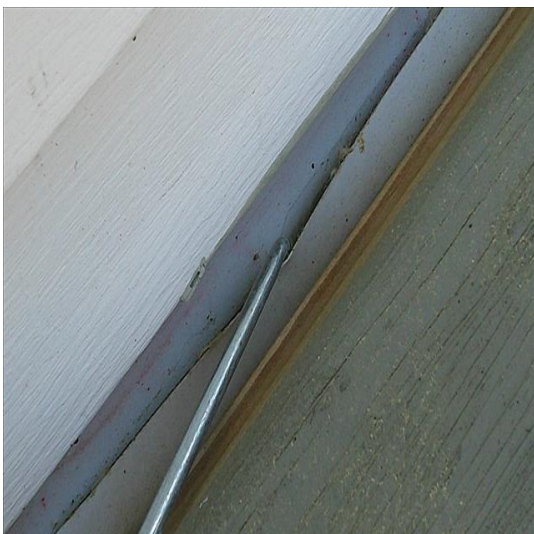
Image Number: 66

Observation: The TPO roof was observed to be incorrectly installed at time of inspection and a seam probe was initiated to determine sources of leaks and stability of roof. The roof was essentially "loose laid" in many areas. The roof was not ballasted. These locations were also directly above the leak locations within the interior. 1) adhesion failure was observed 2) improper curbing was observed 3) incorrect termination of roof material at headwall was observed 4) overlap of roofing material was incorrectly installed

Cause: Improper installation.

Determination: Replacement required

Remedy: Roof replacement is required. The roof has no watertight seal and is allowing moisture to gain entry.

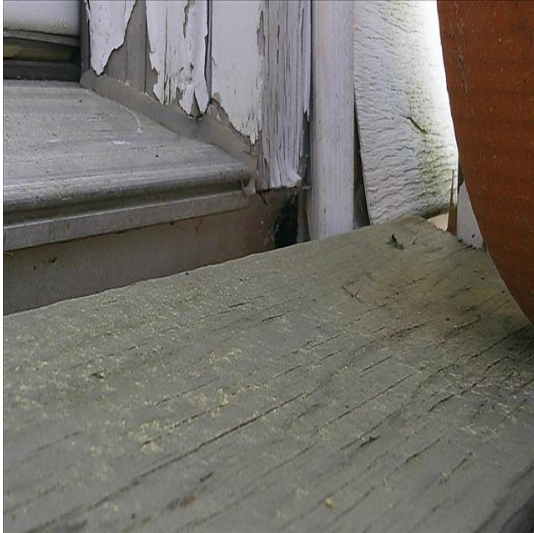
Image Number: 67

Observation: The TPO roof was observed to be incorrectly installed at time of inspection and a seam probe was initiated to determine sources of leaks and stability of roof. The roof was essentially "loose laid" in many areas. The roof was not ballasted. These locations were also directly above the leak locations within the interior. 1) adhesion failure was observed 2) improper curbing was observed 3) incorrect termination of roof material at headwall was observed 4) overlap of roofing material was incorrectly installed

Cause: Improper installation.

Determination: Replacement required

Remedy: Roof replacement is required. The roof has no watertight seal and is allowing moisture to gain entry.

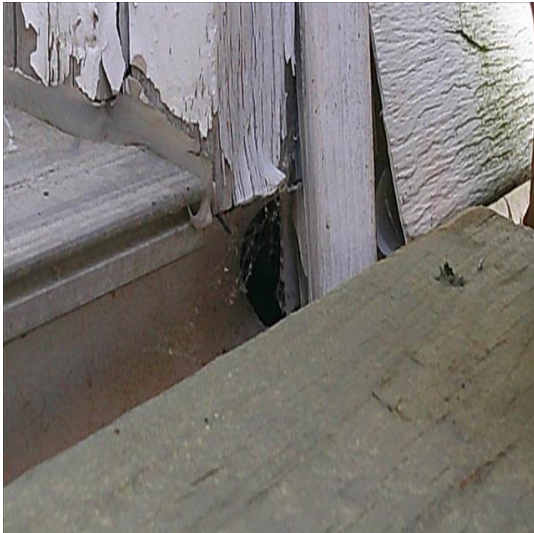
Image Number: 68

Observation: The TPO roof was observed to be incorrectly installed at time of inspection and a seam probe was initiated to determine sources of leaks and stability of roof. The roof was essentially "loose laid" in many areas. The roof was not ballasted. These locations were also directly above the leak locations within the interior. 1) adhesion failure was observed 2) improper curbing was observed 3) incorrect termination of roof material at headwall was observed 4) overlap of roofing material was incorrectly installed

Cause: Improper installation.

Determination: Replacement required

Remedy: Roof replacement is required. The roof has no watertight seal and is allowing moisture to gain entry.

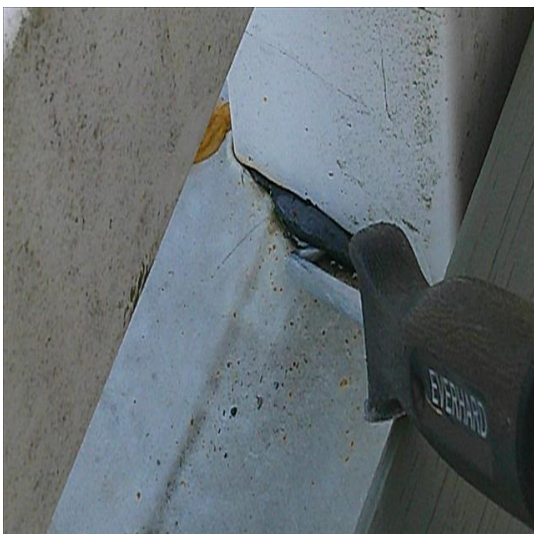
Image Number: 69

Observation: The TPO roof was observed to be incorrectly installed at time of inspection and a seam probe was initiated to determine sources of leaks and stability of roof. The roof was essentially "loose laid" in many areas. The roof was not ballasted. These locations were also directly above the leak locations within the interior. 1) adhesion failure was observed 2) improper curbing was observed 3) incorrect termination of roof material at headwall was observed 4) overlap of roofing material was incorrectly installed

Cause: Improper installation.

Determination: Replacement required

Remedy: Roof replacement is required. The roof has no watertight seal and is allowing moisture to gain entry.

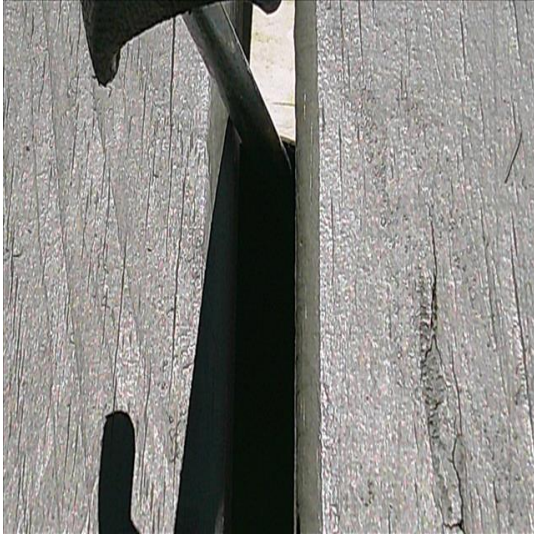
Image Number: 70

Observation: The TPO roof was observed to be incorrectly installed at time of inspection and a seam probe was initiated to determine sources of leaks and stability of roof. The roof was essentially "loose laid" in many areas. The roof was not ballasted. These locations were also directly above the leak locations within the interior. 1) adhesion failure was observed 2) improper curbing was observed 3) incorrect termination of roof material at headwall was observed 4) overlap of roofing material was incorrectly installed

Cause: Improper installation.

Determination: Replacement required

Remedy: Roof replacement is required. The roof has no watertight seal and is allowing moisture to gain entry.

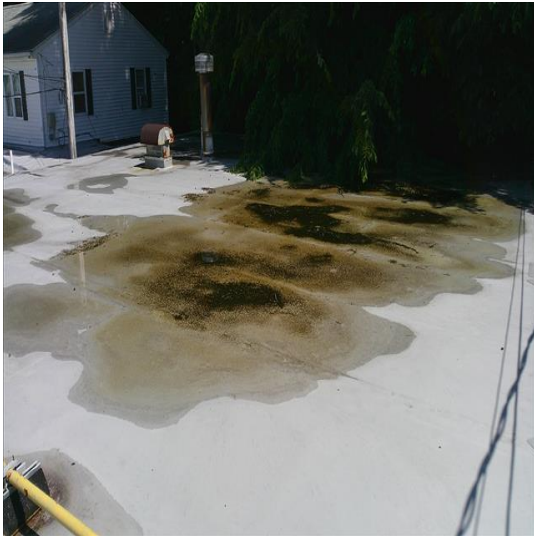
Image Number: 71

Observation: Ponding was observed at time of inspection. A weather report was initiated for the property to determine the last recorded precipitation, with the last day of rain recorded on the 6 of June. Building owner stated that precipitation was noted after the 6 of June and before the inspection. The presence of ponding after 72 hours is problematic as the weight of the standing water may pose structural issues and damage to the roof covering.

Cause: Improper integration of the slope to assist in drainage. Lack of drainage.

Determination: Replacement required

Remedy: Install internal roof drainage system (AND/OR) consider a tapered insulation system or LWIC (lightweight insulated concrete) to achieve proper slope to assist in drainage.

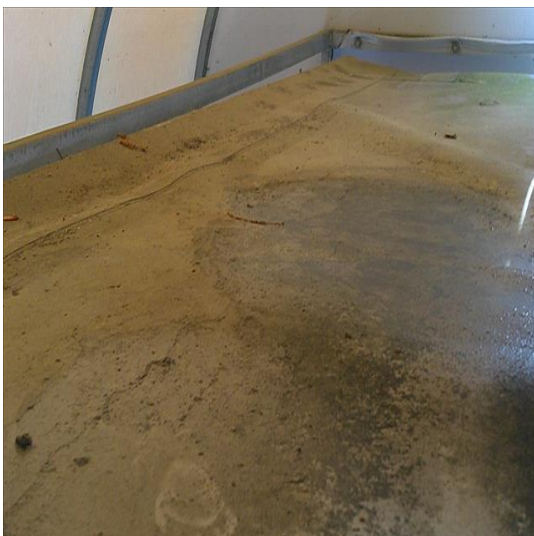
Image Number: 72

Observation: The TPO roof was observed to have improper termination at edges at time of inspection. The material was terminated appropriately 1/4" from the surface of the edge of the roof at all locations. A termination bar or a coated TPO coated drip edge with welding was not observed at time of inspection.

Cause: Improper installation.

Determination: Replacement required

Remedy: A termination bar of some nature or a TPO coated drip edge with weld needs to be installed to prevent moisture from running back under the roof surface.

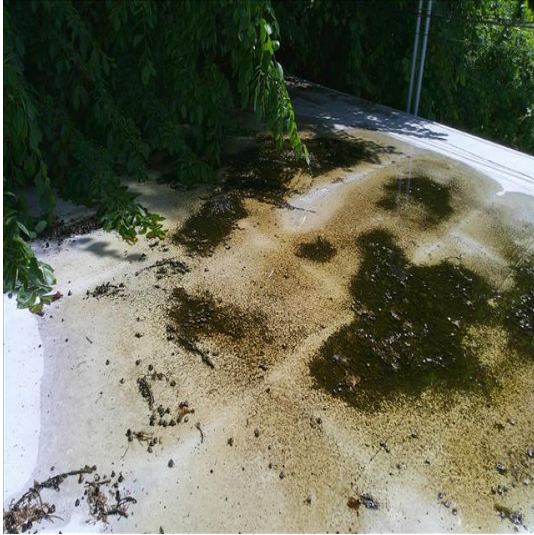
Image Number: 73

Observation: Ponding was observed at time of inspection. A weather report was initiated for the property to determine the last recorded precipitation, with the last day of rain recorded on the 6 of June. Building owner stated that precipitation was noted after the 6 of June and before the inspection. The presence of ponding after 72 hours is problematic as the weight of the standing water may pose structural issues and damage to the roof covering.

Cause: Improper integration of the slope to assist in drainage. Lack of drainage.

Determination: Replacement required

Remedy: Install internal roof drainage system (AND/OR) consider a tapered insulation system or LWIC (lightweight insulated concrete) to achieve proper slope to assist in drainage.

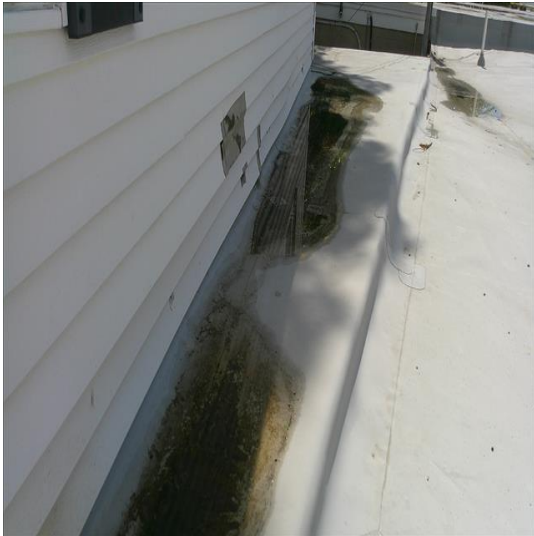
Image Number: 74

Observation: Ponding was observed at time of inspection. A weather report was initiated for the property to determine the last recorded precipitation, with the last day of rain recorded on the 6 of June. Building owner stated that precipitation was noted after the 6 of June and before the inspection. The presence of ponding after 72 hours is problematic as the weight of the standing water may pose structural issues and damage to the roof covering.

Cause: Improper integration of the slope to assist in drainage. Lack of drainage.

Determination: Replacement required

Remedy: Install internal roof drainage system (AND/OR) consider a tapered insulation system or LWIC (lightweight insulated concrete) to achieve proper slope to assist in drainage.

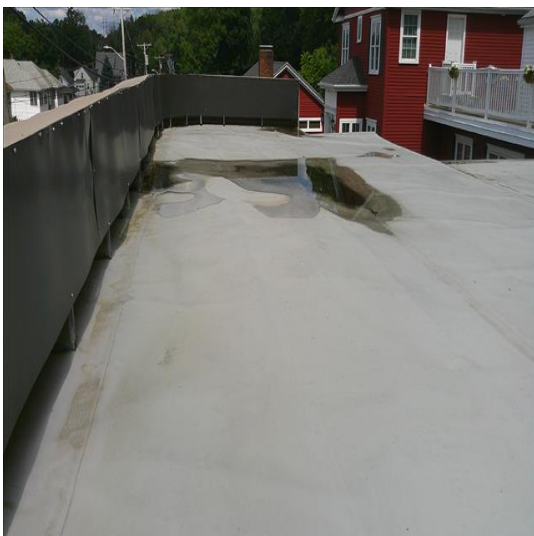
Image Number: 75

Observation: Ponding was observed at time of inspection. A weather report was initiated for the property to determine the last recorded precipitation, with the last day of rain recorded on the 6 of June. Building owner stated that precipitation was noted after the 6 of June and before the inspection. The presence of ponding after 72 hours is problematic as the weight of the standing water may pose structural issues and damage to the roof covering.

Cause: Improper integration of the slope to assist in drainage. Lack of drainage.

Determination: Replacement required

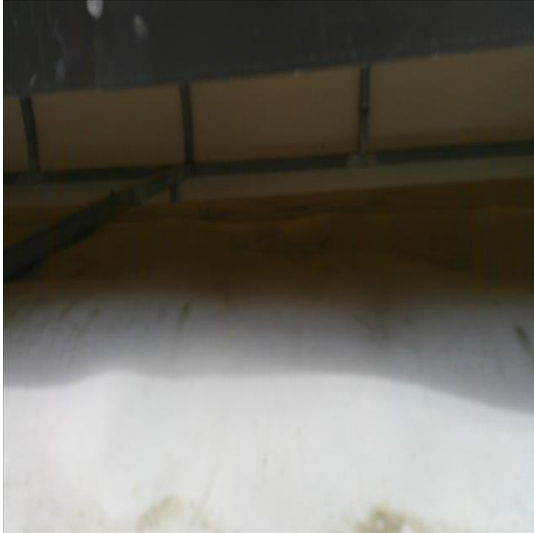
Image Number: 76

Observation: The TPO roof was observed to have improper termination at edges at time of inspection. The material was terminated appropriately 1/4" from the surface of the edge of the roof at all locations. A termination bar or a coated TPO coated drip edge with welding was not observed at time of inspection.

Cause: Improper installation.

Determination: Replacement required

Remedy: A termination bar of some nature or a TPO coated drip edge with weld needs to be installed to prevent moisture from running back under the roof surface.

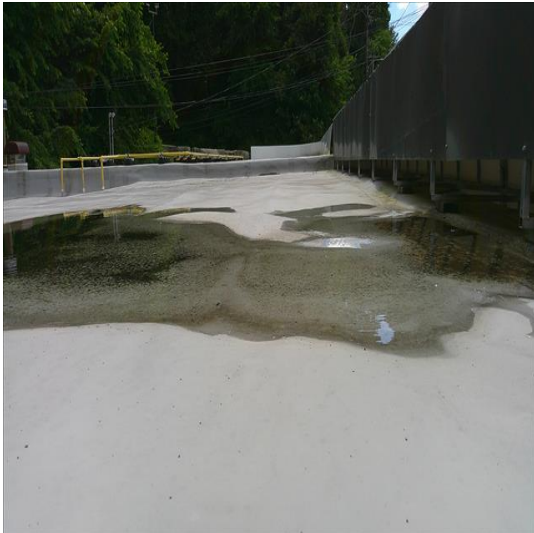
Image Number: 77

Observation: Ponding was observed at time of inspection. A weather report was initiated for the property to determine the last recorded precipitation, with the last day of rain recorded on the 6 of June. Building owner stated that precipitation was noted after the 6 of June and before the inspection. The presence of ponding after 72 hours is problematic as the weight of the standing water may pose structural issues and damage to the roof covering.

Cause: Improper integration of the slope to assist in drainage. Lack of drainage.

Determination: Replacement required

Remedy: Install internal roof drainage system (AND/OR) consider a tapered insulation system or LWIC (lightweight insulated concrete) to achieve proper slope to assist in drainage.

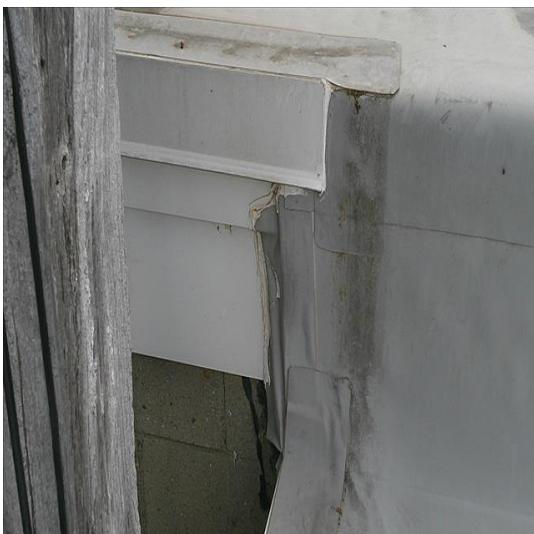
Image Number: 78

Observation: The TPO roof was observed to have improper termination at edges at time of inspection. The material was terminated appropriately 1/4" from the surface of the edge of the roof at all locations. A termination bar or a coated TPO coated drip edge with welding was not observed at time of inspection.

Cause: Improper installation.

Determination: Replacement required

Remedy: A termination bar of some nature or a TPO coated drip edge with weld needs to be installed to prevent moisture from running back under the roof surface.

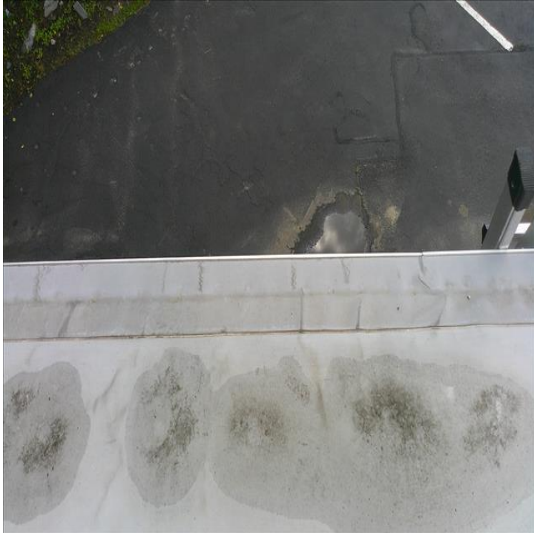
Image Number: 79

Observation: The TPO roof was observed to have improper termination at edges at time of inspection. The material was terminated appropriately 1/4" from the surface of the edge of the roof at all locations. A termination bar or a coated TPO coated drip edge with welding was not observed at time of inspection.

Cause: Improper installation.

Determination: Replacement required

Remedy: A termination bar of some nature or a TPO coated drip edge with weld needs to be installed to prevent moisture from running back under the roof surface.

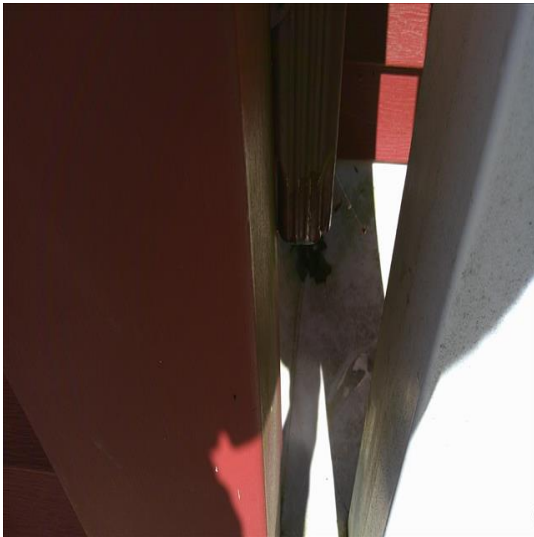
Image Number: 80

Observation: Gutter downspout was observed to be draining directly onto the roof surface at time of inspection. This may create accelerated deterioration of the area. Gutters were observed to have debris present and gutter was pulling away from fascia in (1) location.

Cause: Improper installation / deferred maintenance.

Determination: Replacement required

Remedy: Connect a downspout to the gutter that is terminating directly onto the roof surface at the rear of the building. Fasten gutters to fascia to prevent gutters from damaging the fascia and potentially being compromised and clean gutters.

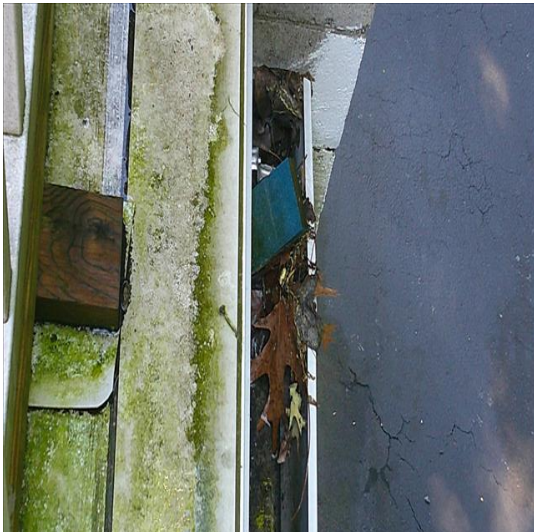
Image Number: 81

Observation: Gutter downspout was observed to be draining directly onto the roof surface at time of inspection. This may create accelerated deterioration of the area. Gutters were observed to have debris present and gutter was pulling away from fascia in (1) location.

Cause: Improper installation / deferred maintenance.

Determination: Replacement required

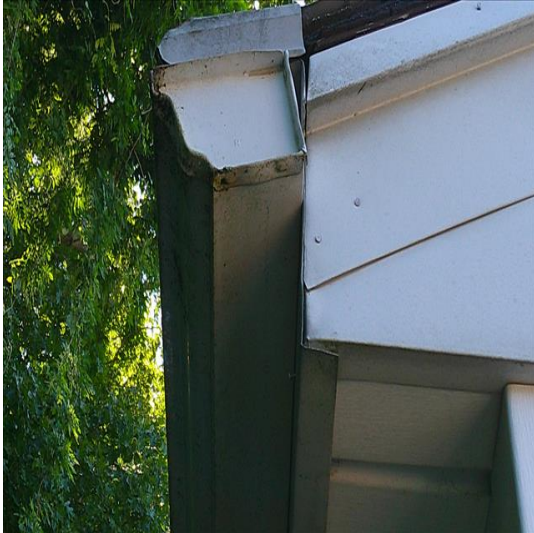
Image Number: 82

Observation: Gutter downspout was observed to be draining directly onto the roof surface at time of inspection. This may create accelerated deterioration of the area. Gutters were observed to have debris present and gutter was pulling away from fascia in (1) location.

Cause: Improper installation / deferred maintenance.

Determination: Replacement required

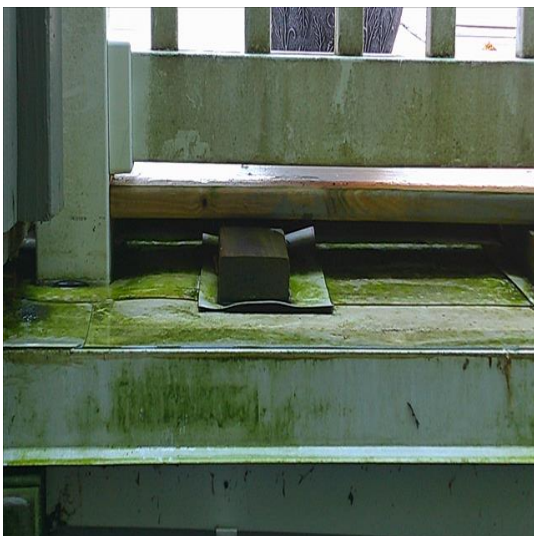
Image Number: 85

Observation: Improper installation of roof decking over the roof surface was observed at time of inspection. 2x4's are not an acceptable form of roof decking pedestals.

Cause: Improper installation.

Determination: Replacement required

Remedy: Replace 2x4's with the correct pedestals.

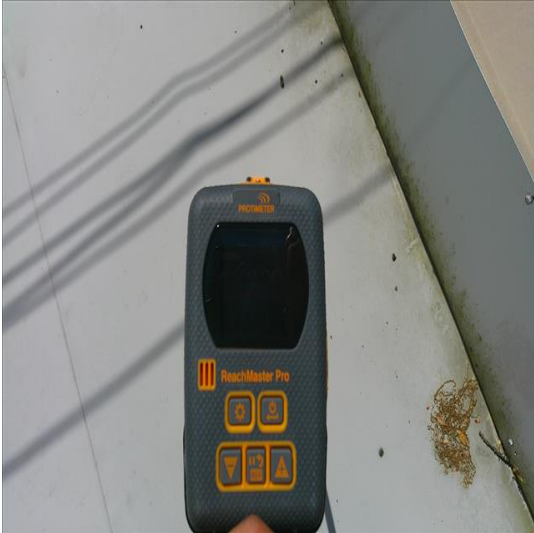
Image Number: 86
Observation: A moisture meter reading was conducted on the TPO roof and it was determined that some areas near the tenting or billowing of the material had moisture readings that were higher than the standard acceptable rate. The photo is hard to see but the number on this recording was upwards of 300 in the red, which for this meter is high.
Cause: Improper installation of roof.
Remedy: Replacement of roof is recommended.
Determination: Replacement required

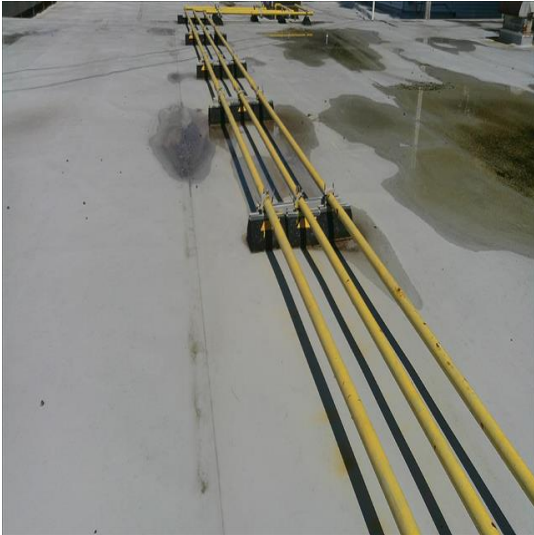
Image Number: 87
Observation: The gas lines were observed to be properly coated in yellow to alert to the presence of gas lines on the roof and properly chaired with a layer of roofing to prevent damage to the roof, at time of inspection.

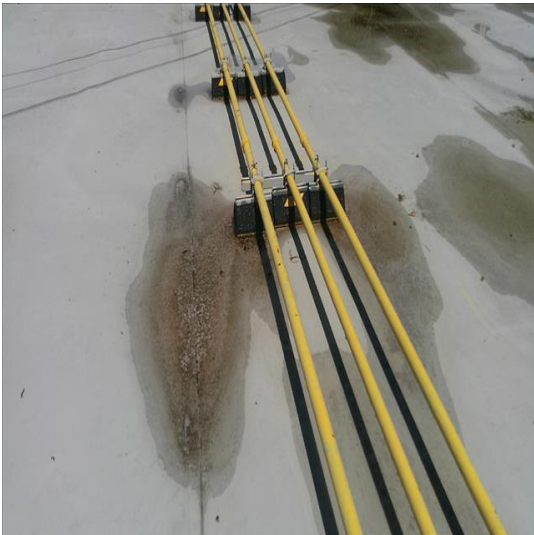
Image Number: 88
Observation: The gas lines were observed to be properly coated in yellow to alert to the presence of gas lines on the roof and properly chaired with a layer of roofing to prevent damage to the roof, at time of inspection.

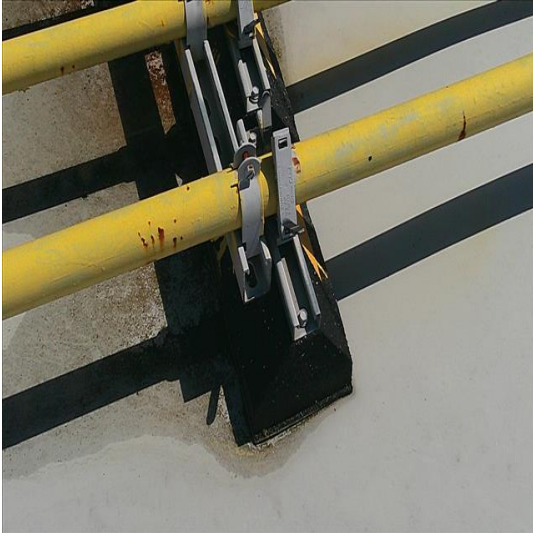
Image Number: 89

Observation: The gas lines were observed to be properly coated in yellow to alert to the presence of gas lines on the roof and properly chaired with a layer of roofing to prevent damage to the roof, at time of inspection.

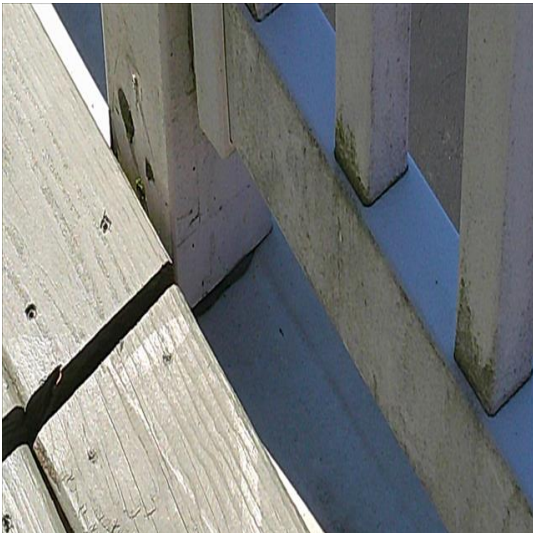
Image Number: 91

Observation: Improper installation of the fencing for the roof was observed at time of inspection. The area directly below this section had leaking observed at time of inspection. This is due to the improper flashing and integration of this penetration into a flat roof. Sealant was improperly distributed in the place of flashing.

Cause: Improper installation.

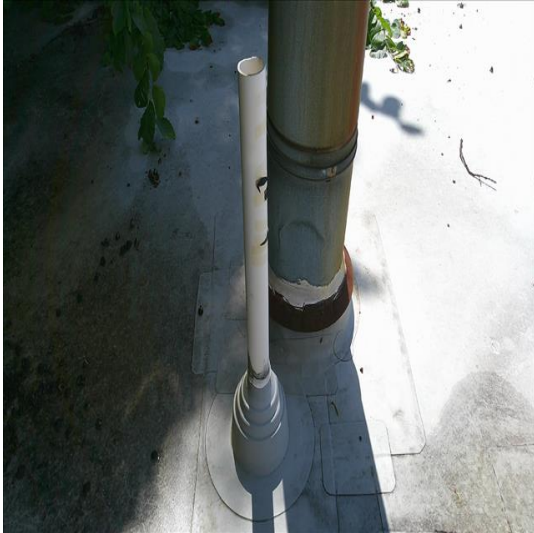
Image Number: 92

Observation: Incorrect installation of roof penetration flashings were observed in some areas at time of inspection. (3) vents were observed to be properly flashed and sealed and (1) RTU (rooftop unit) were observed to have correct curb flashing whereas (2) pipe flashings and (1) curb were observed to have incorrect and non watertight flashing and incorrect installation/integration.

Cause: Improper installation.

Determination: Replacement required

Remedy: Replace these flashings and integrations and ensure that they are watertight. The TPO roof systems need to be correctly integrated into pipes and curbs to ensure moisture does not gain entry.

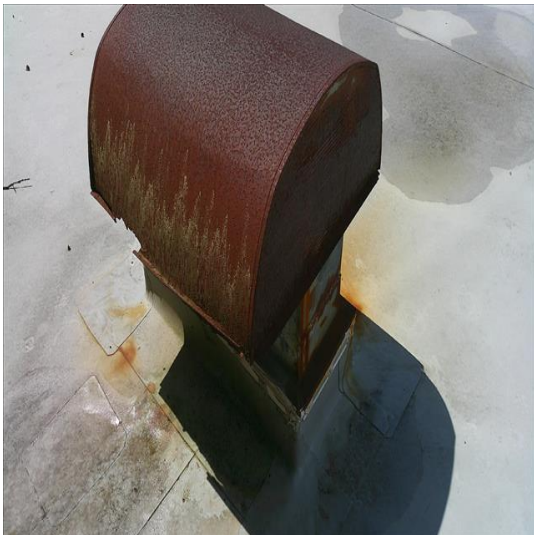
Image Number: 93

Observation: Incorrect installation of roof penetration flashings were observed in some areas at time of inspection. (3) vents were observed to be properly flashed and sealed and (1) RTU (rooftop unit) were observed to have correct curb flashing whereas (2) pipe flashings and (1) curb were observed to have incorrect and non watertight flashing and incorrect installation/integration.

Cause: Improper installation.

Determination: Replacement required

Remedy: Replace these flashings and integrations and ensure that they are watertight. The TPO roof systems need to be correctly integrated into pipes and curbs to ensure moisture does not gain entry.

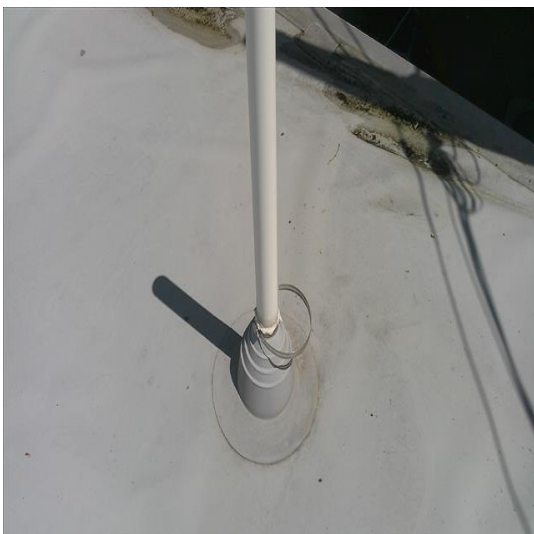
Image Number: 94

Observation: Incorrect installation of roof penetration flashings were observed in some areas at time of inspection. (3) vents were observed to be properly flashed and sealed and (1) RTU (rooftop unit) were observed to have correct curb flashing whereas (2) pipe flashings and (1) curb were observed to have incorrect and non watertight flashing and incorrect installation/integration.

Cause: Improper installation.

Determination: Replacement required

Remedy: Replace these flashings and integrations and ensure that they are watertight. The TPO roof systems need to be correctly integrated into pipes and curbs to ensure moisture does not gain entry.
