LeakFREE® Roof Inspection

Report No :
130075

Property Inspected :
[REDACTED]
[REDACTED]

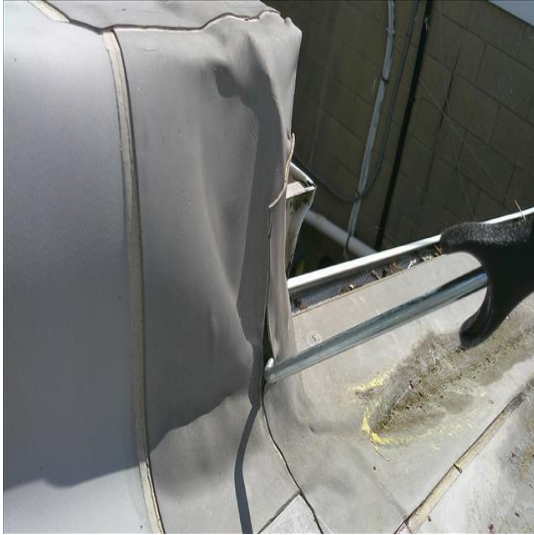
Image Number: 95

Observation: Incorrect installation of roof penetration flashings were observed in some areas at time of inspection. (3) vents were observed to be properly flashed and sealed and (1) RTU (rooftop unit) were observed to have correct curb flashing whereas (2) pipe flashings and (1) curb were observed to have incorrect and non watertight flashing and incorrect installation/integration.

Cause: Improper installation.

Determination: Replacement required

Remedy: Replace these flashings and integrations and ensure that they are watertight. The TPO roof systems need to be correctly integrated into pipes and curbs to ensure moisture does not gain entry.

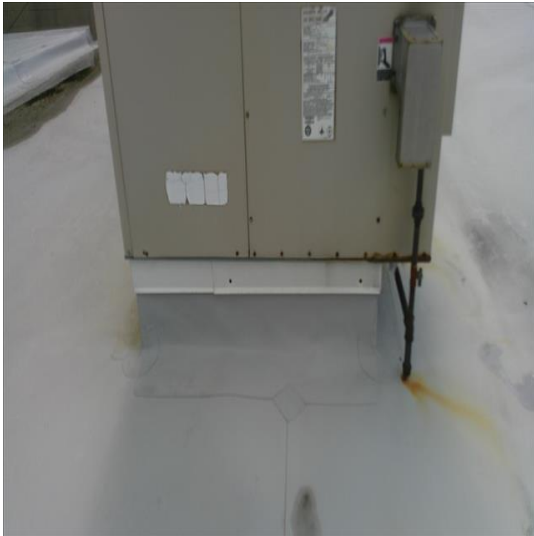
Image Number: 96

Observation: Incorrect installation of roof penetration flashings were observed in some areas at time of inspection. (3) vents were observed to be properly flashed and sealed and (1) RTU (rooftop unit) were observed to have correct curb flashing whereas (2) pipe flashings and (1) curb were observed to have incorrect and non watertight flashing and incorrect installation/integration.

Cause: Improper installation.

Determination: Replacement required

Remedy: Replace these flashings and integrations and ensure that they are watertight. The TPO roof systems need to be correctly integrated into pipes and curbs to ensure moisture does not gain entry.

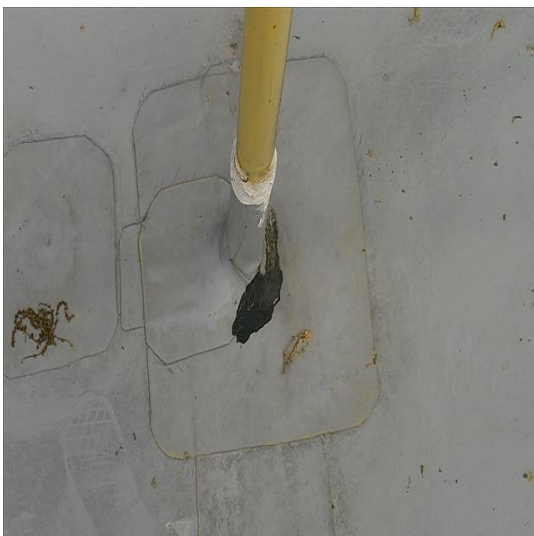
Image Number: 97

Observation: Incorrect installation of roof penetration flashings were observed in some areas at time of inspection. (3) vents were observed to be properly flashed and sealed and (1) RTU (rooftop unit) were observed to have correct curb flashing whereas (2) pipe flashings and (1) curb were observed to have incorrect and non watertight flashing and incorrect installation/integration.

Cause: Improper installation.

Determination: Replacement required

Remedy: Replace these flashings and integrations and ensure that they are watertight. The TPO roof systems need to be correctly integrated into pipes and curbs to ensure moisture does not gain entry.

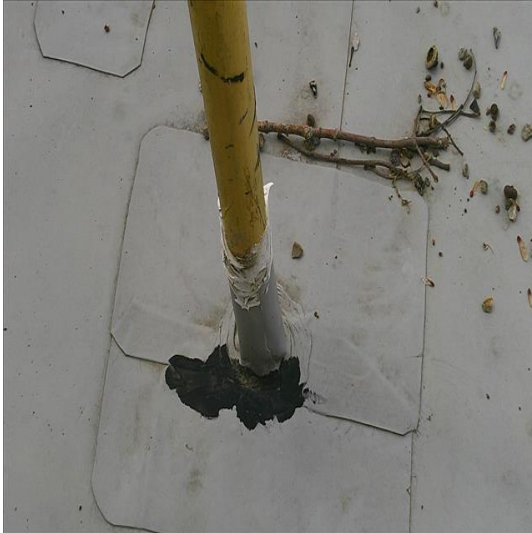
Image Number: 98

Observation: Incorrect installation of roof penetration flashings were observed in some areas at time of inspection. (3) vents were observed to be properly flashed and sealed and (1) RTU (rooftop unit) were observed to have correct curb flashing whereas (2) pipe flashings and (1) curb were observed to have incorrect and non watertight flashing and incorrect installation/integration.

Cause: Improper installation.

Determination: Replacement required

Remedy: Replace these flashings and integrations and ensure that they are watertight. The TPO roof systems need to be correctly integrated into pipes and curbs to ensure moisture does not gain entry.

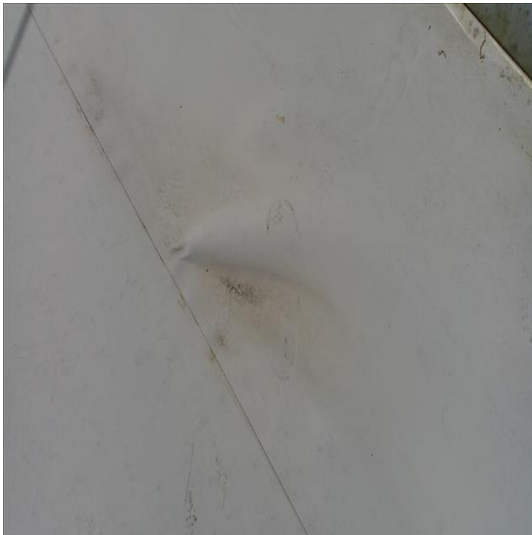
Image Number: 99

Observation: The TPO roof system over the dog grooming facility was observed to have the following deficiencies that require attention; 1) Tenting was observed at locations where a wall/vertical transition was present 2) billowing 3) wrinkling of material. All of these issues indicate that improper installation occurred, and that water is making its way under the material and causing the tenting, billowing and wrinkling. The building owner did not mention if another roof covering is below the current roof. These deficiencies occur for (2) reasons. 1) gases from underlying roof materials are expelling and causing these deficiencies 2) water is getting under the roof surface and creating air pockets and these issues.

Cause: Improper installation of the roof. It is not watertight.

Determination: Replacement required

Remedy: Replacement of roof or a core sample is required to determine extent of damage.

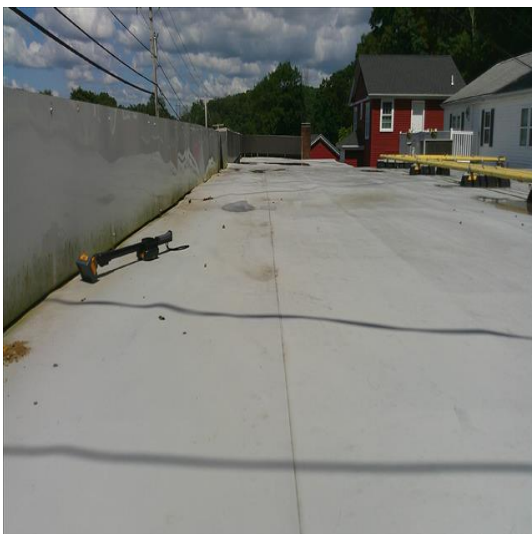
Image Number: 100

Observation: The TPO roof system over the dog grooming facility was observed to have the following deficiencies that require attention; 1) Tenting was observed at locations where a wall/vertical transition was present 2) billowing 3) wrinkling of material. All of these issues indicate that improper installation occurred, and that water is making its way under the material and causing the tenting, billowing and wrinkling. The building owner did not mention if another roof covering is below the current roof. These deficiencies occur for (2) reasons. 1) gases from underlying roof materials are expelling and causing these deficiencies 2) water is getting under the roof surface and creating air pockets and these issues.

Cause: Improper installation of the roof. It is not watertight.

Determination: Replacement required

Remedy: Replacement of roof or a core sample is required to determine extent of damage.

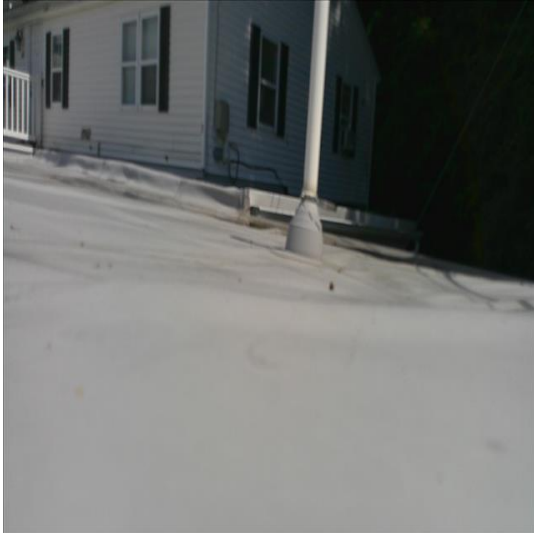
Image Number: 101

Observation: The TPO roof system over the dog grooming facility was observed to have the following deficiencies that require attention; 1) Tenting was observed at locations where a wall/vertical transition was present 2) billowing 3) wrinkling of material. All of these issues indicate that improper installation occurred, and that water is making its way under the material and causing the tenting, billowing and wrinkling. The building owner did not mention if another roof covering is below the current roof. These deficiencies occur for (2) reasons. 1) gases from underlying roof materials are expelling and causing these deficiencies 2) water is getting under the roof surface and creating air pockets and these issues.

Cause: Improper installation of the roof. It is not watertight.

Determination: Replacement required

Remedy: Replacement of roof or a core sample is required to determine extent of damage.

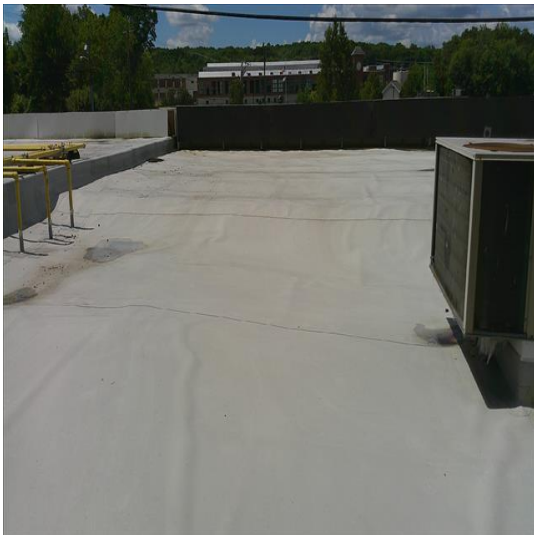
Image Number: 102

Observation: The TPO roof system over the dog grooming facility was observed to have the following deficiencies that require attention; 1) Tenting was observed at locations where a wall/vertical transition was present 2) billowing 3) wrinkling of material. All of these issues indicate that improper installation occurred, and that water is making its way under the material and causing the tenting, billowing and wrinkling. The building owner did not mention if another roof covering is below the current roof. These deficiencies occur for (2) reasons. 1) gases from underlying roof materials are expelling and causing these deficiencies 2) water is getting under the roof surface and creating air pockets and these issues.

Cause: Improper installation of the roof. It is not watertight.

Determination: Replacement required

Remedy: Replacement of roof or a core sample is required to determine extent of damage.

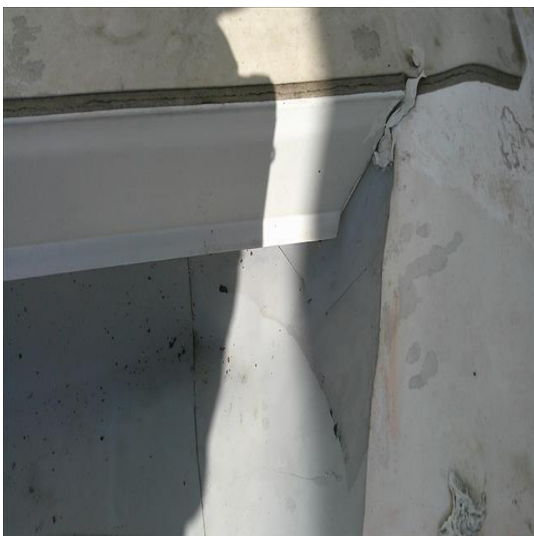
Image Number: 103

Observation: The TPO roof system over the dog grooming facility was observed to have the following deficiencies that require attention; 1) Tenting was observed at locations where a wall/vertical transition was present 2) billowing 3) wrinkling of material. All of these issues indicate that improper installation occurred, and that water is making its way under the material and causing the tenting, billowing and wrinkling. The building owner did not mention if another roof covering is below the current roof. These deficiencies occur for (2) reasons. 1) gases from underlying roof materials are expelling and causing these deficiencies 2) water is getting under the roof surface and creating air pockets and these issues.

Cause: Improper installation of the roof. It is not watertight.

Determination: Replacement required

Remedy: Replacement of roof or a core sample is required to determine extent of damage.

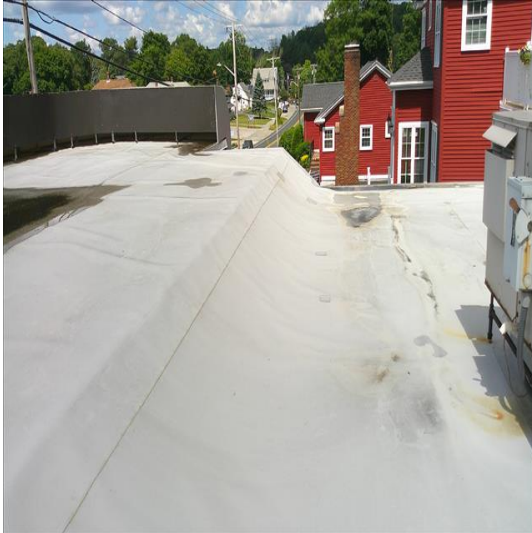
Image Number: 104

Observation: The TPO roof system over the dog grooming facility was observed to have the following deficiencies that require attention; 1) Tenting was observed at locations where a wall/vertical transition was present 2) billowing 3) wrinkling of material. All of these issues indicate that improper installation occurred, and that water is making its way under the material and causing the tenting, billowing and wrinkling. The building owner did not mention if another roof covering is below the current roof. These deficiencies occur for (2) reasons. 1) gases from underlying roof materials are expelling and causing these deficiencies 2) water is getting under the roof surface and creating air pockets and these issues.

Cause: Improper installation of the roof. It is not watertight.

Determination: Replacement required

Remedy: Replacement of roof or a core sample is required to determine extent of damage.

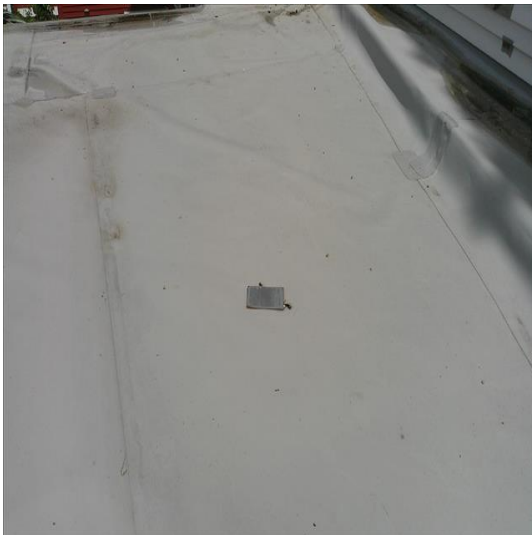
Image Number: 105

Observation: The TPO roof system over the dog grooming facility was observed to have the following deficiencies that require attention; 1) Tenting was observed at locations where a wall/vertical transition was present 2) billowing 3) wrinkling of material. All of these issues indicate that improper installation occurred, and that water is making its way under the material and causing the tenting, billowing and wrinkling. The building owner did not mention if another roof covering is below the current roof. These deficiencies occur for (2) reasons. 1) gases from underlying roof materials are expelling and causing these deficiencies 2) water is getting under the roof surface and creating air pockets and these issues.

Cause: Improper installation of the roof. It is not watertight.

Determination: Replacement required

Remedy: Replacement of roof or a core sample is required to determine extent of damage.

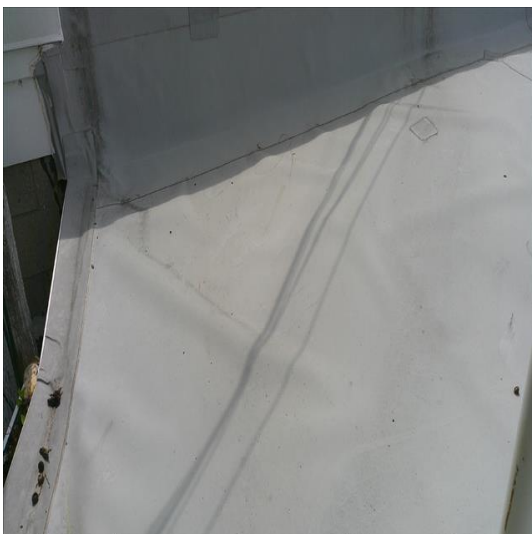
Image Number: 106

Observation: The TPO roof system over the dog grooming facility was observed to have the following deficiencies that require attention; 1) Tenting was observed at locations where a wall/vertical transition was present 2) billowing 3) wrinkling of material. All of these issues indicate that improper installation occurred, and that water is making its way under the material and causing the tenting, billowing and wrinkling. The building owner did not mention if another roof covering is below the current roof. These deficiencies occur for (2) reasons. 1) gases from underlying roof materials are expelling and causing these deficiencies 2) water is getting under the roof surface and creating air pockets and these issues.

Cause: Improper installation of the roof. It is not watertight.

Determination: Replacement required

Remedy: Replacement of roof or a core sample is required to determine extent of damage.

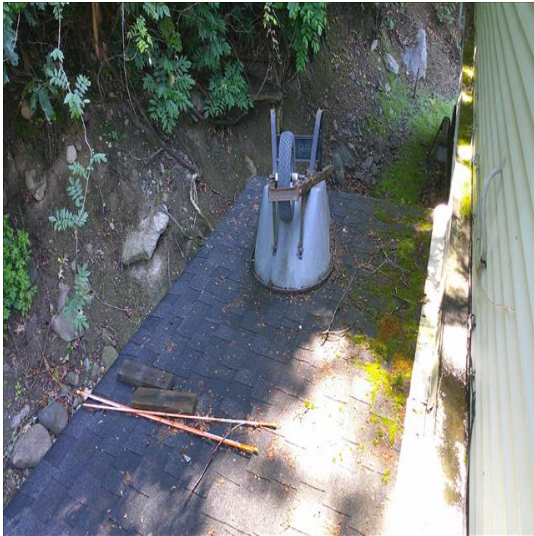
Image Number: 107

Observation: The pitched roof at the rear of the property was observed to have debris and equipment laying directly on the roof surface, moss growing and improper installation of flashing/evidence of previous repairs at the headwall/roof transitions. The roof will deteriorate at an accelerated rate due to the presence of these items on the roof surface. Moss is common in shaded and damp areas. The roof flashing at the headwall was incorrectly installed, with pitch/tar being used as a flashing substitute in some locations.

Cause: Improper installation/deferred maintenance.

Determination: Replacement required

Remedy: Remove these items from the roof surface. Monitor the roof and head wall transition to ensure there is no active leaking.

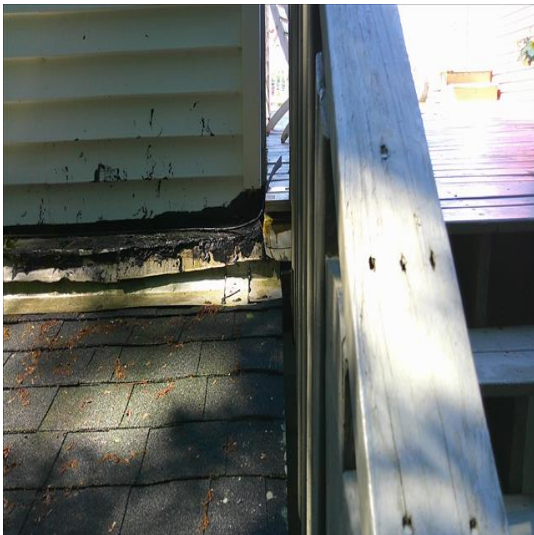
Image Number: 108

Observation: The pitched roof at the rear of the property was observed to have debris and equipment laying directly on the roof surface, moss growing and improper installation of flashing/evidence of previous repairs at the headwall/roof transitions. The roof will deteriorate at an accelerated rate due to the presence of these items on the roof surface. Moss is common in shaded and damp areas. The roof flashing at the headwall was incorrectly installed, with pitch/tar being used as a flashing substitute in some locations.

Cause: Improper installation/deferred maintenance.

Determination: Replacement required

Remedy: Remove these items from the roof surface. Monitor the roof and head wall transition to ensure there is no active leaking.

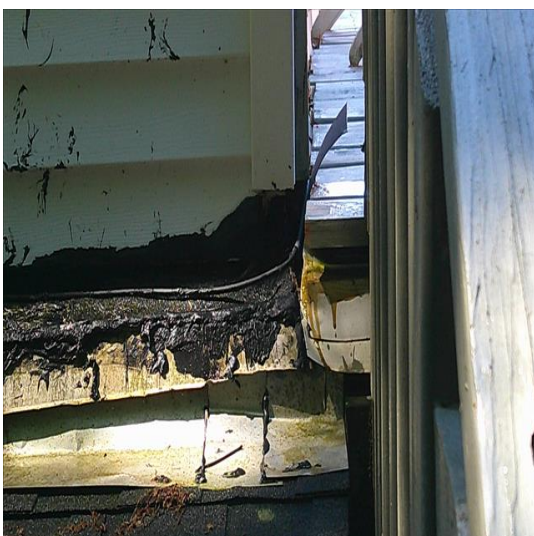
Image Number: 109

Observation: The pitched roof at the rear of the property was observed to have debris and equipment laying directly on the roof surface, moss growing and improper installation of flashing/evidence of previous repairs at the headwall/roof transitions. The roof will deteriorate at an accelerated rate due to the presence of these items on the roof surface. Moss is common in shaded and damp areas. The roof flashing at the headwall was incorrectly installed, with pitch/tar being used as a flashing substitute in some locations.

Cause: Improper installation/deferred maintenance.

Determination: Replacement required

Remedy: Remove these items from the roof surface. Monitor the roof and head wall transition to ensure there is no active leaking.

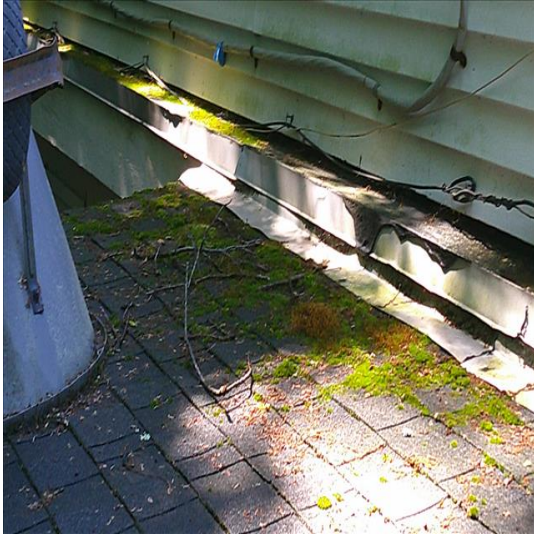
Image Number: 110

Observation: The pitched roof at the rear of the property was observed to have debris and equipment laying directly on the roof surface, moss growing and improper installation of flashing/evidence of previous repairs at the headwall/roof transitions. The roof will deteriorate at an accelerated rate due to the presence of these items on the roof surface. Moss is common in shaded and damp areas. The roof flashing at the headwall was incorrectly installed, with pitch/tar being used as a flashing substitute in some locations.

Cause: Improper installation/deferred maintenance.

Determination: Replacement required

Remedy: Remove these items from the roof surface. Monitor the roof and head wall transition to ensure there is no active leaking.
